UNIVERSITY OF LIEGE
FACULTY OF APPLIED SCIENCE

**Analysis of clogging of bridges during Liège 2021
flood events**

THESIS FOR A MASTER OF SCIENCE IN CIVIL
ENGINEERING SPECIALIZED IN URBAN AND
ENVIRONMENTAL ENGINEERING BY GIANNI MASSIN

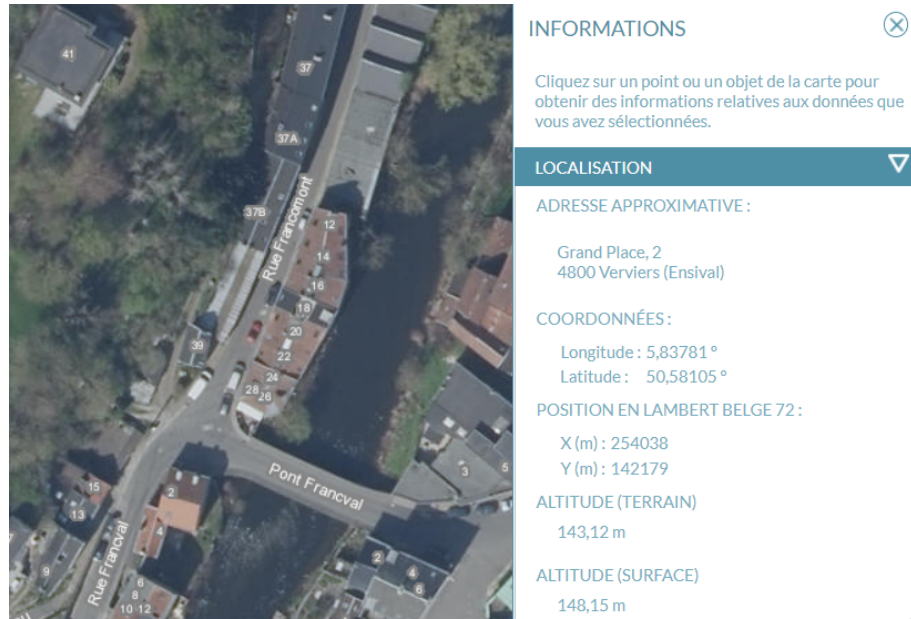
Figure 2.17: Location information of the bridge Francval in Verviers

WalOnMap was the main tool used to encode the location part. By following the Vesdre river, it was easy to localize the bridges and discovers the location information as it is directly given by the website using its information tool. The parameters Type of structure, River, Municipality, Structure / street name, X reg, Y reg, Lat, Long were all defined by using WalOnMap. Figure 2.17 shows the information about the bridge Francval, located in Verviers.

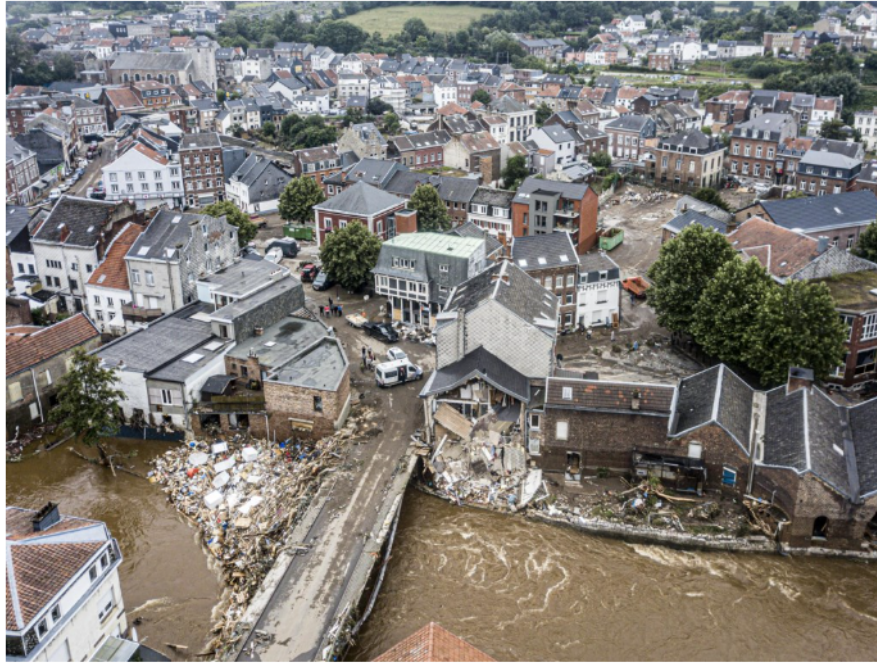
Figure 2.23: Real clogging of the bridge francval

Imagej is a software able to measure the distances between two points on a picture, based on a pixel distance, assuming a reference measurement is known on the picture. This software was used to determine the length, width and volume of the debris based on photos showing the acucmulation of debris on the bridges that we are studying. Most of the time, an aerial photo was taken for the use of imagej in order to have a vertical view, ensuring that the pixel measurement was close to the reality, while a close photo of the clogging was used to estimate points of comparisons. The procedure was to use an general image from WalOnMap and generate a reference measurement of this image on Imagej. After that, a surface of the estimated clogging or carpet was traced and the area automatically calculated. Width and length were calculated based on this surface shape and volume was estimated with an estimation of the average height. Figures 2.24 and 2.25 show this procedure for the bridge Francval. The photo showing the real clogging is in figure 2.23.
