## **Thermal stability and wear behaviour of AISI S2 tool steel processed by Laser Powder Bed Fusion**

***Thermal stability and wear behaviour of AISI S2 tool steel  
processed by Laser Powder Bed Fusion***

Master's Thesis in order to obtain the degree  
of Master of Science in Materials Engineering by

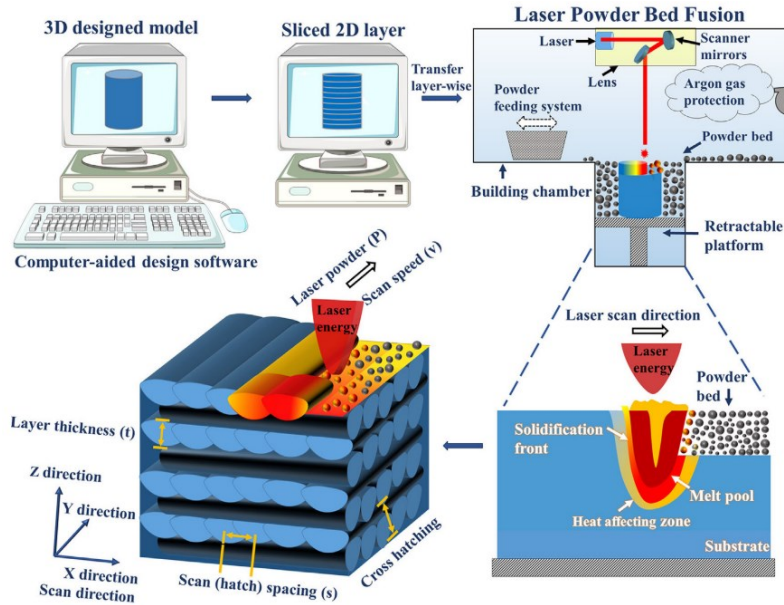
Figure 1: Schematic illustration of the LPBF process[18].

Over the past few decades, Laser Powder Bed Fusion (LPBF), previously known as Selective Laser Melting (SLM) [13], has emerged as a particularly suitable technique among AM methods for producing near-net shape parts from powder. This technique involves the selective fusion of a powder-bed using a high-powered laser source [11, 12]. The LPBF process is currently regarded as the most versatile metal AM process [3]. It begins with the creation of a 3D CAD model, which is sliced into thin layers with selected scan paths [15]. If necessary, the initial step of printing involves preheating the platform to ensure a constant and controlled temperature [14]. The preheating step can improve the processability, mitigate the lack fusion and cold cracking defects, and reduce the residual stresses [13, 15]. The LPBF operates within an inert gas-protected chamber to prevent oxidation and contamination [17]. The powder feeding system distributes a thin, uniform layer of powder over the platform. Then the laser selectively melts this 2D layer of powder, which solidifies assembled. This process is characterized by the interaction between the laser and the powder, which includes a numerous physical phenomenon such as absorptivity of powder to laser radiation, balling phenomenon, and thermal fluctuation [11]. Once a layer is completed, the platform is lowered by a distance equal to the layer thickness, a new layer of powder is spread on top of the previous one, and the process is repeated. This cycle is repeated until the 3D solid object is built [3]. Figure 1 shows a schematic illustration of the process.

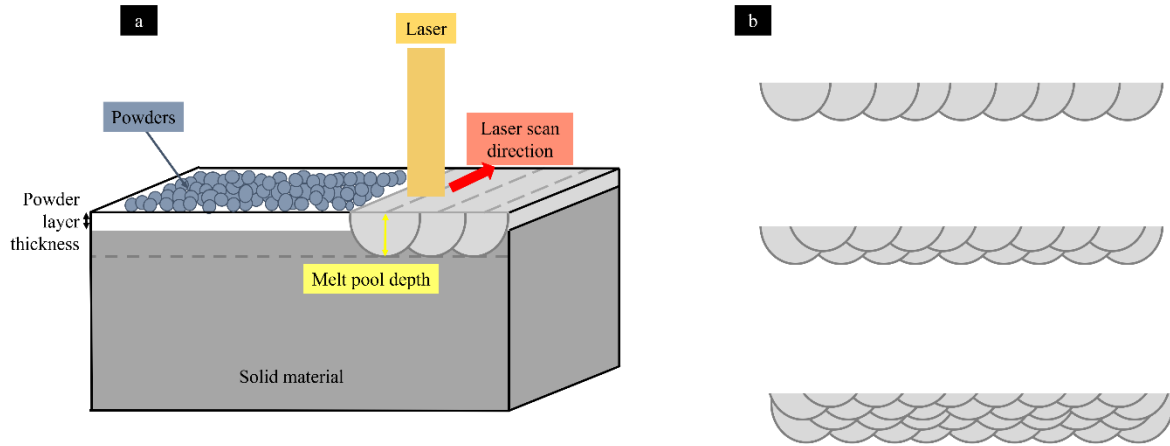
Figure 2: a) sketch of LPBF process showing melt pools and re-melting of the previous layer; b) overlap of the melt pools horizontally and vertically.

continuous passage of the laser causes a re-melting of the top portion of the previous layer to ensure proper attachment of each successive layer (Figure 2). This re-melting process results in a complex thermal history for the microstructure [1]. The area affected by the passage of the laser is called the Heat Affected Zone (HAZ) [21]. The final microstructure of the LPBF is extremely related to the process parameter and the in-situ heat treatments. In general, the microstructure reveals melt pools generated by the laser beam with orientation based on the chosen scanning strategy [22].

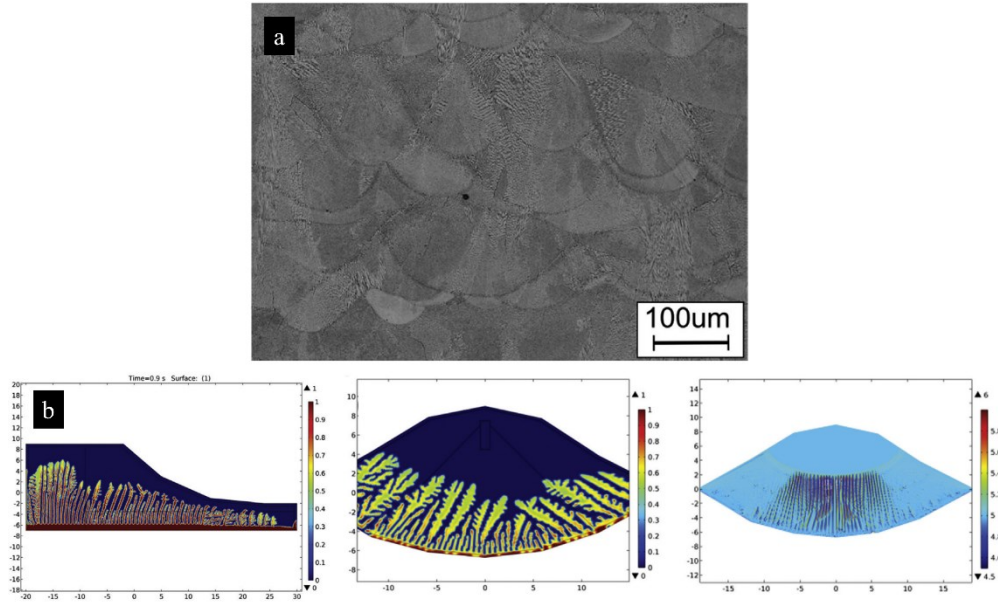
Figure 3: a) Micrograph of the melt pool; b) example of numerical simulation of dendritic solidification in LPBF.[26]

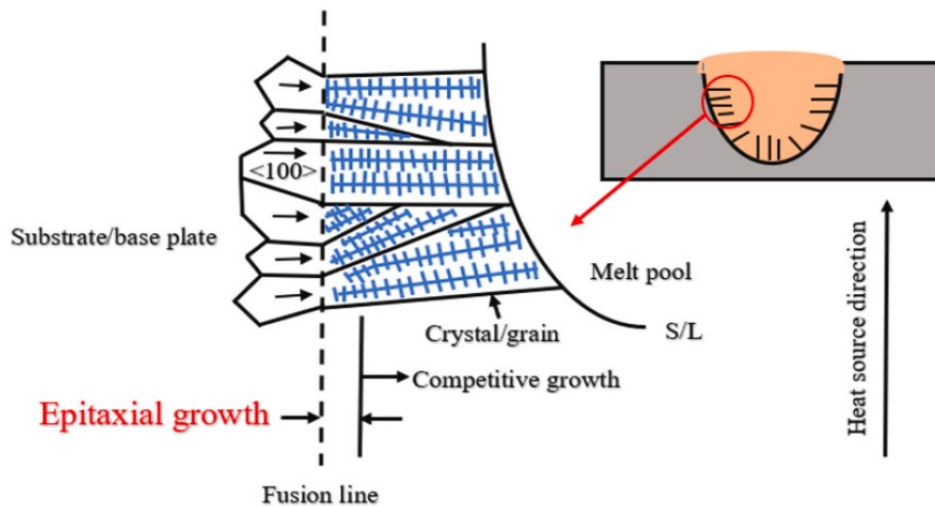
Figure 4: Schematic illustration of epitaxial growth. [3]

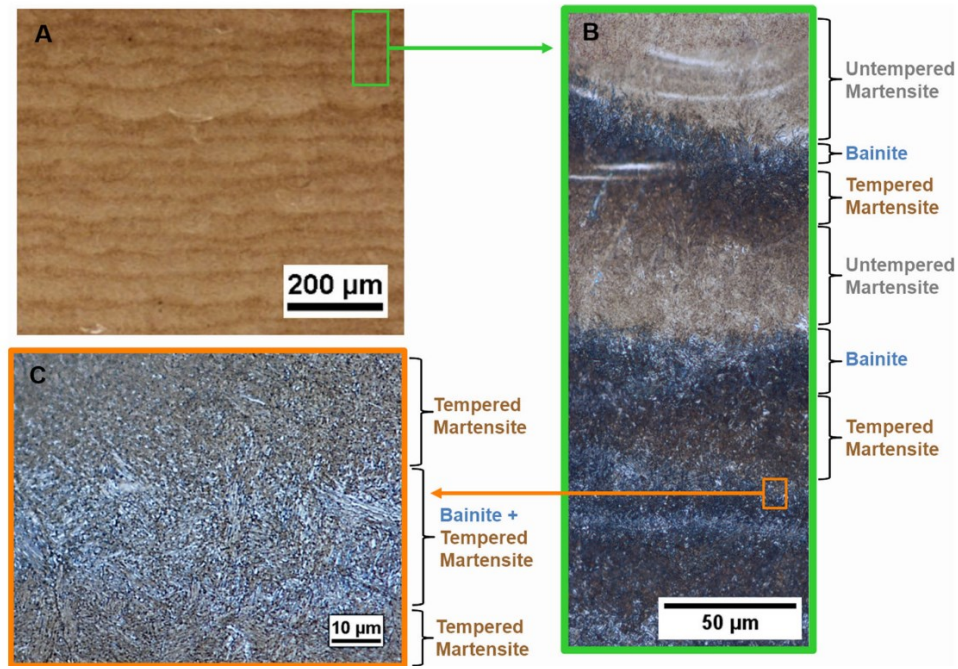
Figure 5: Microstructure of LPBF steel characterized by tempered and untempered martensite and bainite.[24]

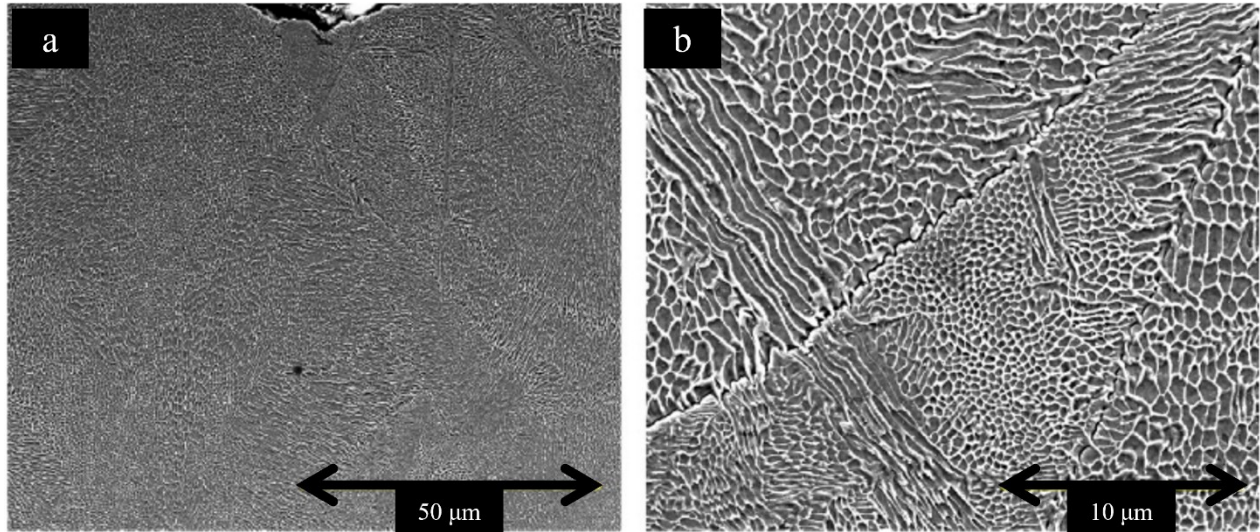
Figure 6: SEM micrographs of martensitic LPBF steel showing cellular structure at a) 50  $\mu\text{m}$  and b) 10  $\mu\text{m}$ . [30]

LPBF microstructures are further characterized by the presence of cellular segregation structures [20, 29, 32] (Figure 6), which can increase the material's strength and dislocation density [24]. This combination of rapid solidification, high thermal gradients, and repeated thermal cycles results in a complex, fine-scale microstructure [3, 33, 34].

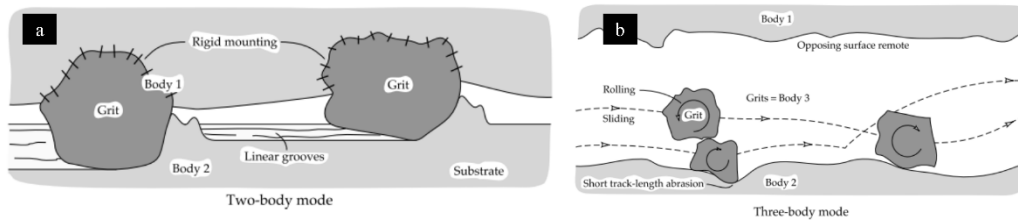
Figure 8: a) two-bodies abrasive mode; b) three-bodies abrasive mode.[56]

Additionally, abrasive wear can manifest in either two-body (Figure 8.a) or three-body modes (Figure 8.b). In the three-body mode, abrasive wear may contend with adhesive wear, emerging after the initial stages of abrasion, during which wear debris plays a contributory role in the process.

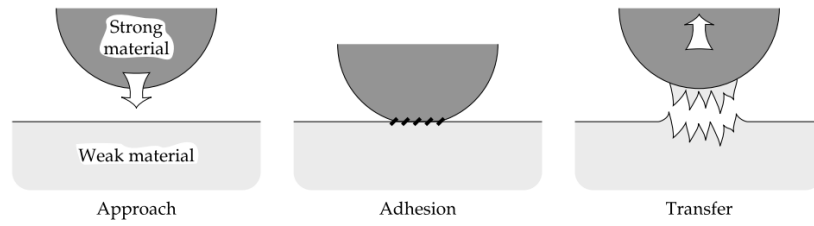
Figure 9: Schematic representation of adhesive wear.[57]

Adhesive wear is a severe form of wear characterized by a high wear rate and unstable Coefficient of Friction [57]. This mode is due to the removal of material due to high adhesive force with high plastic deformation due to the removal (Figure 9).

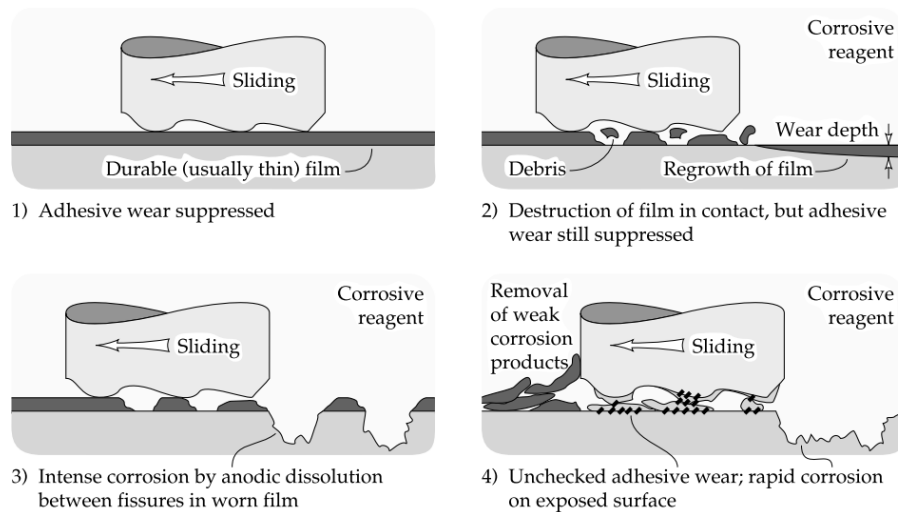
Figure 11: Schematic possible illustration of corrosive wear:[58]

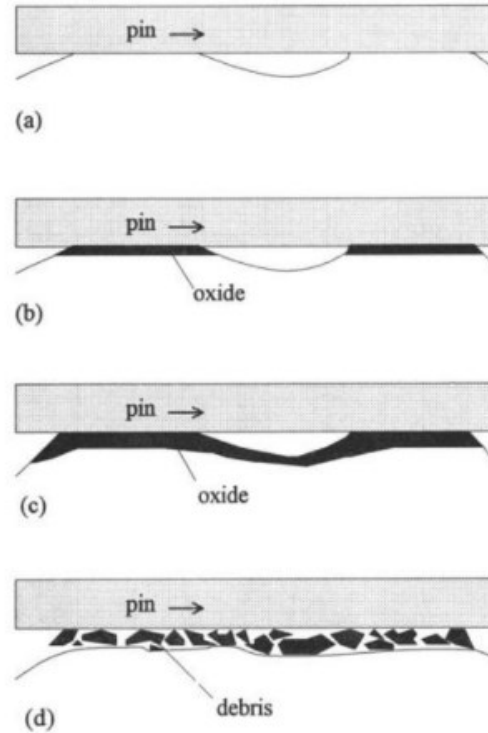
Figure 12: Schematic representation of oxidative wear steps.[60]

In the initial stages of oxidative wear, surfaces come into contact and slide against each other, resulting in severe wear and forming a bond. This contact is not uniform across the entire surface, due to inherent surface roughness. Some areas experience higher contact while others do not contact at all. During this early interaction, plateaus begin to form, and oxide starts to develop in these zones due to the dry-sliding contact and the metal's reaction with oxygen. This initial phase of oxidative wear functions as a mild wear mechanism, characterized by a growing but stationary stage marked by the formation of an oxide film. As sliding continues, the oxide layer thickens and spreads, eventually reaching a critical film thickness. If the oxide layer continues to grow beyond this thickness due to ongoing contact and sliding, it fractures, with a rapidly increasing wear volume. Additionally, secondary hard phases may appear within the metallic substrate, further altering wear properties during subsequent passes and affecting future contact. In this final stage, contact is established in new areas of the surface, making the process repetitive [32, 36, 37].

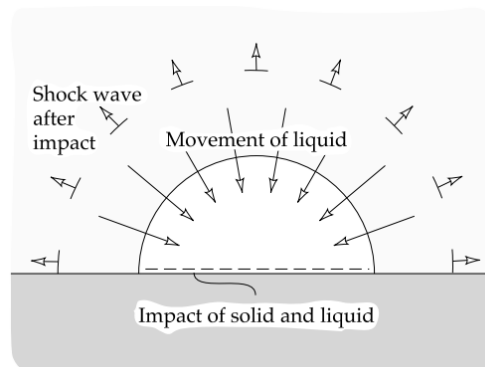
Figure 15: Mechanism of bubble collapsing in cavitation wear.[56]

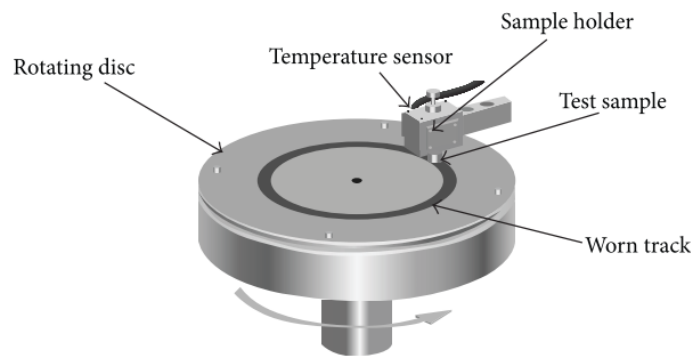
Figure 16: Pin-on-disc machine.[64]

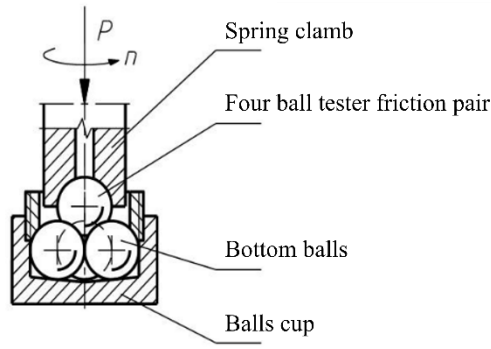
Figure 17: Schematic illustration of four ball tester.[65]

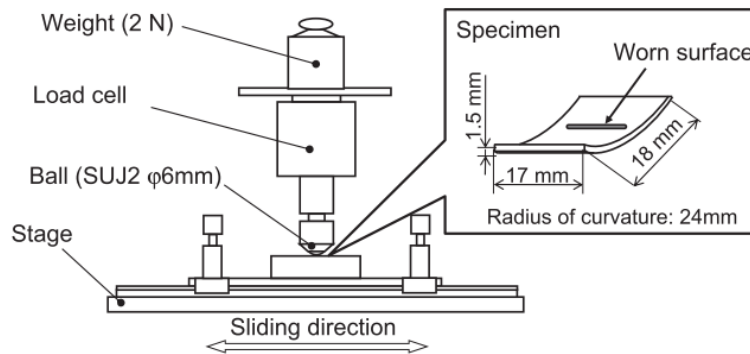
Figure 18: Reciprocating sliding friction scheme.[66]

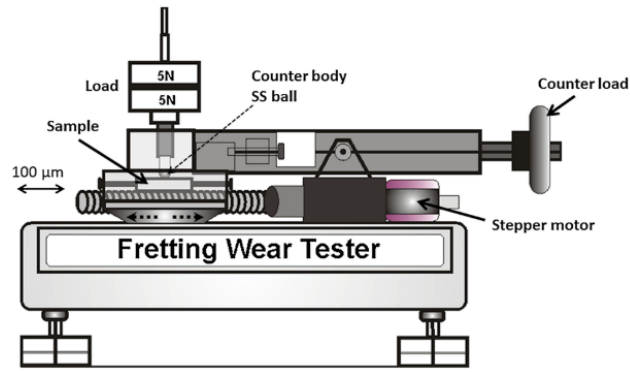
Figure 19: Fretting wear tester scheme.[67]

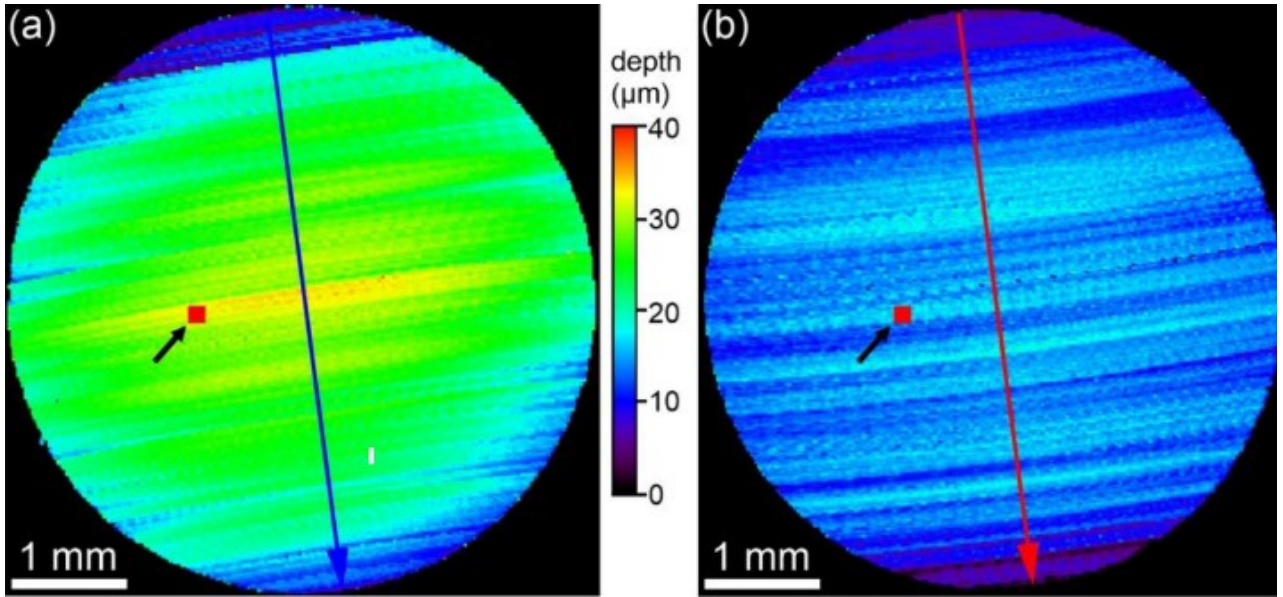
Figure 20: wear track of the same steel a) LPBF printed and b) conventional steel [69]

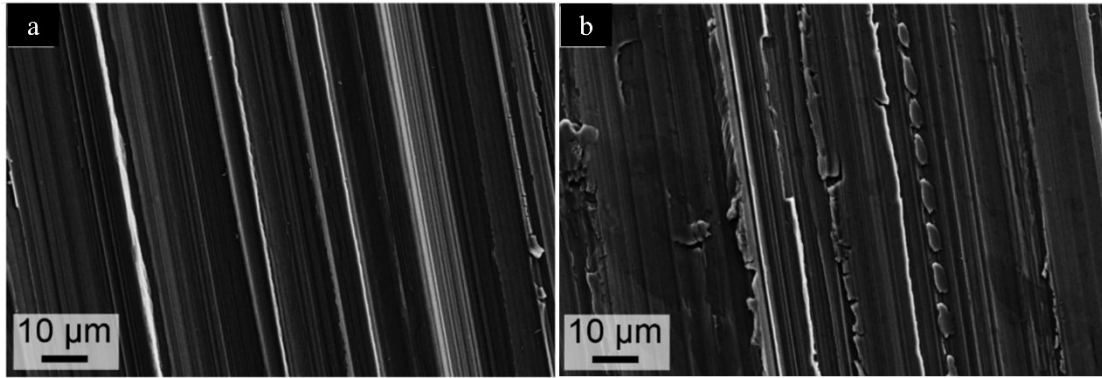
Figure 21: wear track of tool steel; a) grooves and b) plastic deformation of grooves.

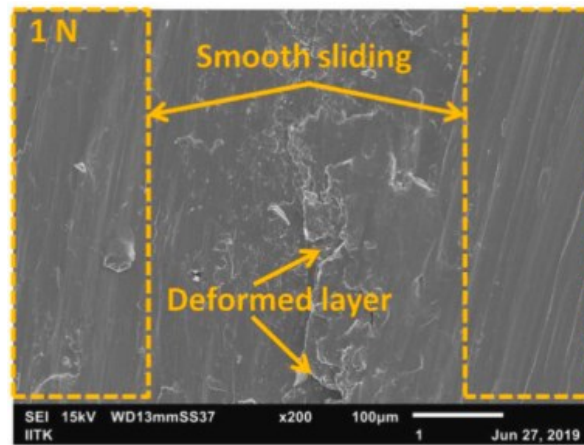
Figure 22: wear track with some deformed zone and smooth sliding.[70]

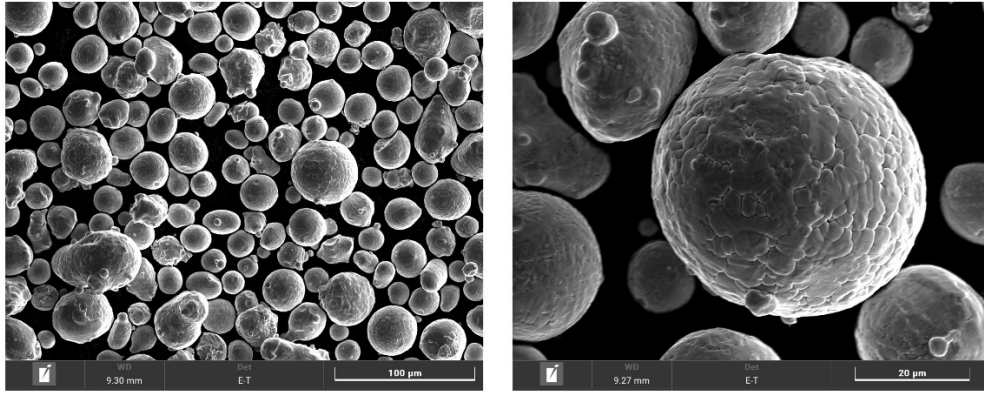
Figure 23: SEM micrographs of the S2 powders.

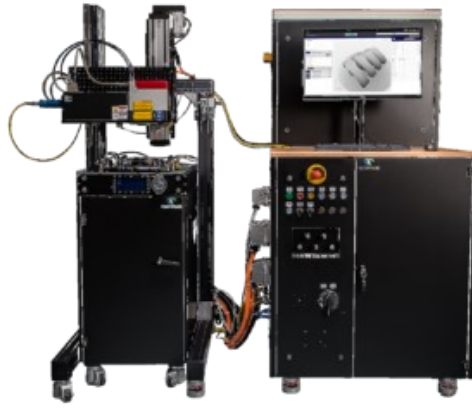
Figure 24: AconityMINI machine. [72]

The samples were printed using an AconityMINI LPBF device, as shown in Figure 24. The processability of S2 powder was studied in previous works of the MMS team [1, 2]. Samples produced in this work were processed with the parameters that allow to achieve fully dense and defect-free parts (Table 2). Two types of samples were produced. One type will be used for the wear test. These samples have a parallelepiped geometry, with a height of 10 mm, a depth and width of 35 mm. According to the dimension of the substrate (140 mm in diameter), four samples were processed during one job (Figure 25). Sample 4 was not considered for further investigation, as it has many spatters on its surface. The second type of samples have a cylindrical geometry, and they will be used for thermal analysis.

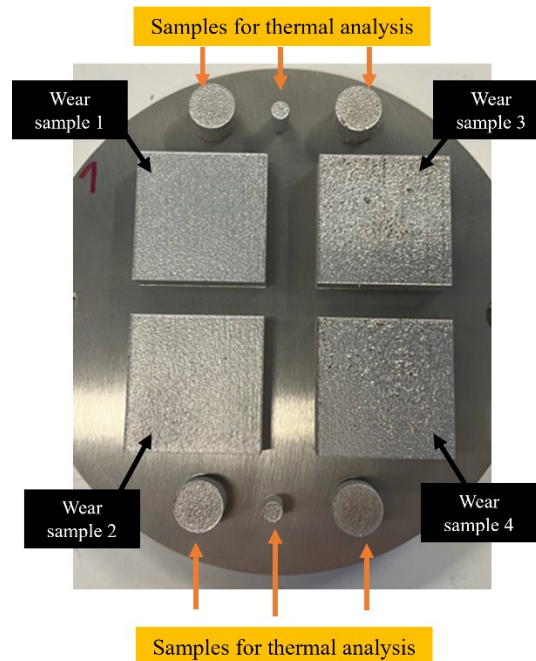
Figure 25: Printed samples. The black arrows indicate the samples for the wear test, and the orange arrows indicate the samples for the heat treatment.

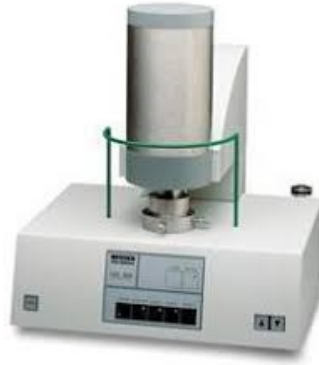
Figure 26: DSC Jupiter -404C from NETZSCH [73].

After production, samples were cut from the substrate by electron-discharge machining. Pieces with a diameter of 5 mm and a height of 2 mm were obtained from the cylinders (Figure 25), in order to fit within the alumina crucible of the DSC. The DSC was a Jupiter - 404C (Figure 26). Based on the results of a previous work of the MMS team [5], three isothermal treatments were carried out at

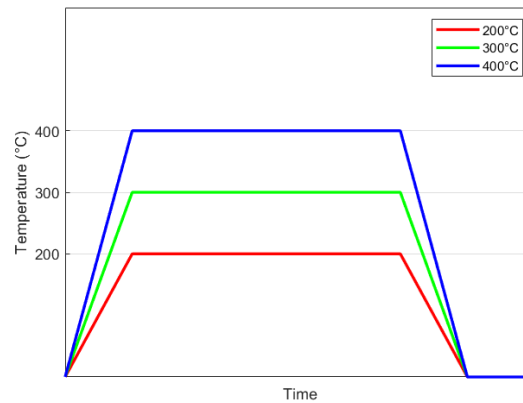
Figure 27: Schematic illustration of the thermal treatments. Isothermal segments are 5 or 10 hours.

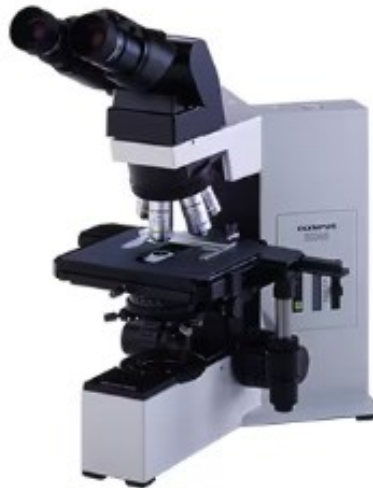
*Figure 28: Olympus BX60 [74].*

Microstructure observations were conducted using an Olympus BX60 microscope (Figure 28) with magnifications of 2.5x, 5x, and 10x. The observations were performed on the microstructure after thermal treatments and on the entire wear tracks. The focus of microstructural observation was to determine the different dimensions and geometry of the melt pool and analyze the wear tracks. The Stream Analysis Software was used to analyze the pictures taken with OM. Stream is an advanced software that permits image acquisition, processing, and measurement.

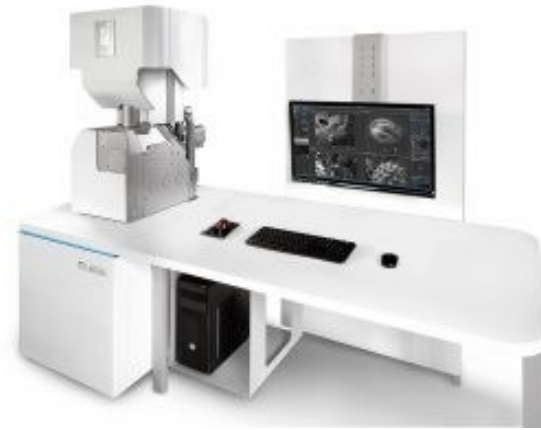
Figure 29: Tescan Clara Ultra-High Resolution SEM machine [75].

A Tescan Clara Ultra-High Resolution (UHR) SEM (Figure 29) was used to investigate microstructure at high magnification. Samples after heat treatments, wear tracks, and cross-sections of the wear tracks were investigated. Moreover, Energy Dispersive Spectroscopy (EDS) was used to recognize the element composition in different zones, either at single points or a line, to understand the possible formation of oxides during wear tests and the composition of the debris.

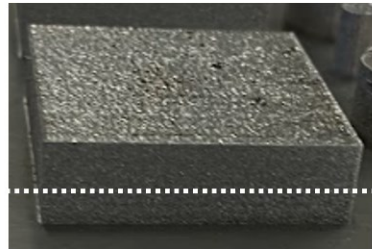
Figure 30: Sample cut for the wear test. The white line is the cutting, for each printed sample four faces will result.

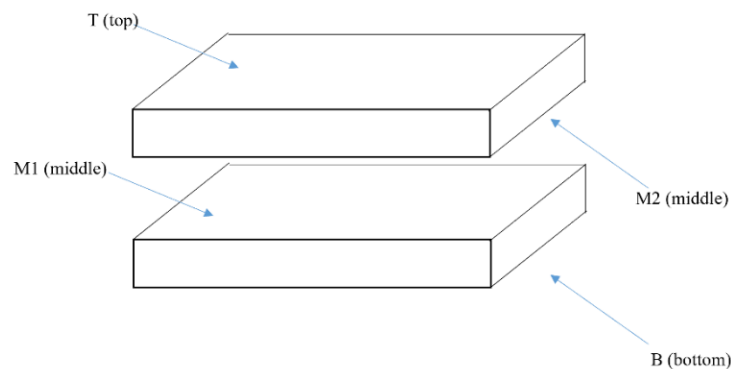
Figure 31: Schematic illustration of wear sample designation from one cut printed sample.

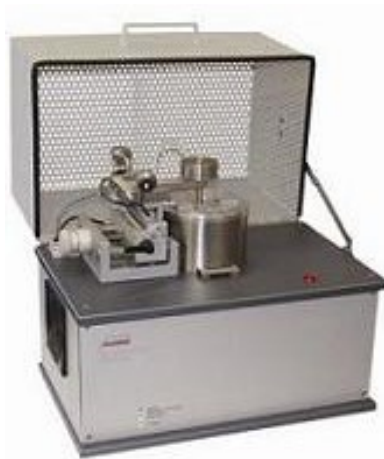
Figure 32: High Temperature Tribometer [77].

Wear tests were performed with the High Temperature Tribometer 01-04611 by the “CSM Instruments SA” company (Figure 32). Both room and high-temperature tests were performed using different samples. The test samples were cut and polished. All the tests were performed using a 6 mm diameter Alumina ( $\text{Al}_2\text{O}_3$ ) ball as the counter-body, with a consistent velocity (10 cm/s) and load (10N) maintained throughout. When possible, two tests were performed on the same face by adjusting the test radius. The Tribometer software collected data and graphs of the Coefficient of Friction (CoF), penetration depth, sample and oven temperature, and friction force during tests. At room temperature, an initial long test of 1500 m (Test RT1500) was conducted. Subsequently, to analyze the evolution of the CoF and the wear sequence, two interrupted tests (RT18 and RT65) were carried out based on the CoF graph of the RT1500 Test, halted at 18,05 m and 65,04 m respectively. This experimental approach of interrupted tests had been previously developed in other experiments of MMS teams [76]. Once the performance of the CoF at room temperature was investigated, high-temperature long-distance wear tests were performed. The temperatures (200°C, 300°C, and 400°C) were consistent with those used in the thermal treatments (section 3.2), allowing for comparison of microstructure changes between thermal treatments and during wear tests. Each of the four long-duration tests (RT1500, HT200, HT300, and HT400) had a duration of over four and a half hours. Specifically, the high-temperature tests proceeded in three steps: first, the entire chamber was brought to the set temperature, then the test was conducted, followed by the final step involving cooling to room temperature.

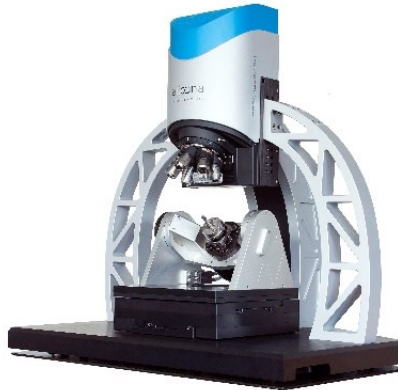
Figure 34: Alicona InfiniteFocusG5 [78].

The Alicona InfiniteFocusG5 (Figure 34) was used to analyze the wear tracks and the surface of the  $\text{Al}_2\text{O}_3$  counter-body after each test. This machine employs a non-contact, optical, three-dimensional measurement principle based on Focus-Variation. The primary component of the system is precision optics containing various lens systems that can be equipped with different objectives, enabling measurements [78]. The instrument's objective magnification is up to 100x.

This instrument was utilized after each wear test to assess the worn volume and the width of the track, as well as to capture micrographs displaying wear variations in different colours. Additionally, the counter-bodies were analyzed to understand their wear.

Using the profilometer (Figure 34), measurements of the width of the worn tracks and the worn volume were conducted (Table 8). The wear rate was obtained by dividing the worn volume by the sliding distance. The worn volume increases with the increase of the sliding distance, due to the

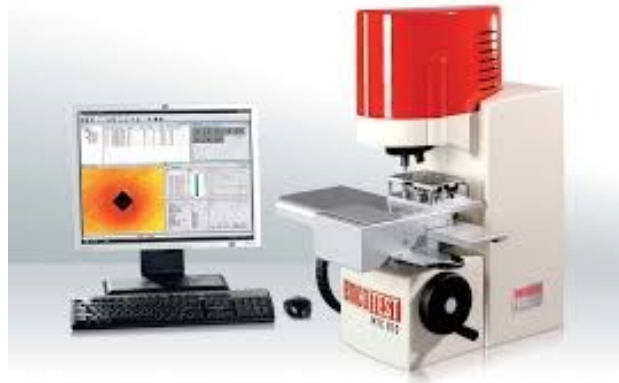
*Figure 35: EMCO M1C 010 hardness machine [79].*

Hardness indentations were performed on the samples after the 5- and 10-hour isothermal treatments, as well as on the unworn surface of the wear tests. The machine used for this experiment was an EMCO M1C 010 (Figure 35). The position of every indentation was manually set, and the load remained consistent for every test (HV5). The purpose of these tests was to compare the results to better understand the microstructural changes after thermal treatment.

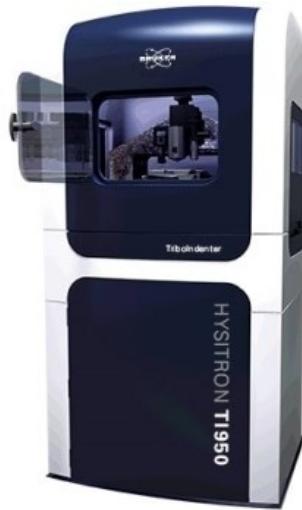
*Figure 36: TI 950 Tribometer nanoindenter [80].*

Nano-indentations were performed in the cross-section of the wear tracks using a TI 950 Triboindenter nanoindenter supplied by the “Hysitron” company (Figure 36).

Nano-hardness indentation grids were conducted within the subsurface regions of the wear tests to elucidate the evolution of nano-hardness across various sections beneath the worn track and to discern potential microstructural alterations resulting from the interaction with the counter body. These grids spanned dimensions of  $36 \times 36 \mu\text{m}$ , comprising  $25 \times 25$  points. The spacing between individual points was consistently maintained at  $1.5 \mu\text{m}$ , with a displacement of  $100 \text{ nm}$ .

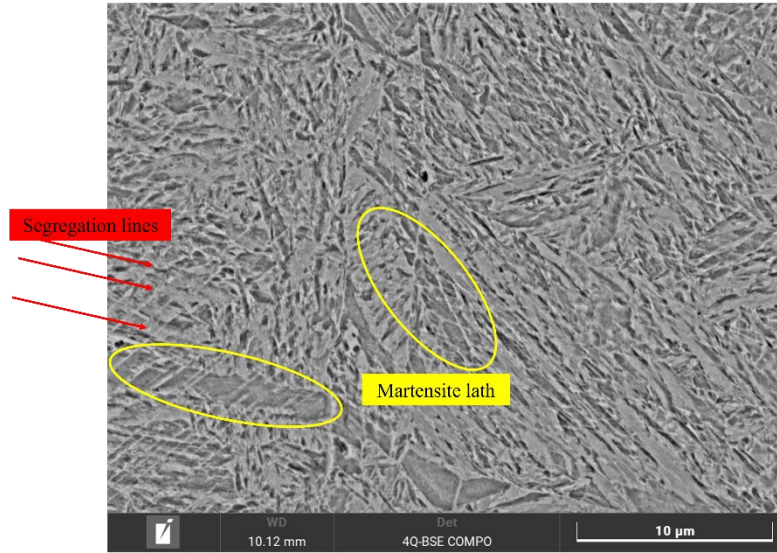
Figure 38: SEM micrograph. Segregation, laths of martensite, and precipitations are highlighted.

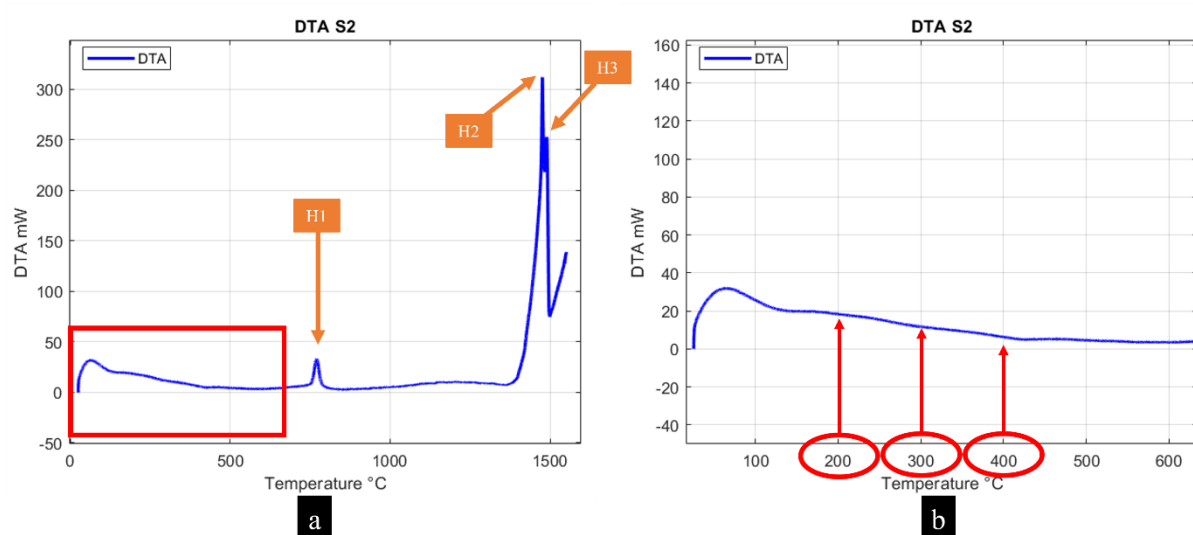
Figure 40: DTA curves of S2; a) shows the complete curve with the red rectangle that highlights the zone of interest; b) is a zoom of the curve a) with the selected temperatures highlighted by red circles and arrows.

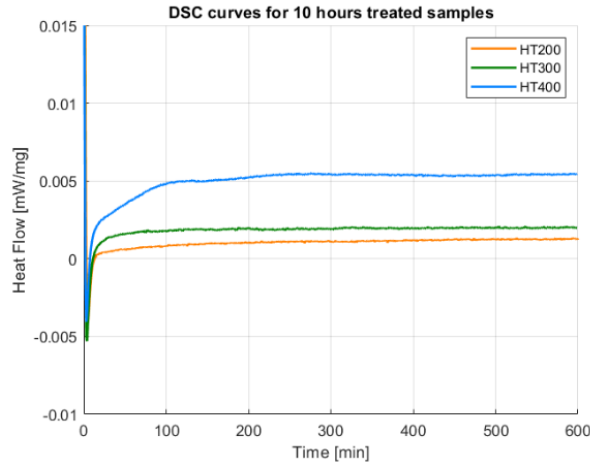
Figure 41: DSC curves for isothermal maintenance with Heat flow plotted on time.

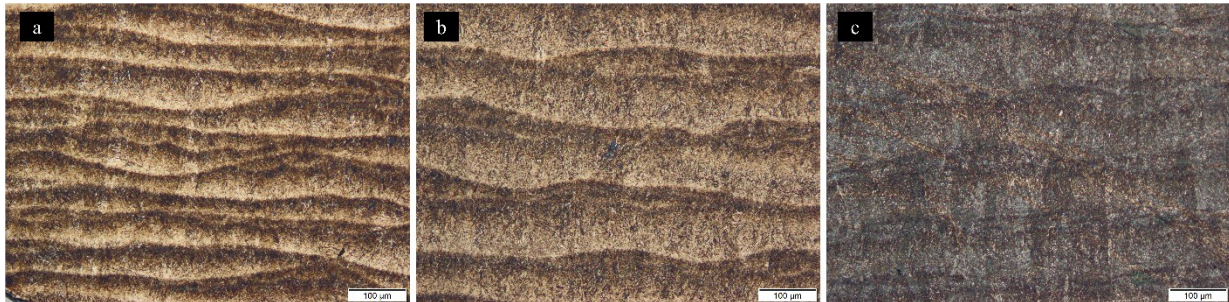
Figure 42: OM micrograph samples post-etching. a) sample treated at 200°C for 10 hours; b) sample treated at 300°C for 10 hours; c) sample treated at 400°C for 10 hours.

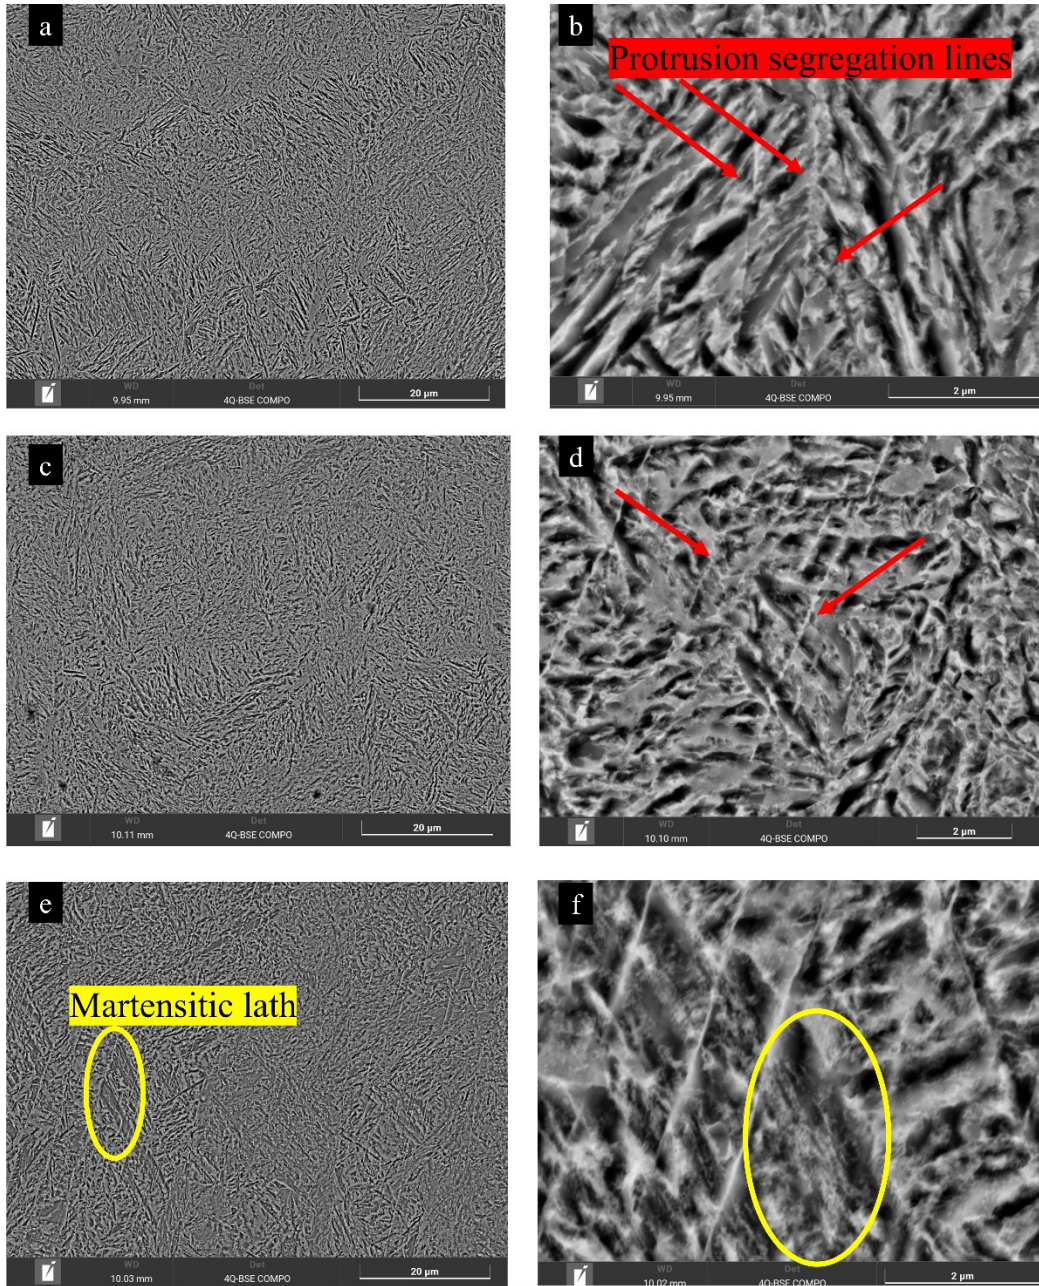
Figure 43: SEM micrographs of 10 hours isothermal treated samples at magnification of 20  $\mu\text{m}$  and 2  $\mu\text{m}$  in scale from left to right. a) and b) samples treated at 200°C; c) and d) sample treated at 300°C; e) and f) sample treated at 400°C.

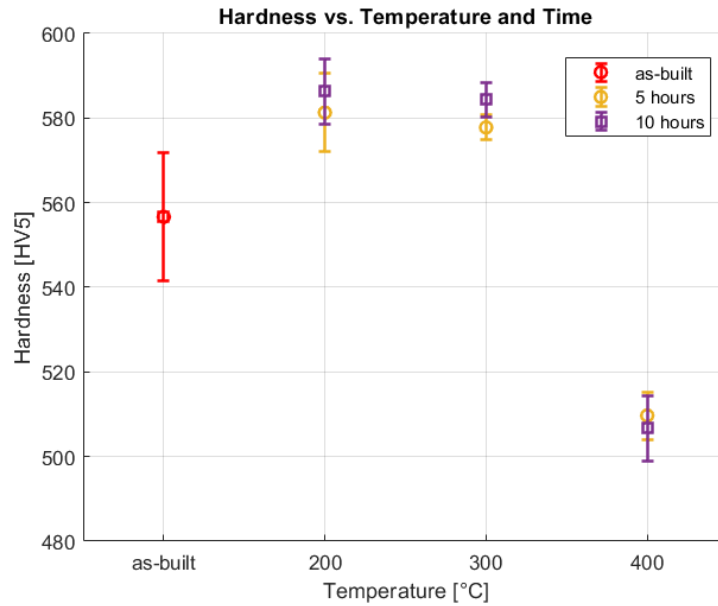
Figure 44: Hardness vs. Temperature and time graphs. The hardness is in HV5.

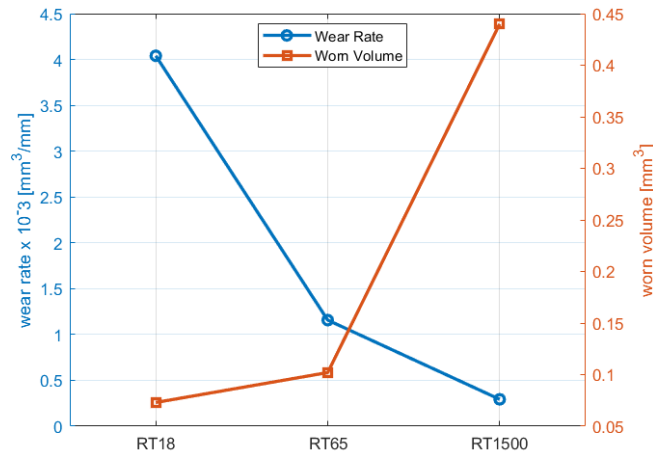
Figure 46: Wear rate (blue) and worn volume (orange) comparison for the three RT tests.

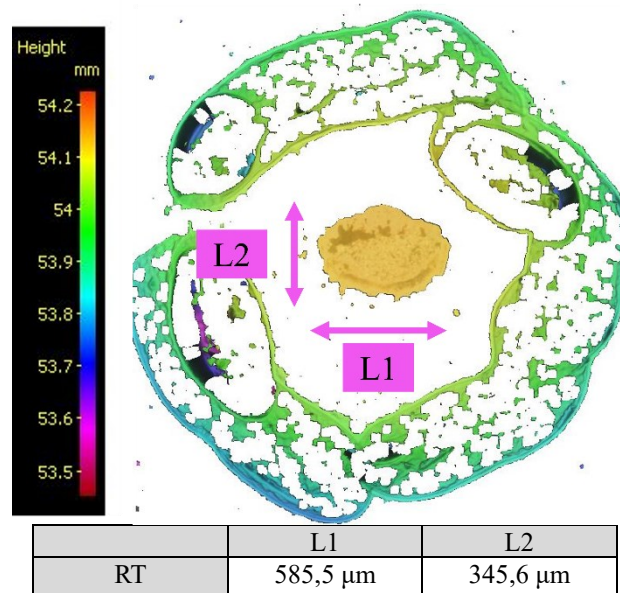
Figure 48: Alumina counter-body photo and size of worn. The range was maintained constant for every examination.

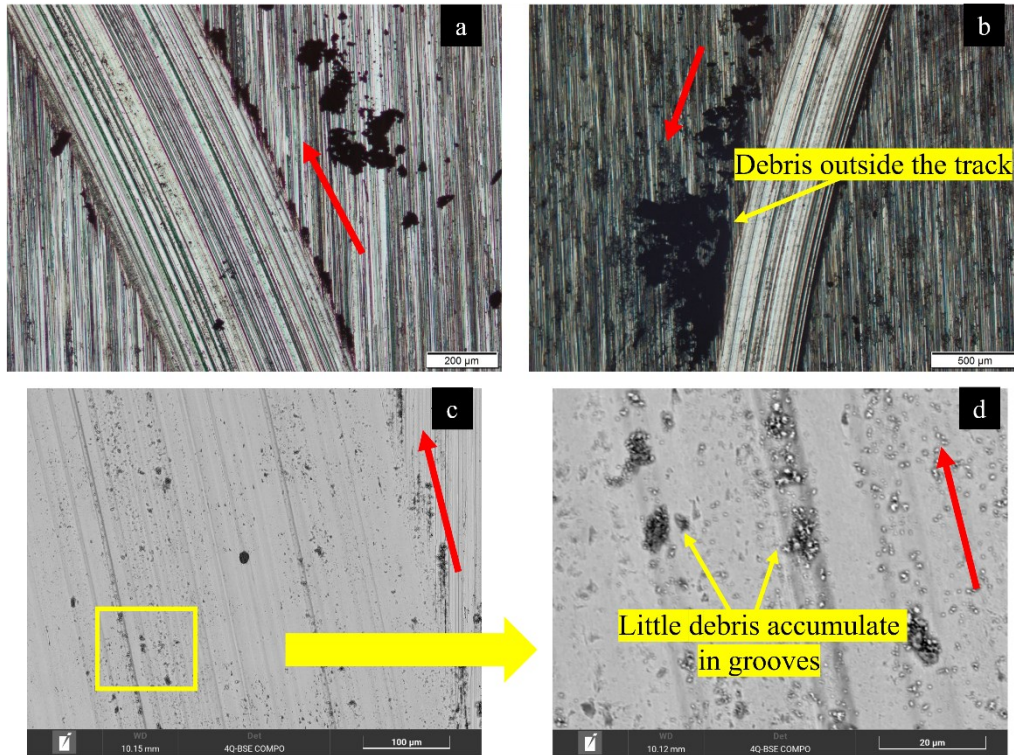
Figure 51: Micrographs of wear tracks of RT1500 test; a) and b) OM micrographs of Track RT1500, c) SEM micrograph and d) a zoom from the yellow rectangle of c) micrograph. The red arrows indicate the sliding direction of the wear tests.

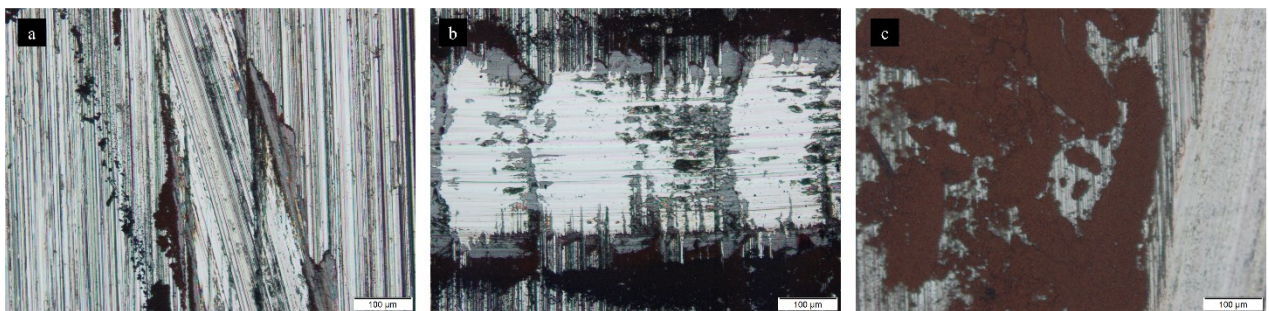
Figure 52: Debris overview of a) RT18; b) RT65 and c) RT1500.

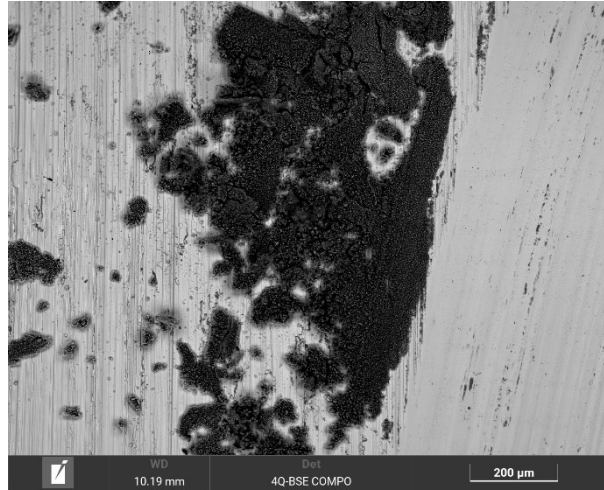
Figure 54: Crushed debris of the RT1500 wear test. The micrograph is taken in the same position as Figure 52.c one.

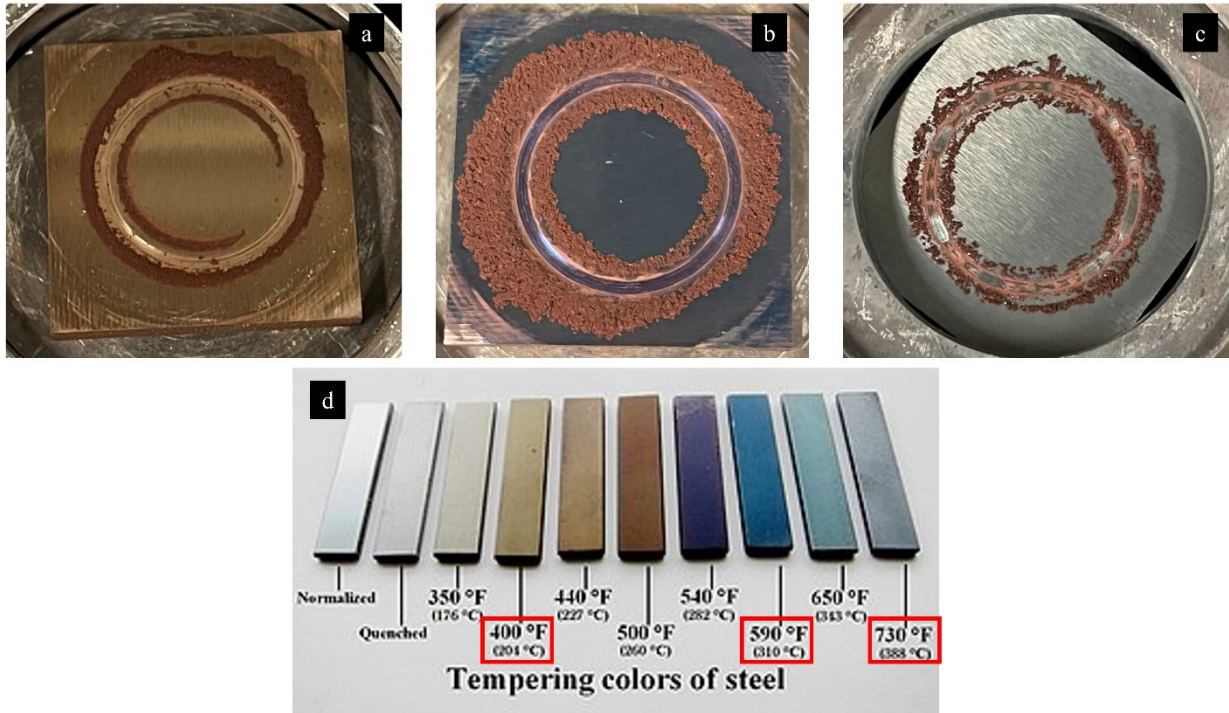
Figure 56: a) wear test at 200°C, showed yellow; b) wear test at 300°C, showed blue; c) wear test at 400°C showed grey; d) tempering steel chart is reported with a highlight on the three temperatures of the wear tests that are consistent with the results[81].

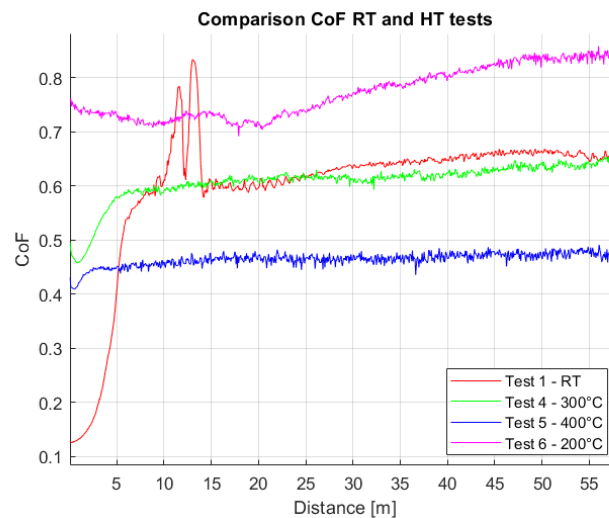
Figure 57: Comparison between Coefficient of Friction of RT and HT tests.

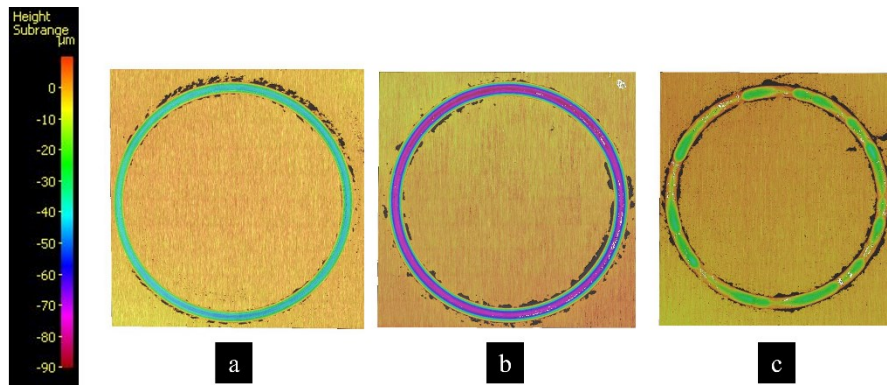
Figure 58: Profilometer photos taken at the same range, reported on the left. a) HT200 test; b) HT300 test and c) HT400 test.

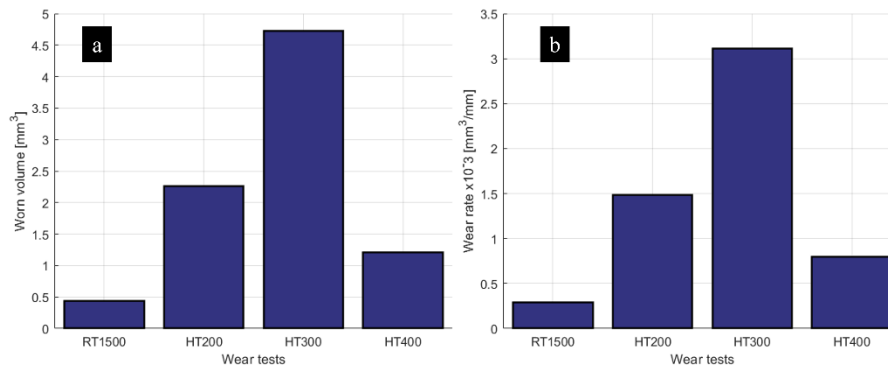
Figure 59: a) Worn volume and b) wear rate comparison of the four long tests.

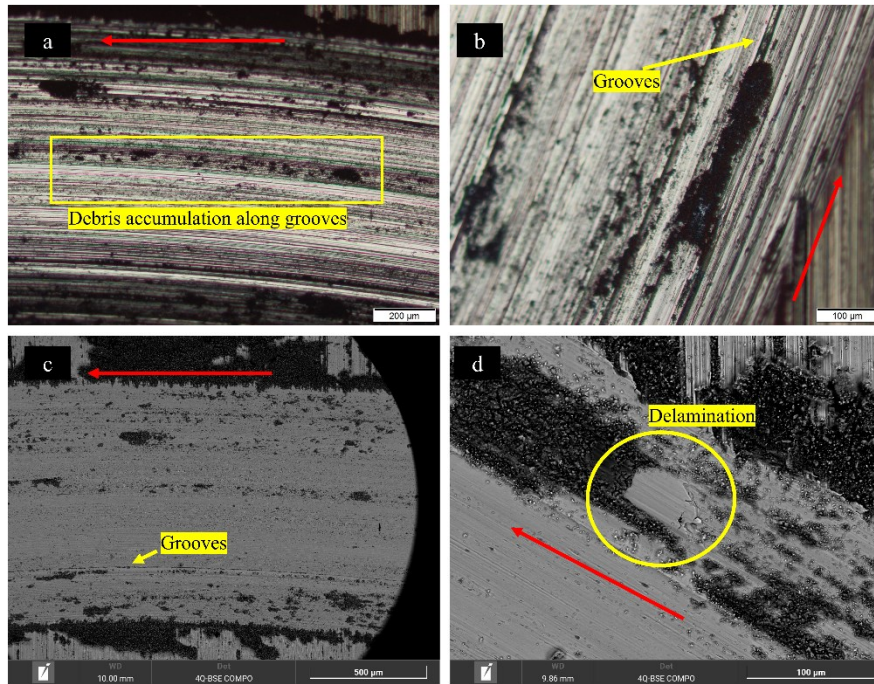
Figure 61: Micrographs wear track HT200 test. a) and b) OM micrographs show the pale yellow surface and the debris along the track; c) SEM photo taken in the same place of a) shows the surface; d) SEM zoom on the detachment along the track.
