## **Thermal stability and wear behaviour of AISI S2 tool steel processed by Laser Powder Bed Fusion**

***Thermal stability and wear behaviour of AISI S2 tool steel  
processed by Laser Powder Bed Fusion***

Master's Thesis in order to obtain the degree  
of Master of Science in Materials Engineering by

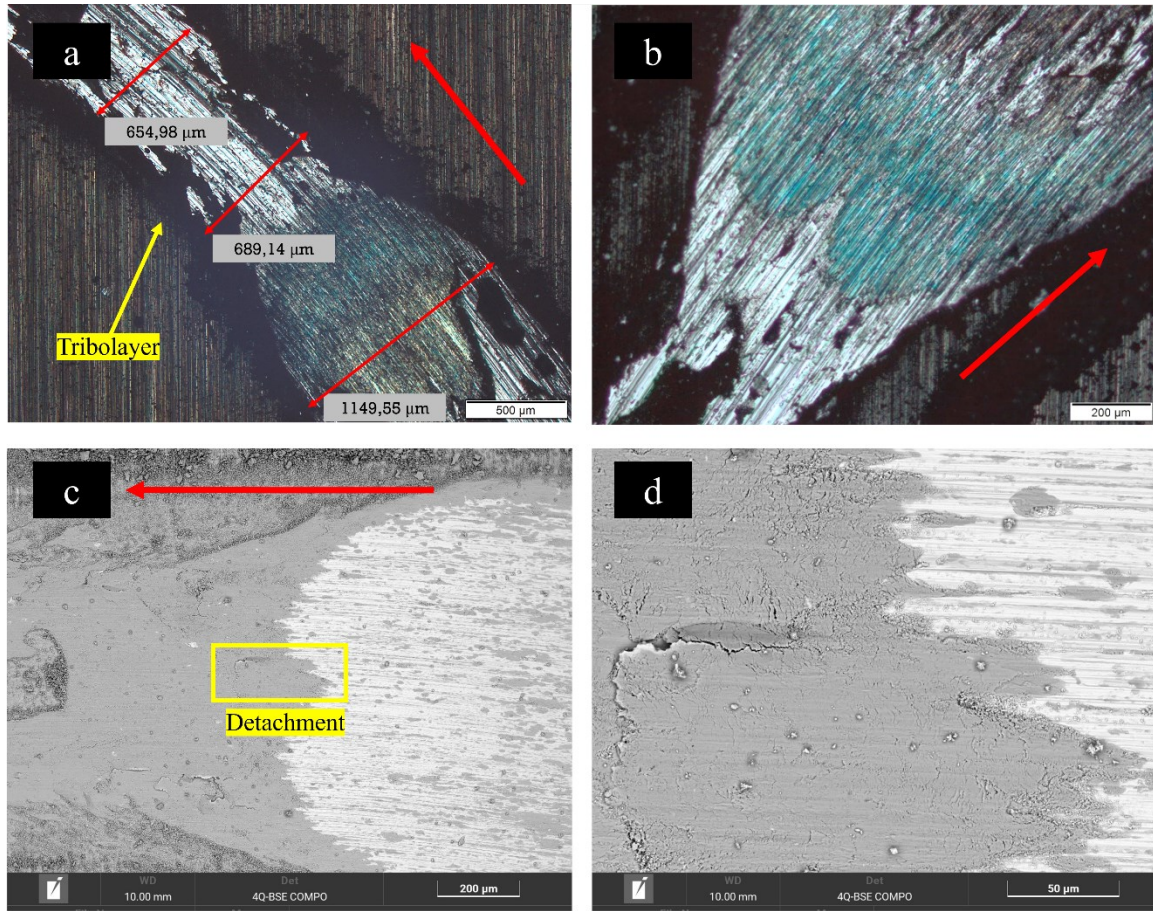
Figure 63: Micrographs HT400 test, red arrows indicate the sliding direction. a) and b) show different parts of the track where the tribolayer is present. c) SEM micrograph of tribolayer and d) zoom of c) where detachment from tribolayer is highlighted.

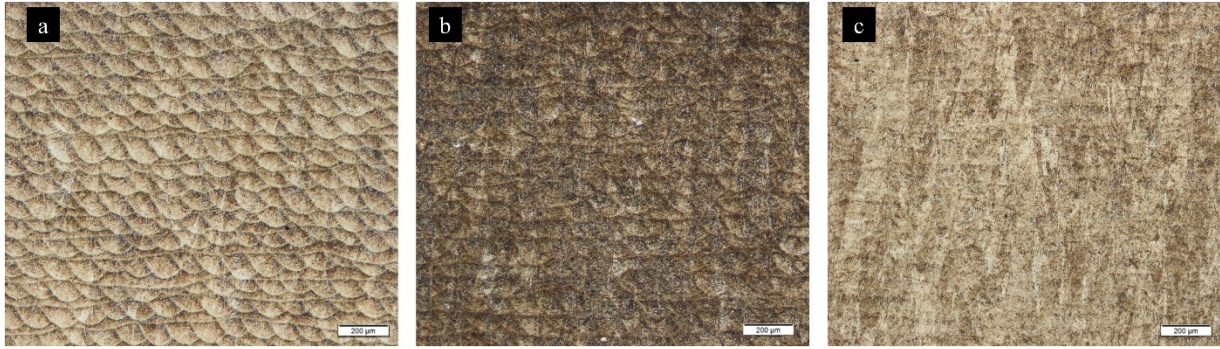
*Figure 64: OM micrographs of the subsurface of wear tests. a) 200°C; b) 300°C; c) 400°C.*

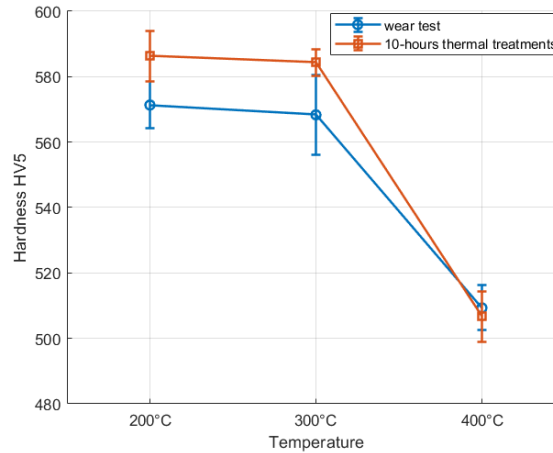
Figure 66: Macro-hardness comparison between HT wear tests and 10-hours thermal treatments.

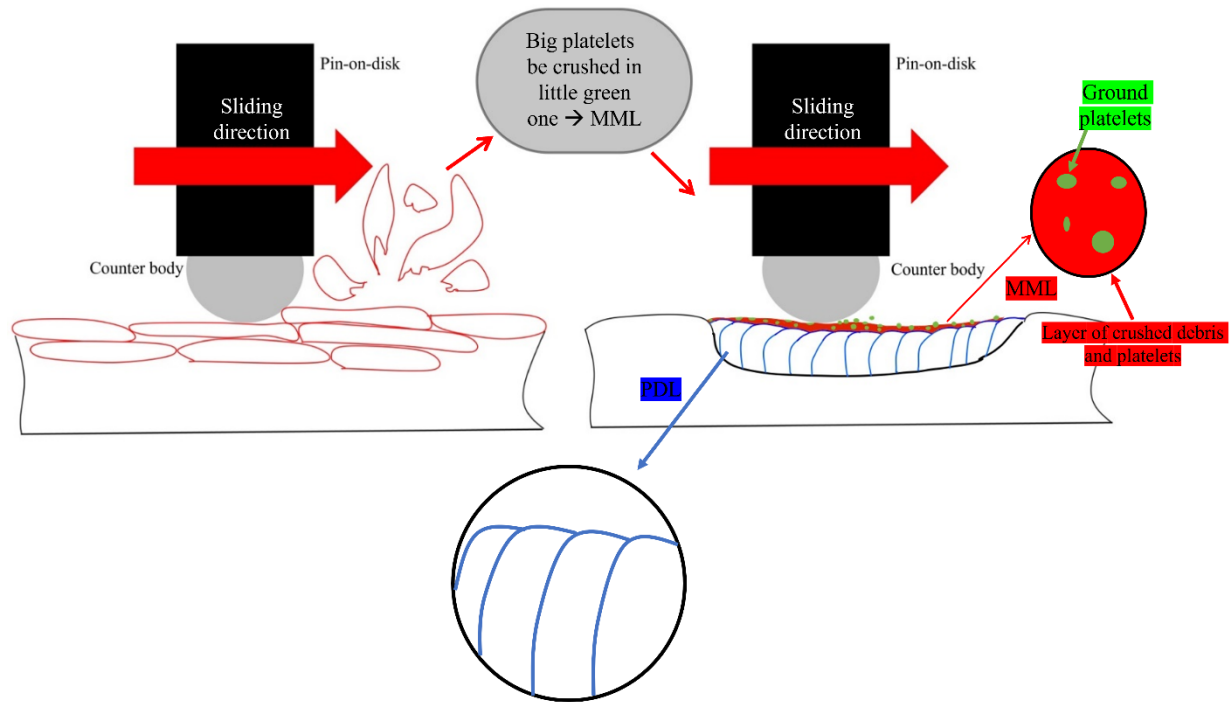
Figure 69: Sketch of MML formation. Platelets were detached, grind, and then form the MML over the PDL.
