Guidelines for Hull Condition Assessment Applicable to Single Skin Bulk Carriers on International Trade

Javier Bru Roncallo

Master Thesis

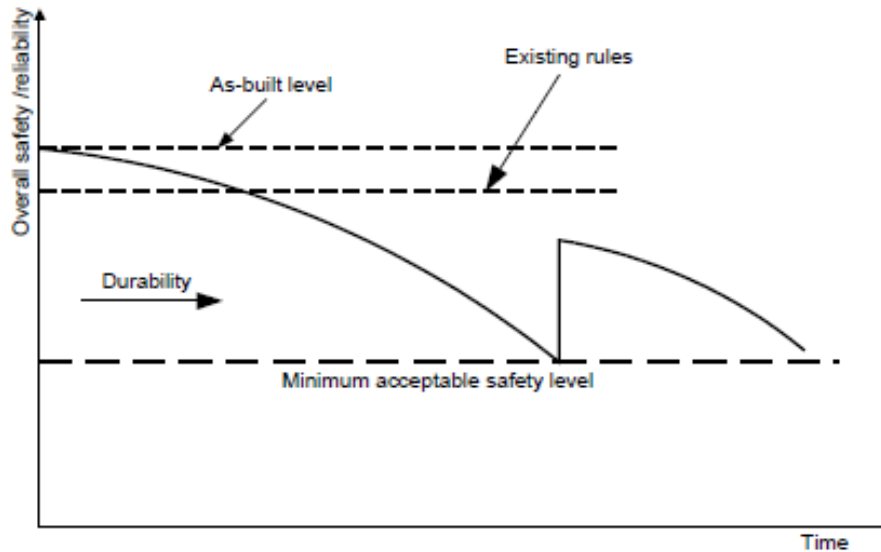
Figure no. 3, from IACS's 2006 Common Rules depicts one of the main aim of the classification rules which is the relation of between the structural requirements and the satisfactory durability of the ship, where the ship structure should have sufficient durability in terms of corrosion margin and fatigue endurance for carrying the intended cargo throughout the intended service period.

Figure 3 - Structural Safety and Durability ((IACS), Common Structural Rules or Bulk carriers, 2006)

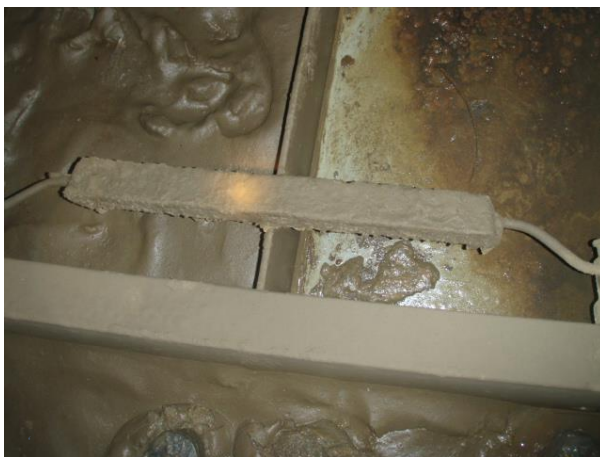
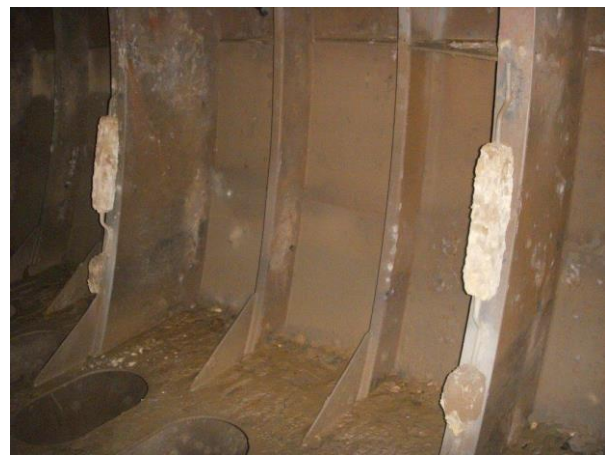
For topside tanks, solar heating in one side of the ship due to the navigational route can lead to increase corrosion rates. Topside, hopper and double bottom tanks have a high humidity while empty and susceptible to atmospheric corrosion. It is important to mention that a protective coating in good condition is the first line of defence against corrosion, since the sacrificial anodes only work when submerged in water. In the below images on figure no. 9, sacrificial anodes inside ballast tanks can be observed.

Figure 9 - Sacrificial Anodes inside Ballast Tanks

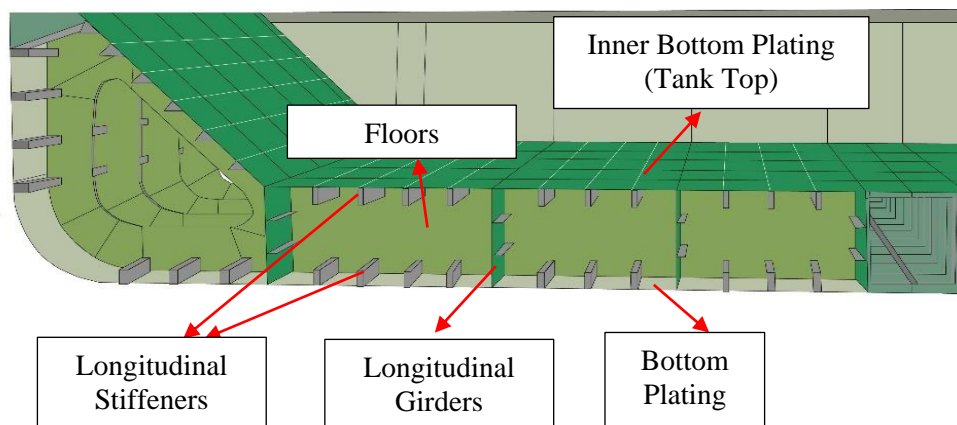
- 1) Bottom & Inner Bottom Plating
- 2) Longitudinal Girders
- 3) Longitudinal Stiffeners Floor
- 4) Floors

Figure no. 12 depicts the different structural elements that comprised bottom region:

Figure 12 - Structural Build Up of the Bottom Region

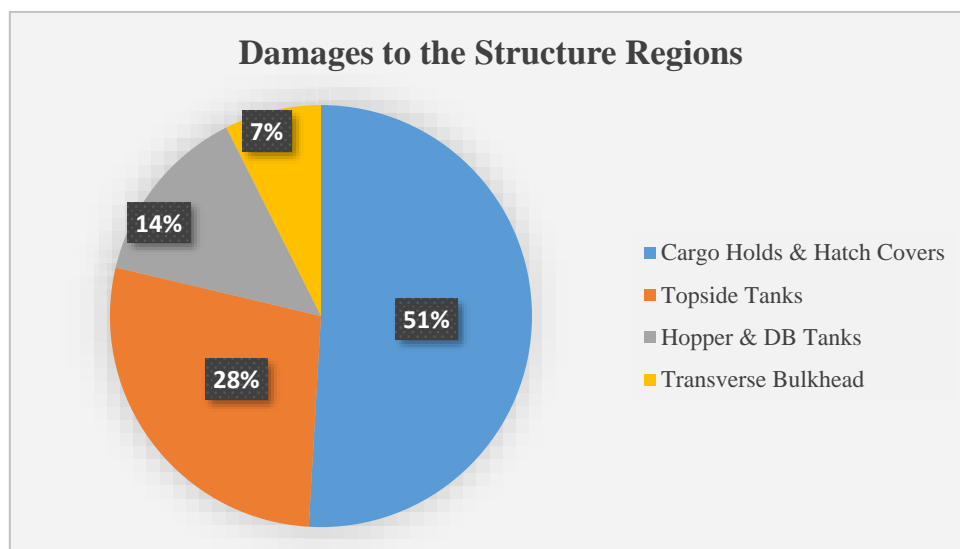
On figure no. 19 shows the percentage distribution of the total number of defects found on OMCS CLASS vessels segregated by hull structure and as it can be seen, defects on cargo holds structure, excessive corrosion on hatch covers and topside tanks structure were the most common and defects on hopper & double bottom tanks and transverse bulkheads transverse bulkheads were the least.

Figure 19 - Defects to the Structure of OMCS CLASS Vessels

Most Common Defects found on OMCS CLASS Bulk Carriers
1. Generalized and localized corrosion of cargo hold side shell frames and brackets.
2. Cracking at cargo hold side shell frame bracket toes.
3. Excessive corrosion on hatch covers
4. Operational damages (grab & bulldozer) to the side shell frames lower brackets, inner bottom plating, hopper and lower stool plating. (Deformations (buckling and indentations)
5. Cracking at intersection of the inner bottom plating and the hopper plating.
6. Cracking at fore and aft extremities of topside tank structures.
7. Excessive corrosion within topside tanks (Frames, longitudinal stiffeners and brackets).
8. Excessive corrosion within Hopper and Double Bottom tanks (Frames, longitudinal stiffeners and brackets).
9. General corrosion and cracking of transverse bulkheads.
10. Cracking of hatch coamings & hatch corners.

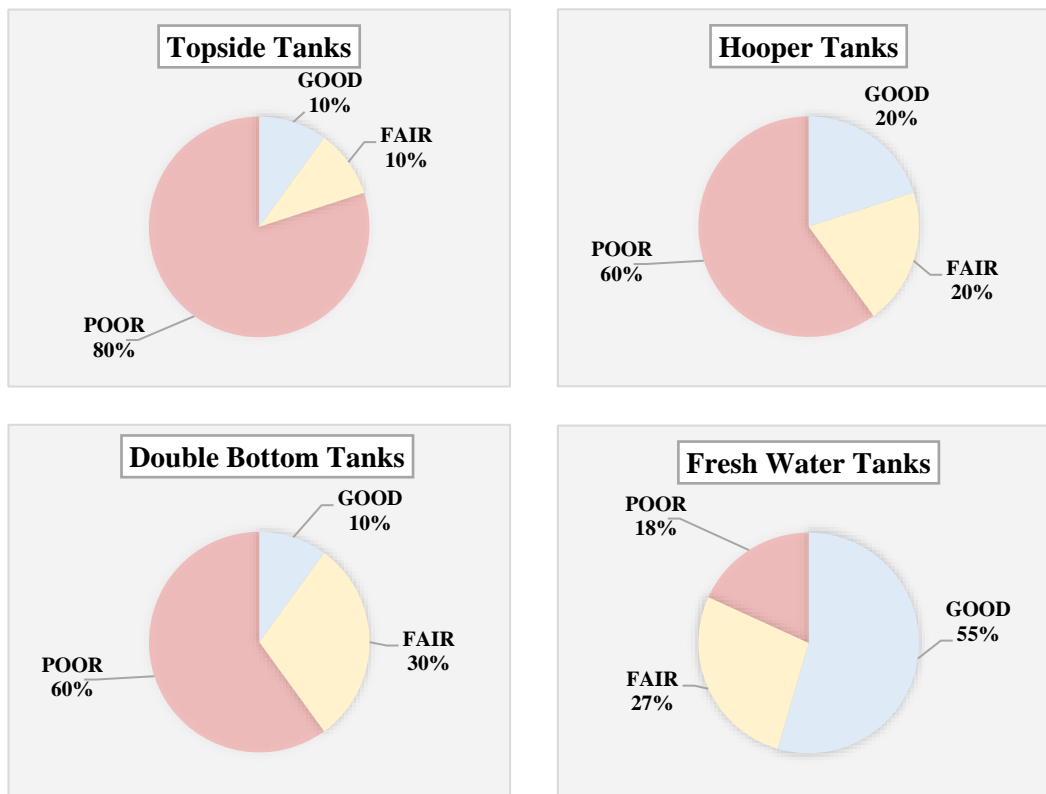
Figure no. 20 shows the condition of the protective coating on the different tanks of OMCS CLASS Vessels.

Figure 20 - Condition of Coating on OMCS CLASS Vessels

For ballast tanks, the corrosive protection system for the most part consist only of the presence of sacrificial anodes since the condition of the protective coating is rated in poor condition for most them. In particular, topside tanks were the ones worst rated.

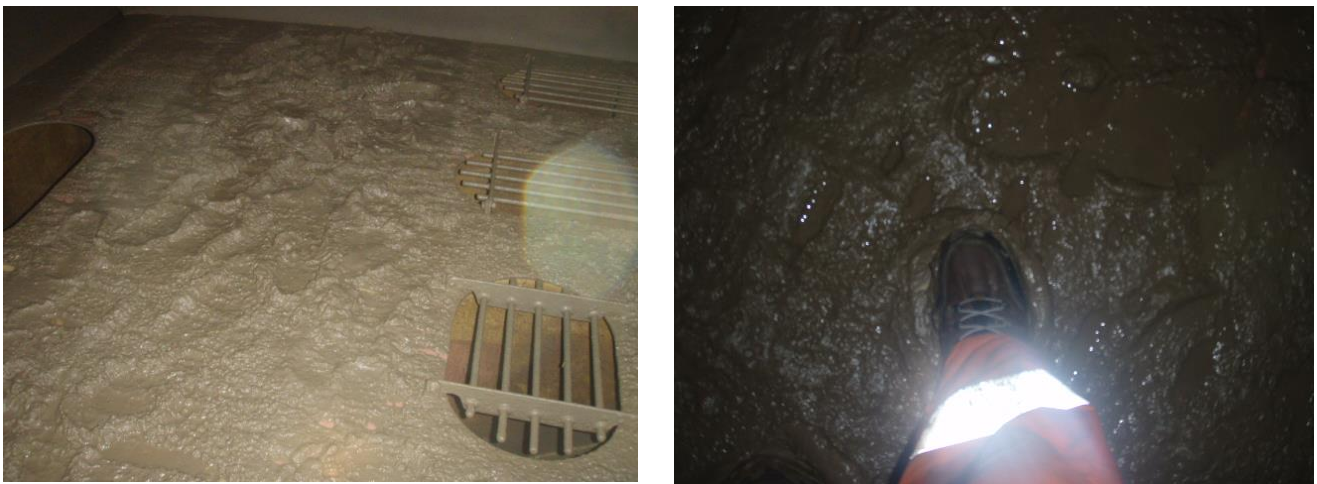
Figures no. 21 shows the typical slippery mud that the surveyors encounter during their ballast tanks inspections.

Figure 21 - Typical slippery mud inside ballast tanks

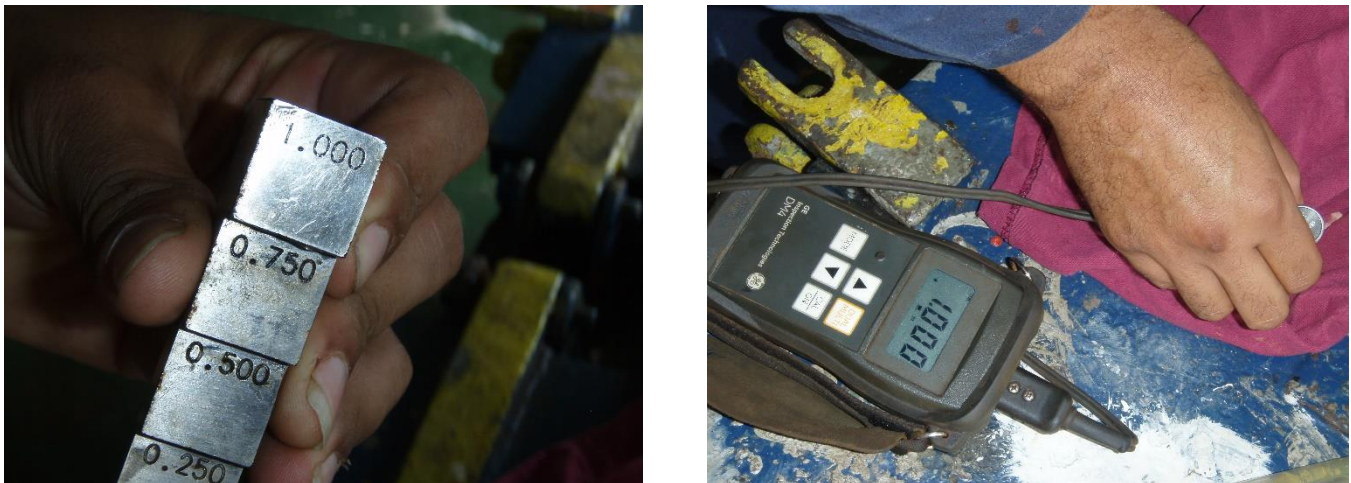
Even though the calibration certificate of the ultrasonic measuring equipment is presented, it is always advisable that the surveyor verify its calibration on situ prior to commence the ship measurements. For this, a calibration block is provided and measurements of thickness of known structures can be performed, as depicted on figures no. 22.

Figure 22 - Calibration block and ultrasonic thickness equipment

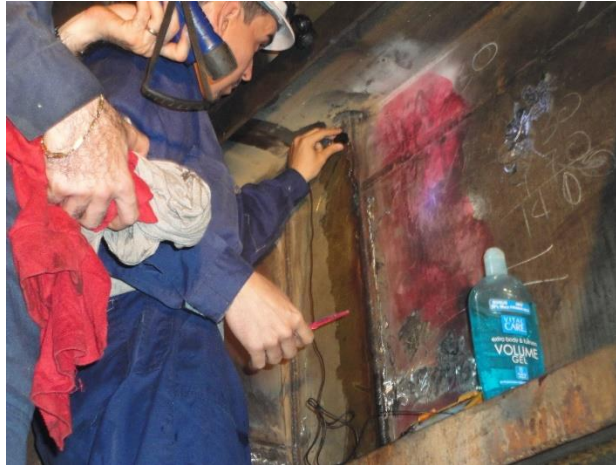
On figure no. 23, it can be observed non-destructive testing being performed on a side shell welding; specifically, dye penetrant and ultrasonic to determine surface and root defects on the welding seam.

Figure 23 - Welding on the side shell checked with dye penetrant and ultrasonic equipment to detect flaws

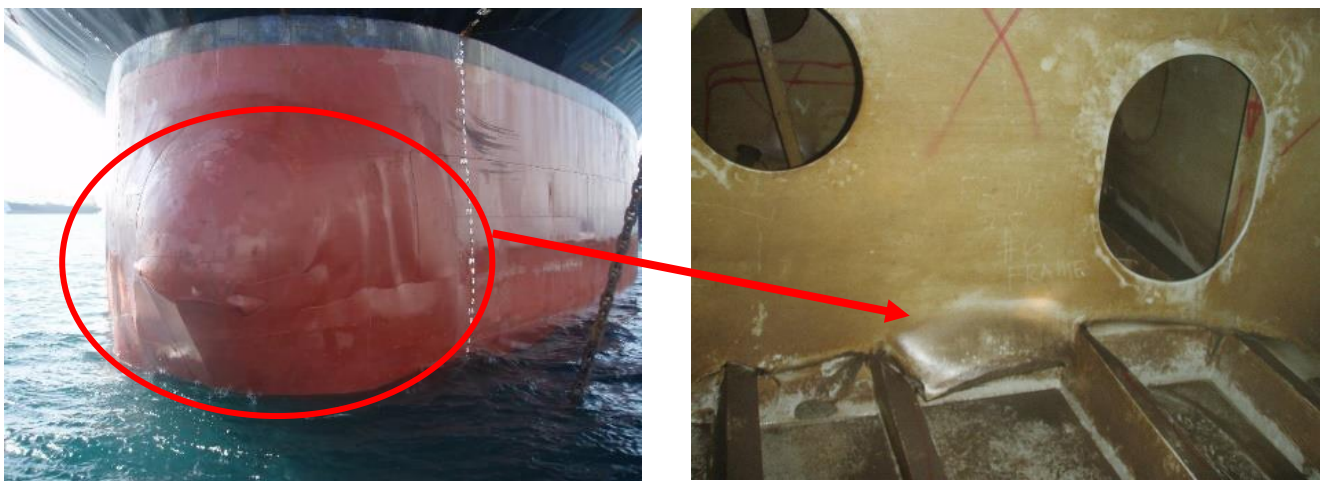
Deformation are usually reported as buckling and bending of the hull structure. The hull structure can suffer of structural overloads where the stresses placed on the structure were greater than the allowable designed stresses and it can be the result of heavy weather, improper loading sequences and accidents such as groundings, collisions, etc. Since bending moments are greater at midships and the largest stresses are on the deck plating, the condition of the ship deck near midships and specially the areas between cargo holds are of great importance during surveys since buckling may occur. Figures no. 26 depict a damage due to overload of the bulbous bow structure due to heavy weather, where due to heavy pounding the structure buckled.

Figure 26 - Bulbous damages due to slamming (Overload)

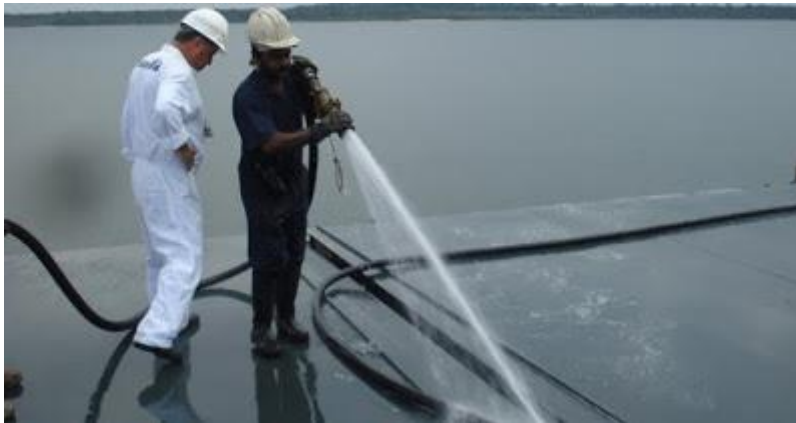
The effectiveness and condition of sealing arrangements are to be carefully inspected and tested either by a combination of chalk and fire hoses test or by using ultrasonic hatch tightness testing equipment. During the hose test, the surveyor should make sure that no leakage inward to the cargo holds take place with the use of the water pressure greater than 250 Kn/m² with a nozzle of 12.5 mm diameter. Figure no. 28 presents a hose testing being carried out.

Figure 28 - Hose Test (Source: SS Marine Surveyors)

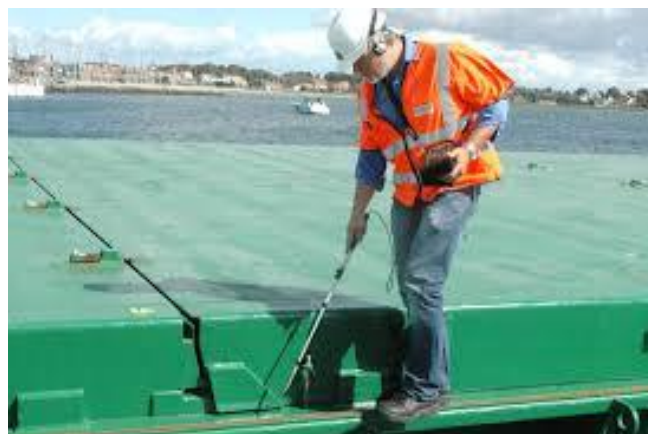
When hose testing, if the water jet cannot be applied directly to the gasket or compression bar connection then hose test would not be suitable, and weathertightness test should be carried out with the assistance of an ultrasonic equipment with a multidirectional transmitter. Figure no. 29 presents an ultrasonic hatch testing being carried out.

Figure 29 - Ultrasonic Hatch Testing (Source: Damco Survey AB)
