Post-processing treatments for improving the wear resistance of FSPed Al-matrix composites

Post-processing treatments for improving the wear resistance of FSPed Al-matrix composite

MARCO STORTI
Final Year Project

Abstract

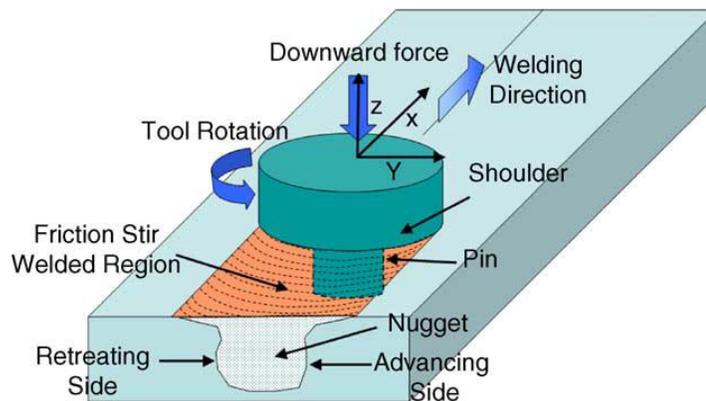
Figure 2-1 Representation of the friction stir welding process. [3]

Friction stir welding (FSW) is a solid-state joining technique, so there is no fusion of material during the process. The basic concept is very simple: a non-consumable rotating tool, comprising a pin and a shoulder, is inserted into the abutting edges of plates to be joined, and moved along the line of the weld. A representation of the process is given in Fig. 2-1.

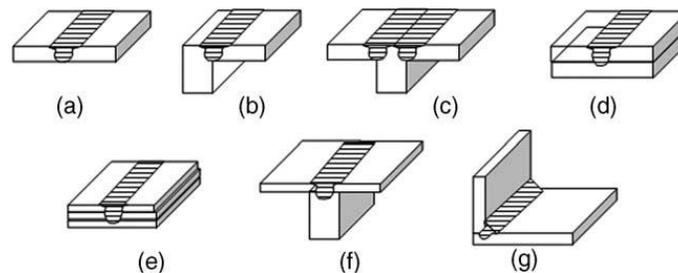
Figure 2-2 Joint configurations for FSW: a) square butt, b) edge butt, c) T butt joint, d) lap joint, e) multiple lap joint, f) T lap joint, g) fillet joint [6].

Nowadays several weld configurations are possible with this technology (see Fig. 2-2).

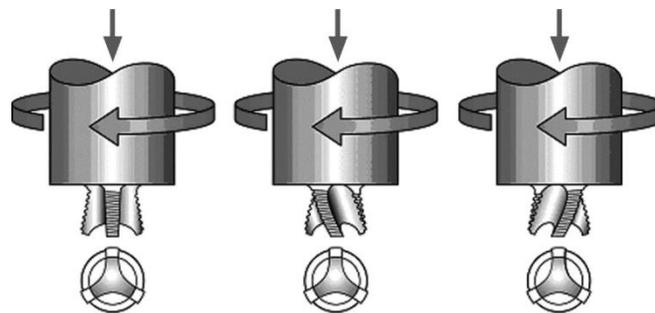
Figure 2-4 Examples of pin's geometry. Flared-Triflute® developed by TWI [7].

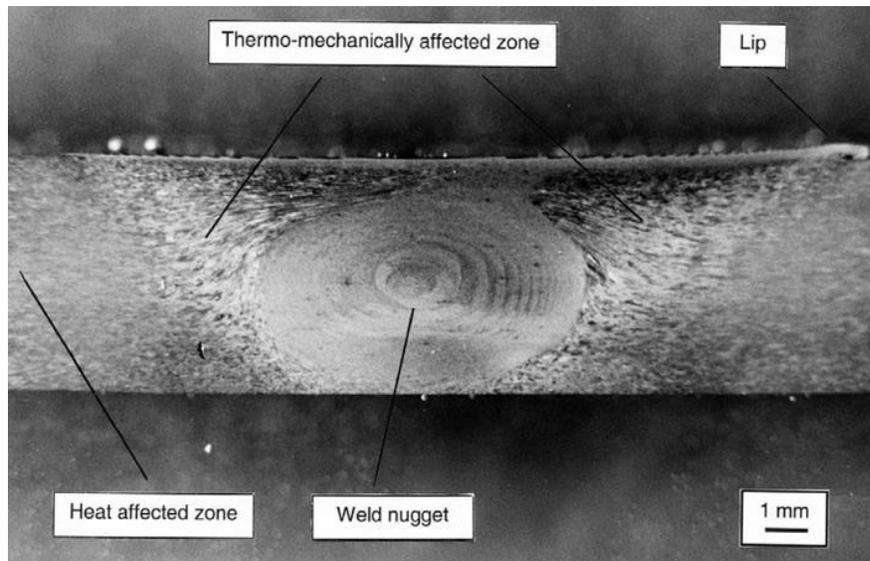
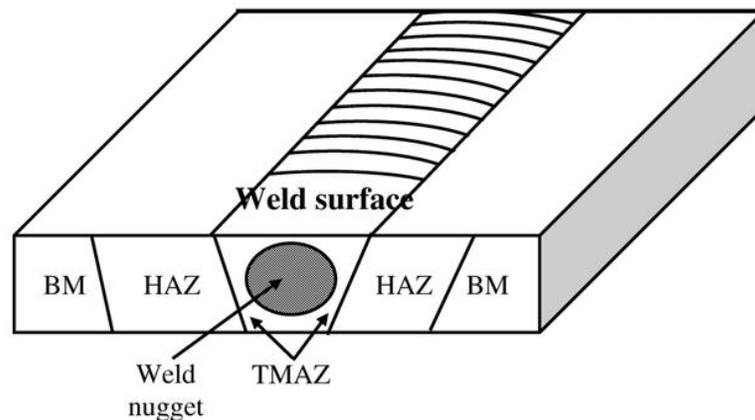
Figure 2-5 Microstructure and schematic representation of a joint produced by FSW [10].

In a friction stir welded joint, different zones with different microstructures and, as a consequence, different mechanical properties can be easily recognized. The differences are mainly due to the different heat input (and temperature distribution) in the various zones and to the magnitude of the plastic deformation.

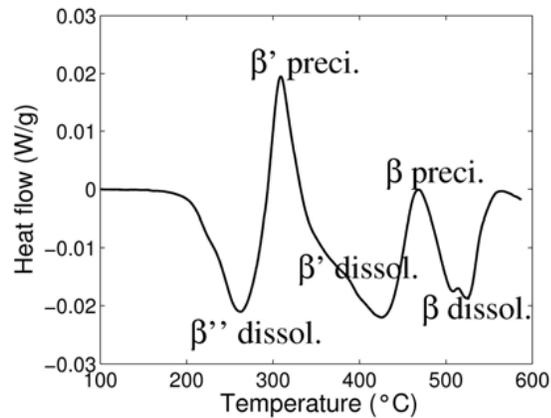
Figure 2-6 DSC of a 6005 aluminum alloy with the same composition of the one used in this project [10].

The precipitation sequence in this alloys is generally described as [119,120] super-saturated solid solution (SSSS) \rightarrow cluster/GP zones \rightarrow β'' phase \rightarrow β'/Q' phase \rightarrow β/Q phase. Wenchao et al. [121] investigated also the initial stages of the mechanism that leads to the precipitation of the GP zones. The precipitation mechanism is revealed by DSC analysis as the one reported in Fig. 2-6.

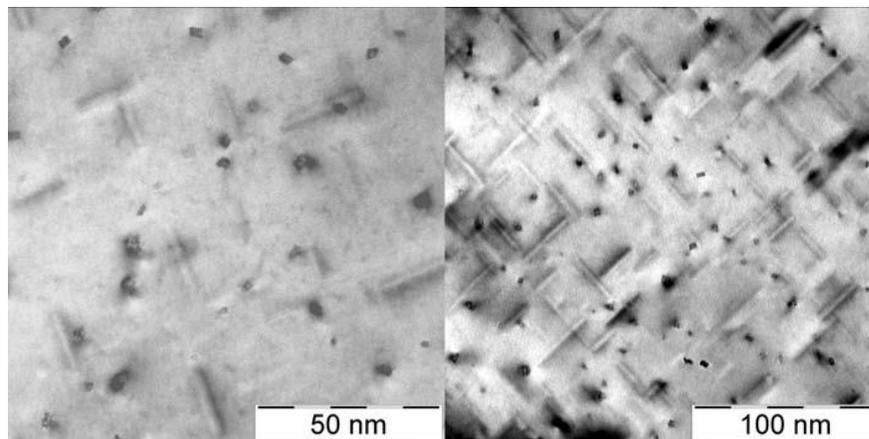
Figure 2-7 β'' precipitation in the base material [10].

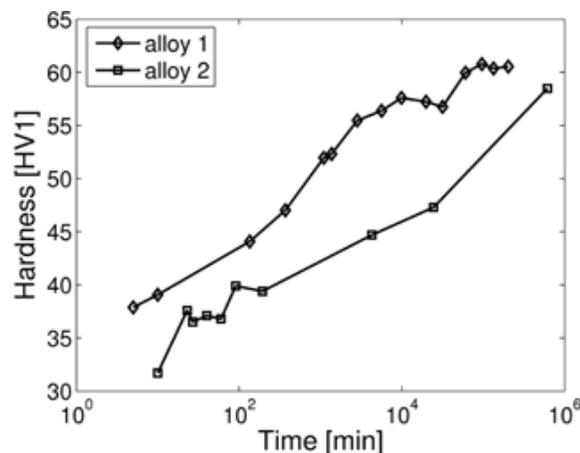
Figure 2-8 Natural ageing effect on hardness on two different 6005 alloys after solution heat treatment [10].

The 6005 alloy can be naturally aged at room temperature, leading to a significant increase in hardness as reported in Fig. 2-8. The process is complete in less than one year [10]. The results are strongly influenced by the exact alloy composition and, in particular the Cu content. This process occurs only starting from a super saturated solid solution condition (higher is the concentration of the solution and more efficient is the precipitation) so a solution treatment followed by water quenching is highly suggested [10,44,58,93].

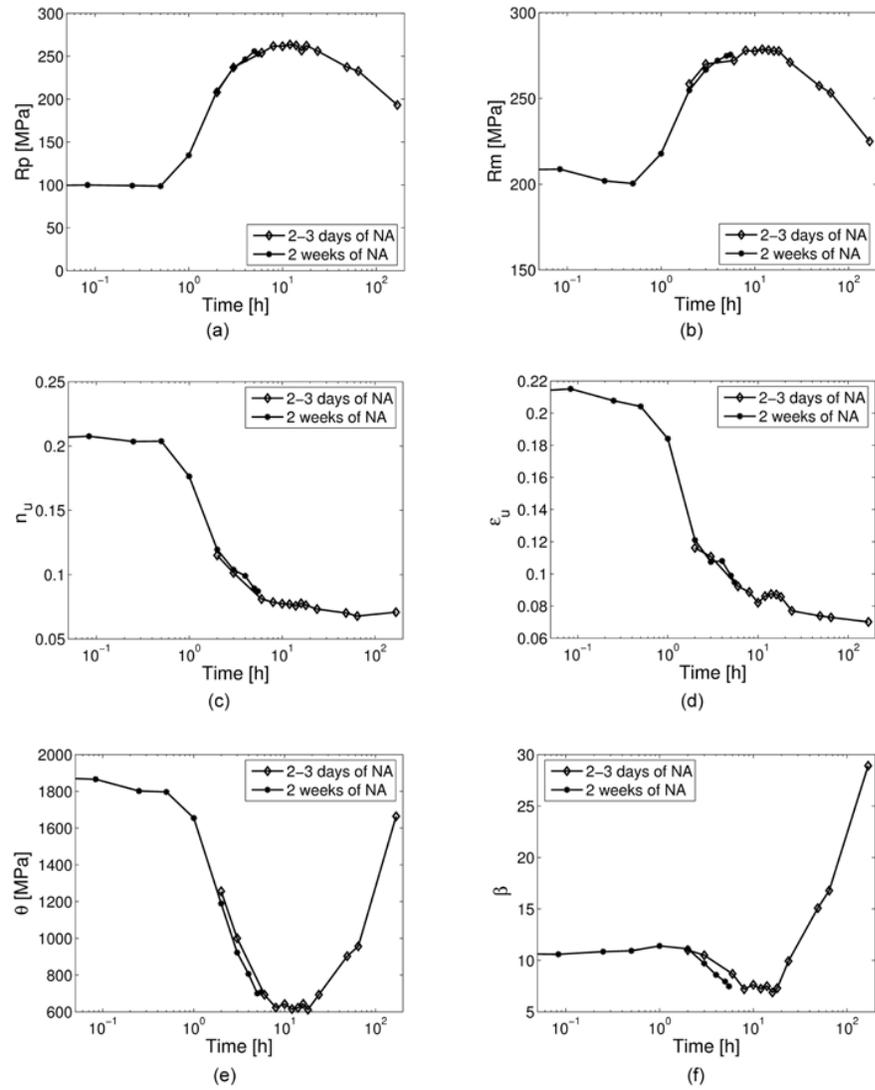
Figure 2-9 Evolution of the tensile properties with the ageing time [10].

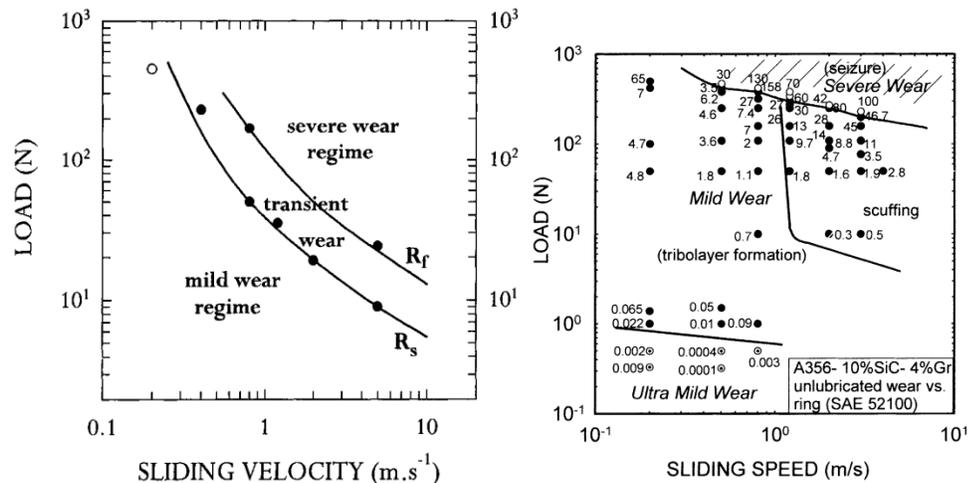
Figure 2-10 Wear maps. On the left wear transition map for 6061 Al against SAE 52100 steel counter face. R_s indicates load and sliding speed at which mild to severe wear transition is first observed CIT. On the right wear map for A356 Al-10% SiC-4% Gr composite worn against SAE 52100 steel counter face [64].

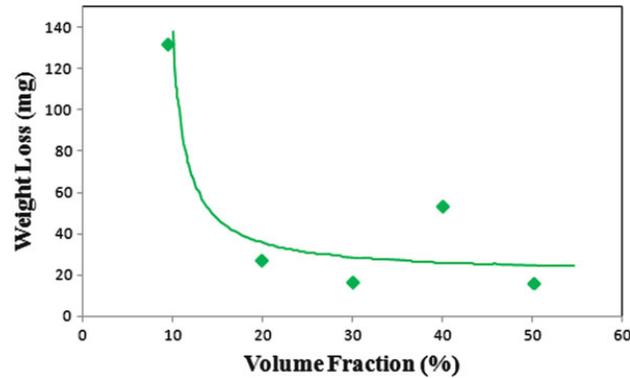
Figure 2-11 Weight loss of an aluminum alloy reinforced with micrometric SiC particles [81].

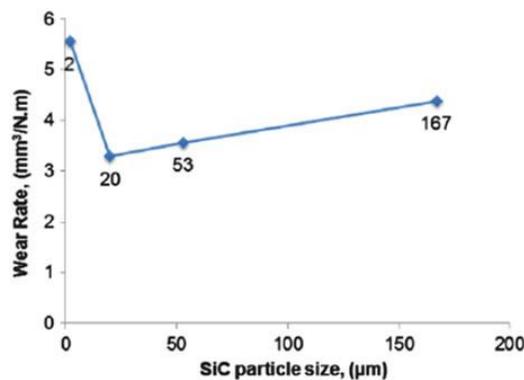
Figure 2-12 Effect of SiC particle size in wear rate of an aluminum alloy [86].

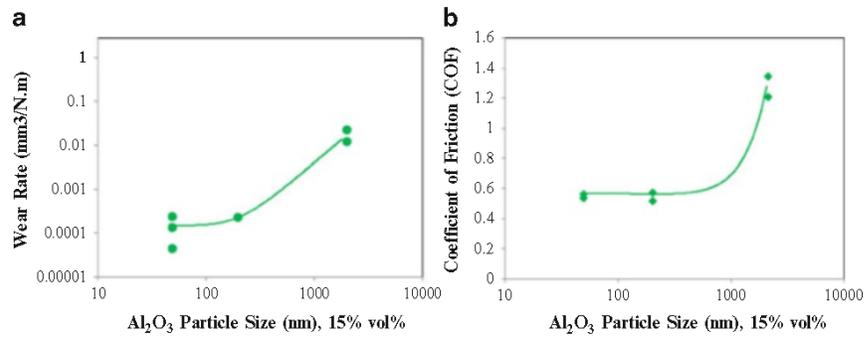
Figure 2-13 Effect of particle size on wear rate and friction coefficient of an aluminum alloy reinforced with 15% of alumina particles [87].

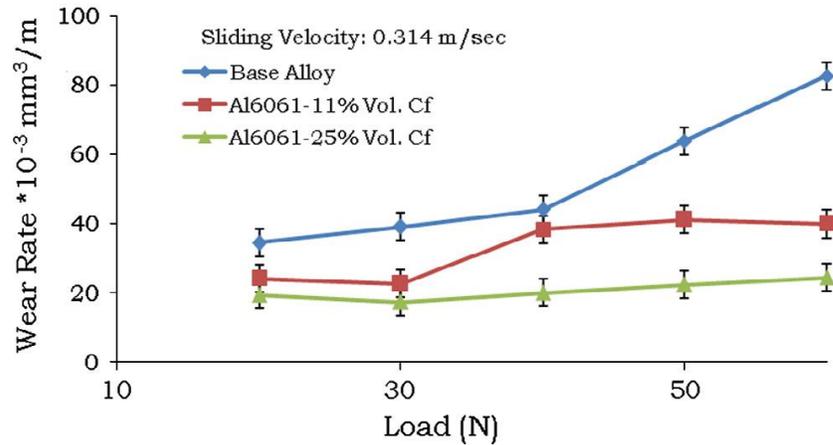
Figure 2-14 Influence of normal load on wear rate on a composite made by Al6061-carbon fibers [50].

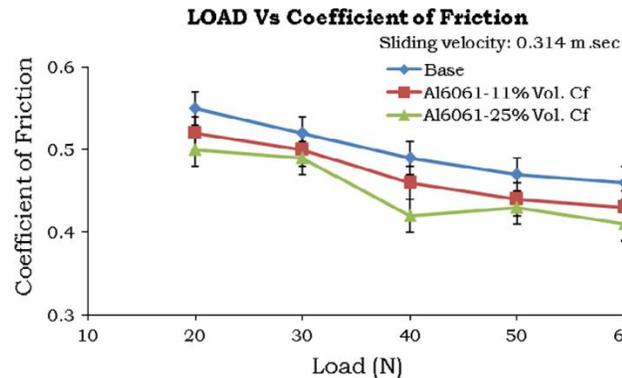
Figure 2-15 Effect of friction coefficient with applied normal load on Al6061-carbon fibers MMC [50].

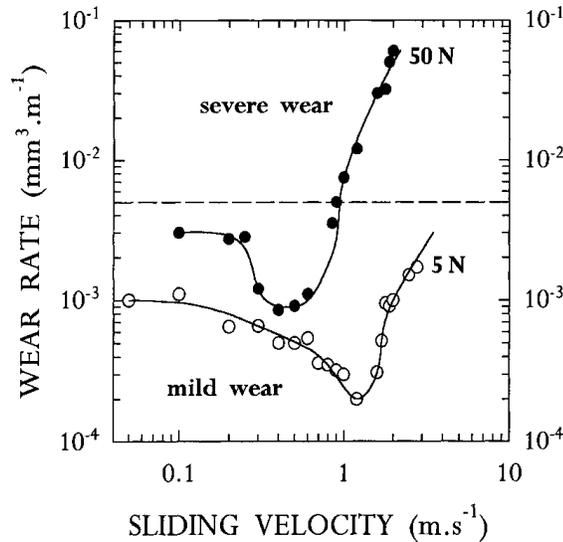
Figure 2-16 Effect of sliding speed on wear rate for a non-reinforced aluminum alloy [63].

In an aluminum alloy without reinforcement at low speed there is an initial decreasing of wear rate and, after a critical value, a rapid increase. This is due to the competition between strain hardening at low speed and thermal softening at higher velocities [63].

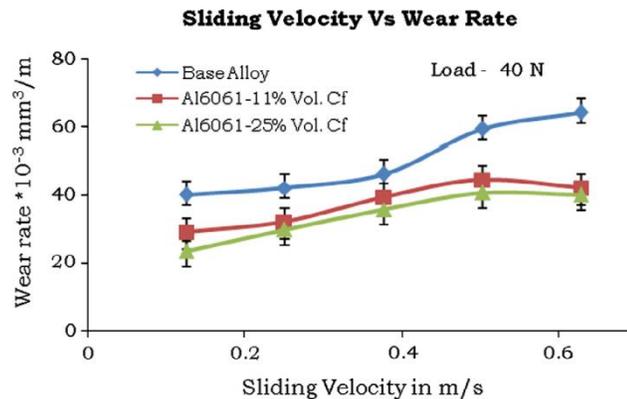
Figure 2-17 Effect of sliding speed on wear rate for Al6061-carbon fibers MMC [50].

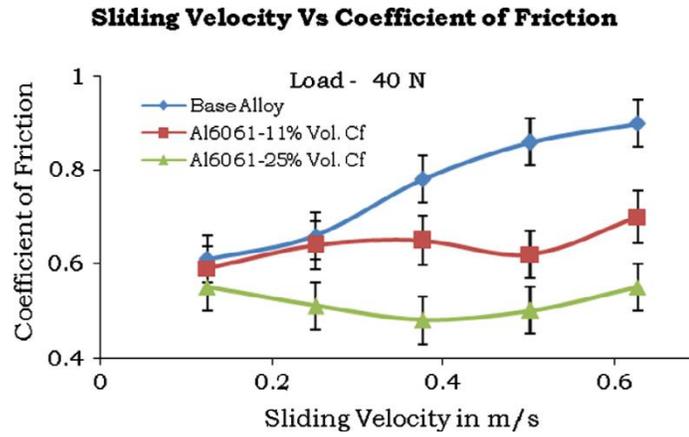
Figure 2-18 Effect of sliding speed on the friction coefficient [50].

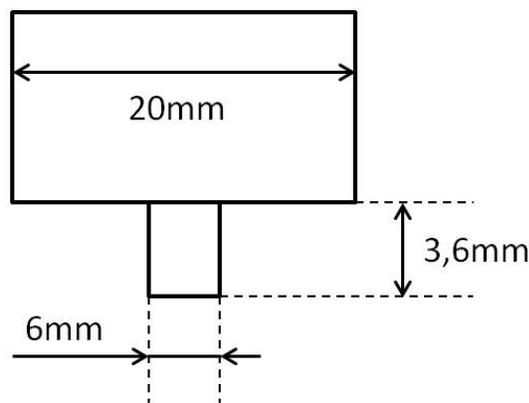
Figure 3-1 Tool's geometry.

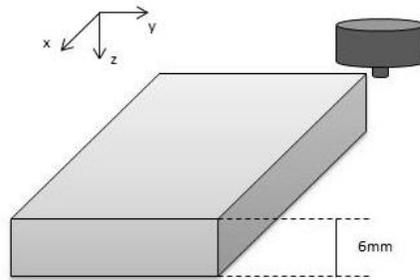
Figure 3-2 Representation on the friction stir process for the production of the reference material.

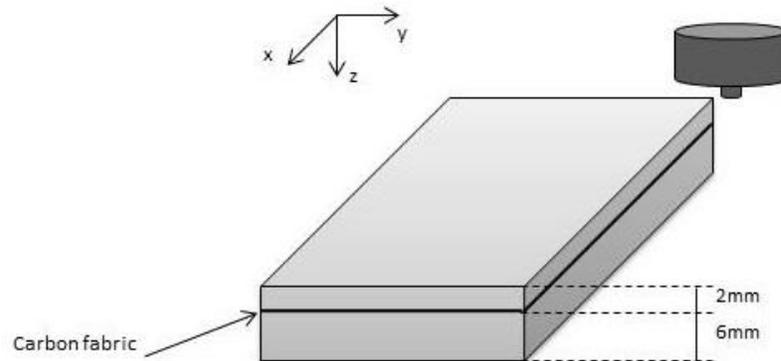
Figure 3-3 Representation of the friction stir process for the production of the composite material.

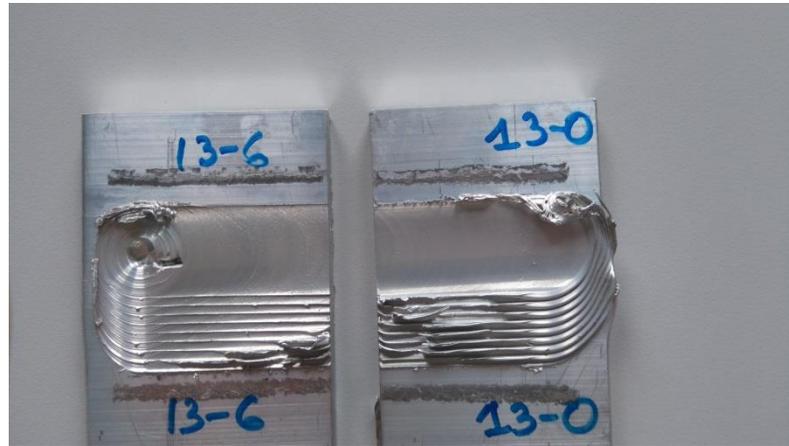
Figure 3-4 Tool marks at the end (on the left) and at the beginning (on the right) of the friction stir processed plate. It is also possible to see the marks left by the clamping system.

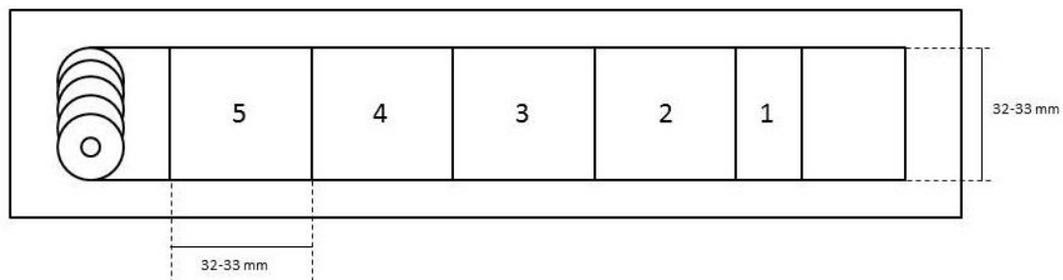
Figure 3-5 Cutting scheme and numeration of the samples. Sample 1 has been used for optical analysis, and the others for the pin on disk test. The external parts have been removed.

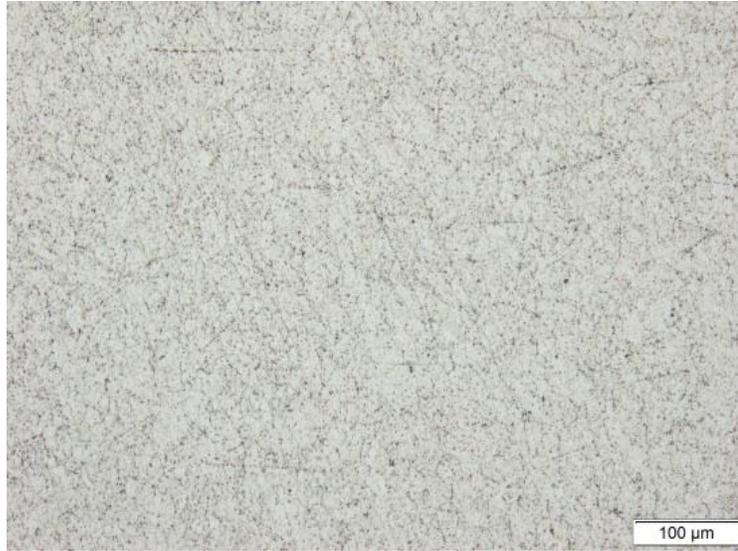
Figure 3-6 Effect of the etching with the Keller's reagent. The sample were uniformly corroded without highlighting the grain boundaries.

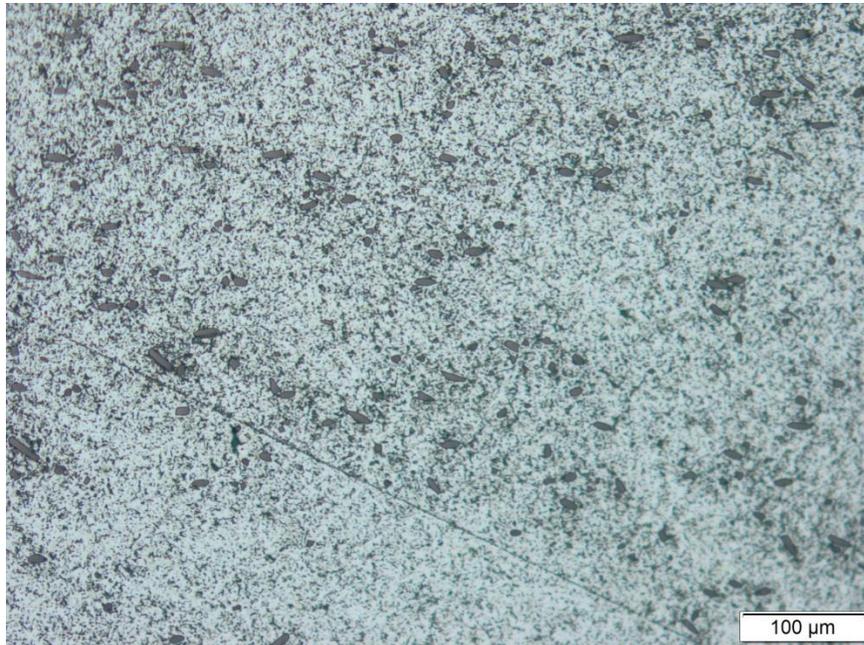
Figure 3-7 Etching test on the composite material with a 0.5% HF (conc.) aqueous solution at room temperature for 20 seconds.

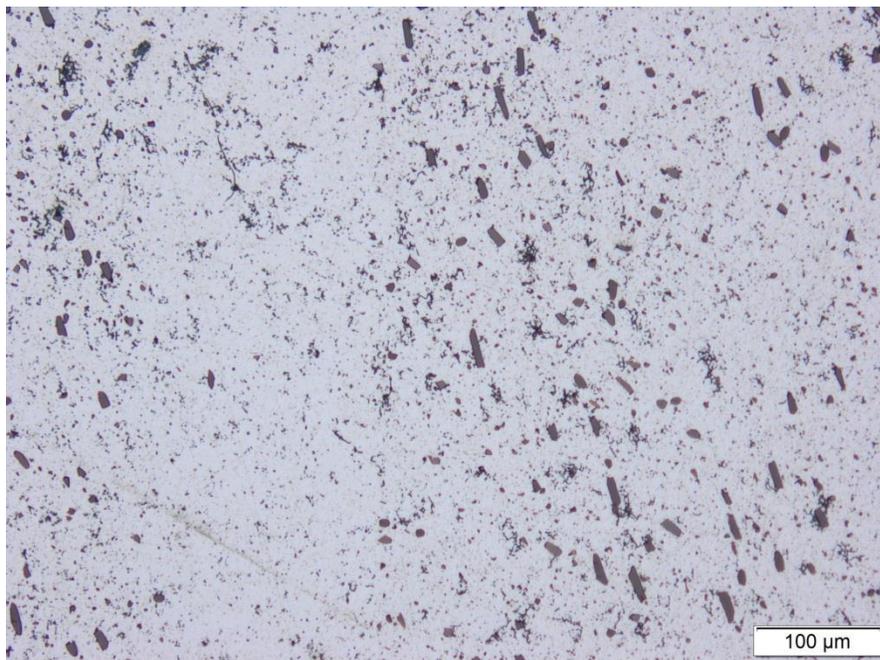
Figure 3-8 Composite samples after the etching with a 0.125% HF (conc.) aqueous solution at room temperature for 3.5 minutes.

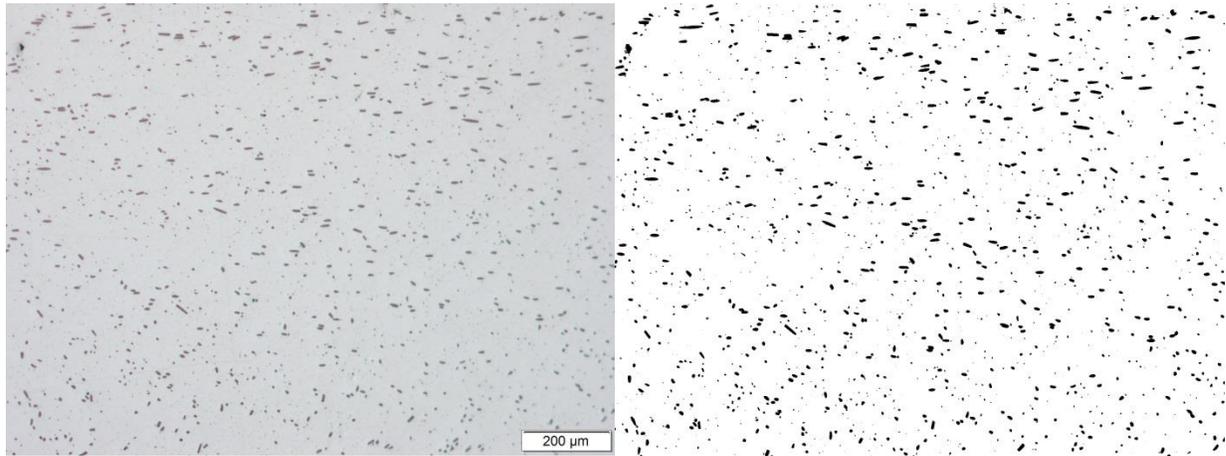
Figure 3-9 Example of the image processing to evaluate the fiber's surface fraction inside the composite material.

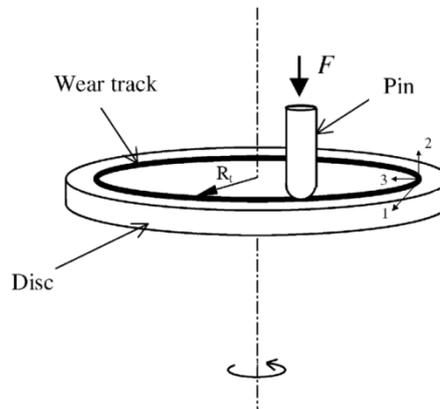
Figure 3-10 Schematic representation of the pin on disk apparatus [122].

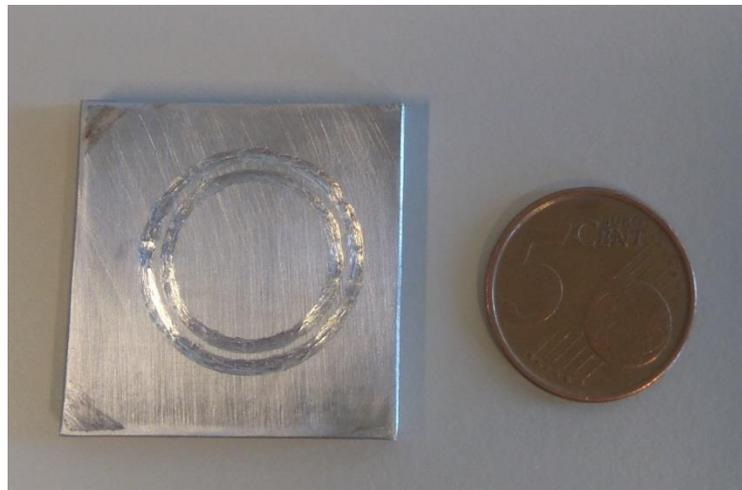
Figure 3-11 Sample after the pin on disk test. The two wear tracks are clearly visible.

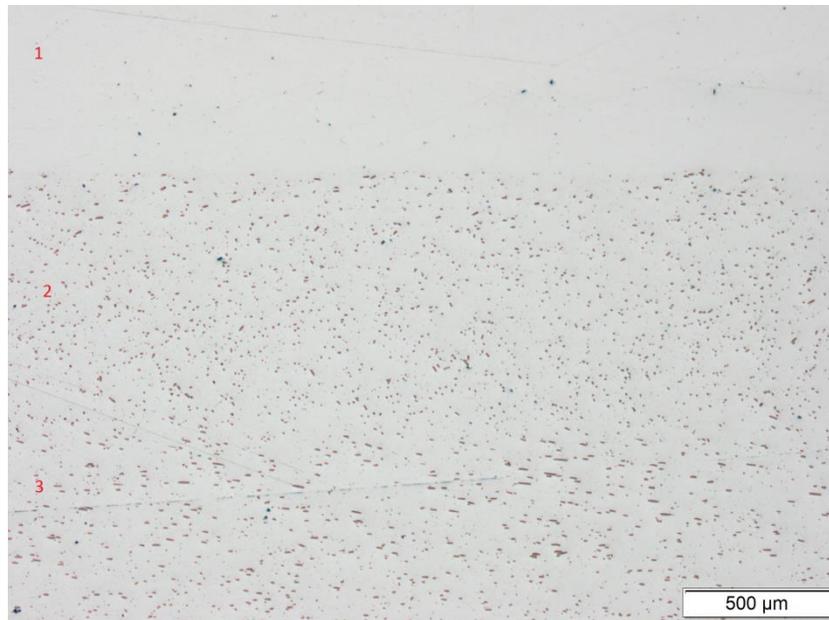
Figure 4-1 Cross section of the sample 8-4, 2.5X. It is possible to see the different orientations of the fibers and the zone without reinforcement.

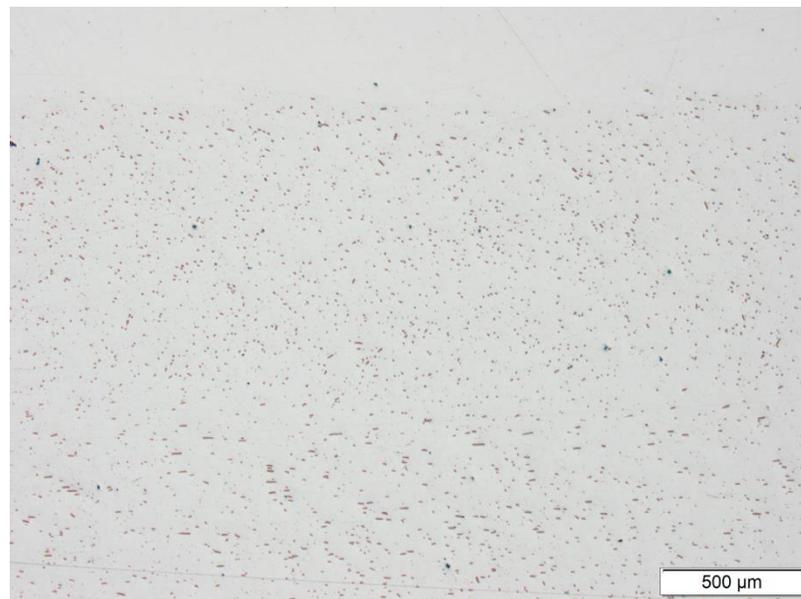
Figure 4-2 Cross section of the sample 8-5, 2.5X. It is possible to see that the fiber's distribution is similar to the one in Fig. 4-1.

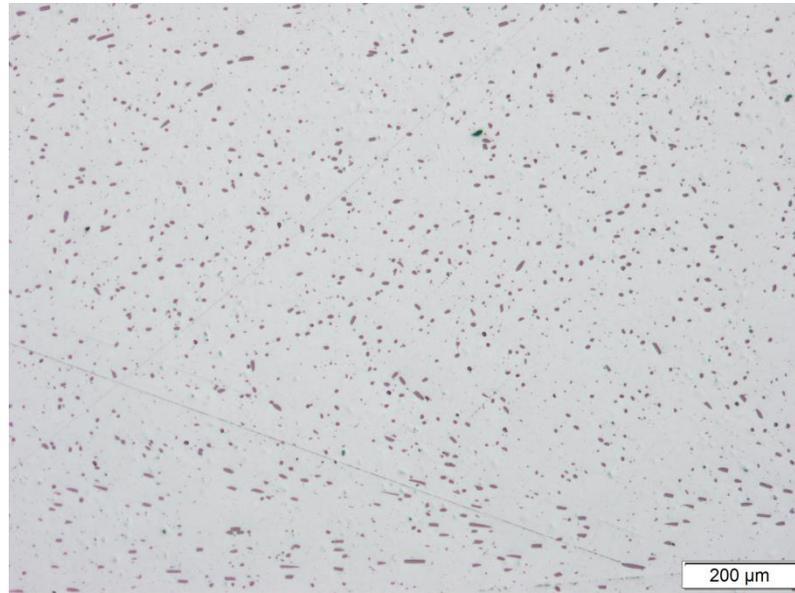
Figure 4-3 Cross section of the sample 8-3 taken at higher magnification, 5X. It is more clear the different orientation of the reinforce.

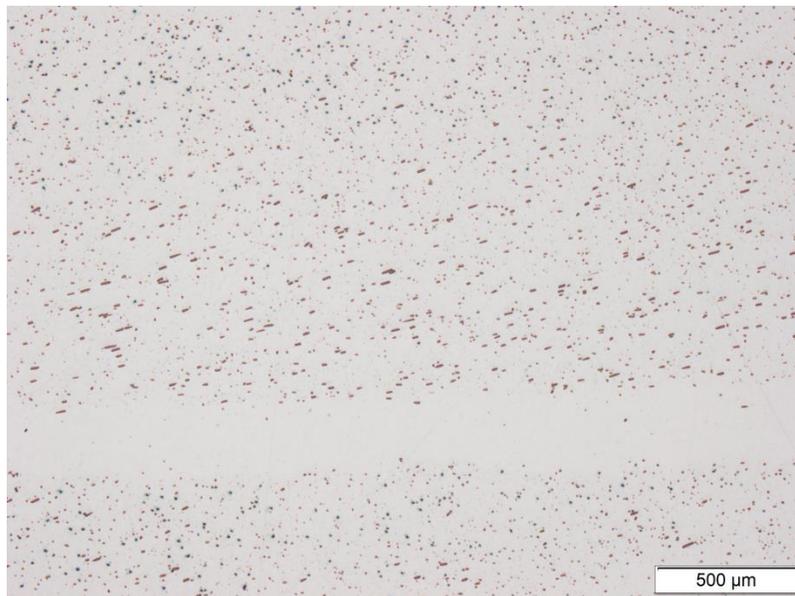
Figure 4-4 Top section of sample 8-4 at 2.5X. The zone without fibers and the different orientation of the fibers are clearly visible .

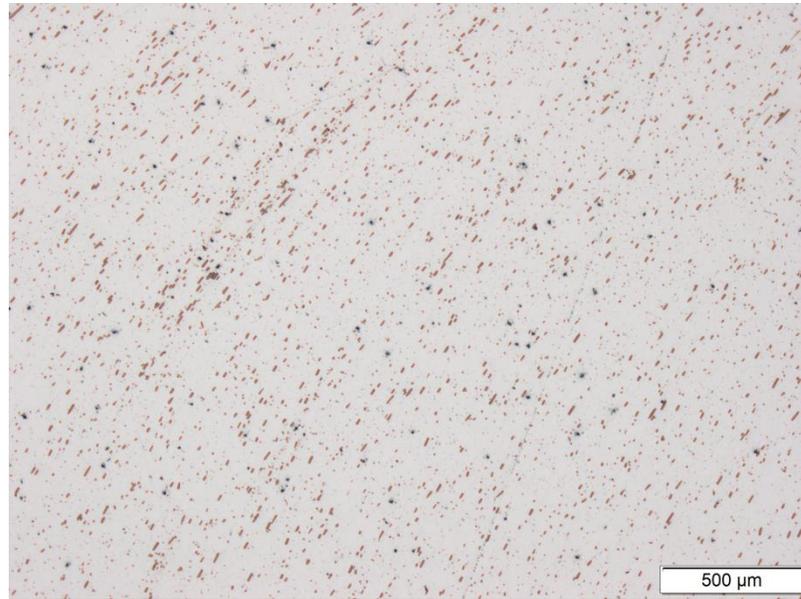
Figure 4-5 Top section of sample 8-3 at 2.5X of the second sample. The effect of the flow of the material in the fiber's distribution are clearly visible.

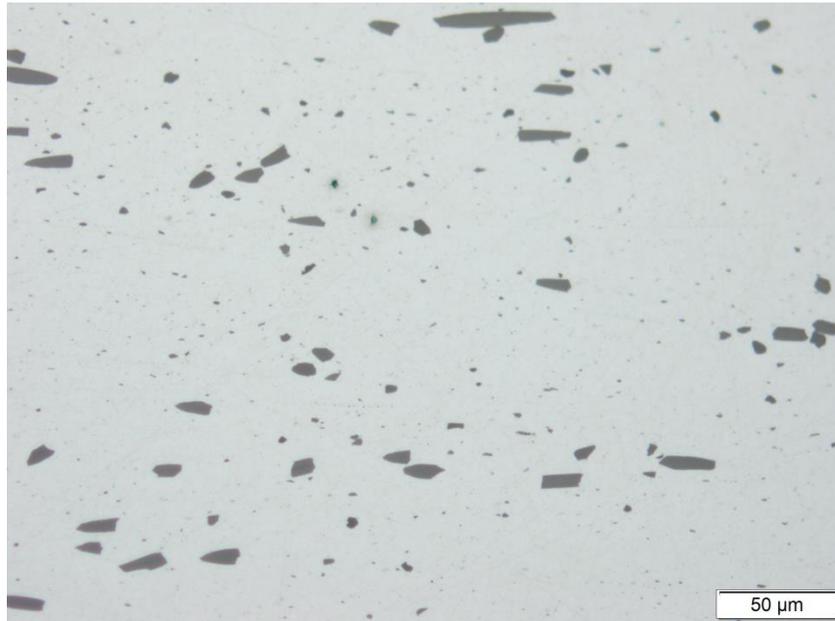
Figure 4-6 Sample 8-4, 20X. It is possible to notice that the fibers are not bigger than 50μm.

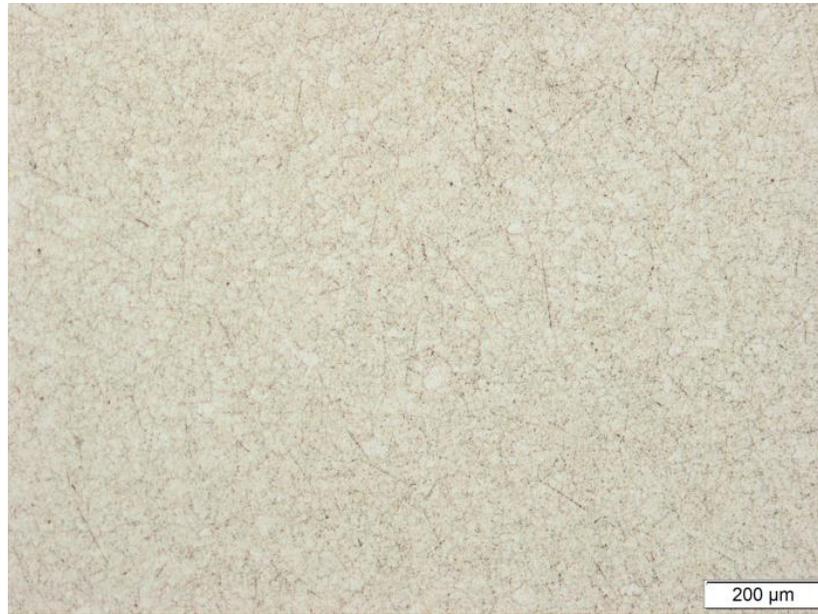
Figure 4-7 Sample 11-5 etched in 0.5% HF (conc.) in water for 3.5min, 5X. The grain boundaries are not sufficiently highlighted for a good estimation of the grain size.

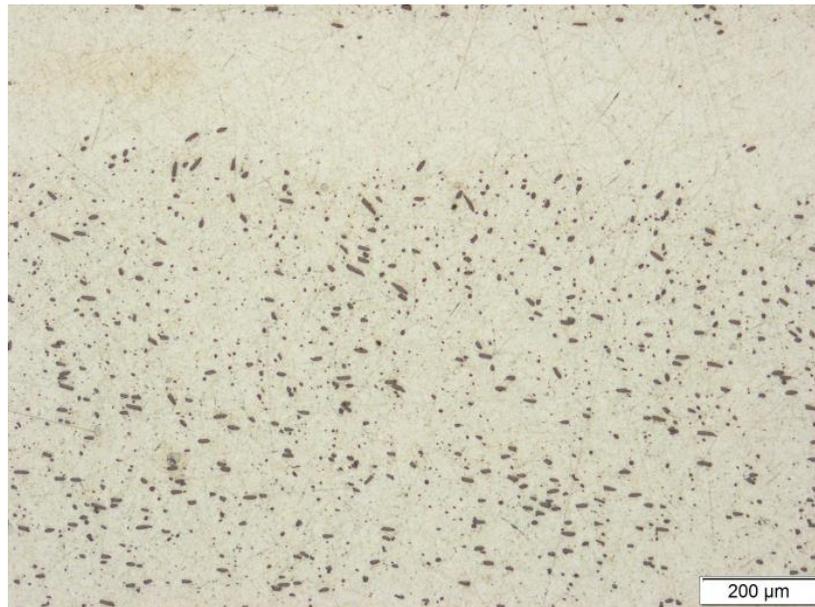
Figure 4-8 Sample 8-5 etched in 0.125% HF (conc.) for 1.5min, 5X. The presence of the fibers accelerates the reaction making grain size evaluation impossible.

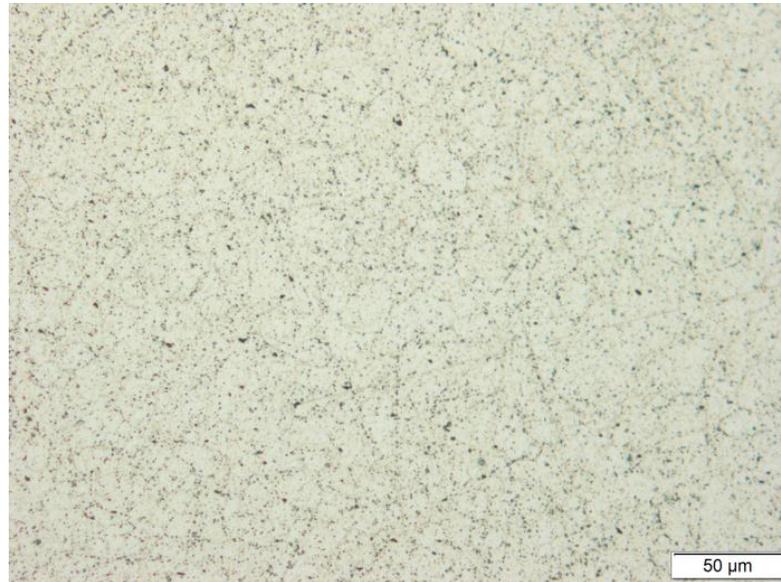
Figure 4-9 Sample 11-5 etched for 2.5 min, 20X. Here is more clear that the corrosion of the samples is not localized on the grain boundaries but tend to be more uniform all over the surface.

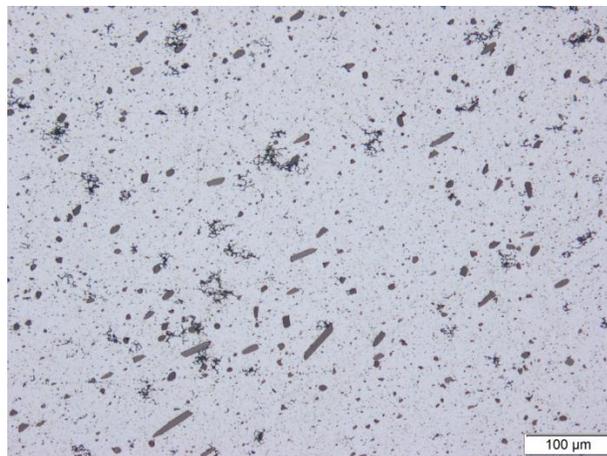
Figure 4-10 Sample 9-0 solution treated for 1 hour and etched in a 0.125 HF (conc.) aqueous solution for 3.5min, 10X. It is possible to see the areas where the grain boundaries are highlighted.

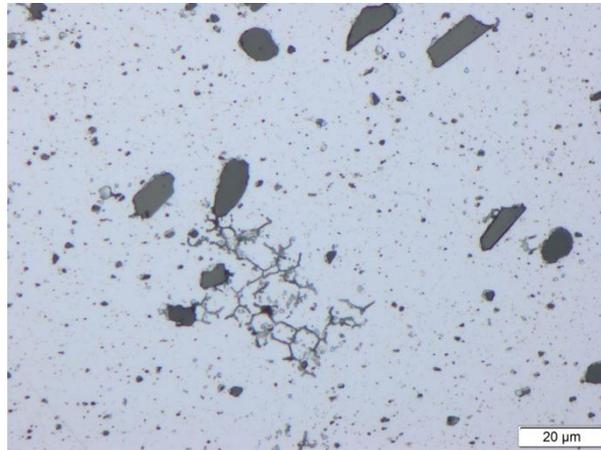
Figure 4-11 Sample 9-6 solution treated for 4 hours and etched in a 0.125 HF (conc.) aqueous solution for 3.5min, 50X. Zoom on an etched area.

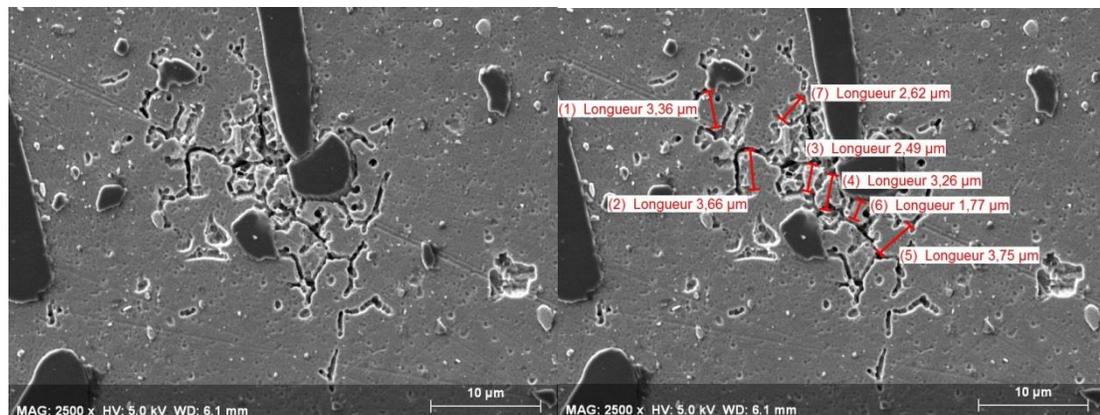
Figure 4-12 Sample 9-6 solution treated for 1 hour. On the left the original picture and on the right the measurement of the grain size.

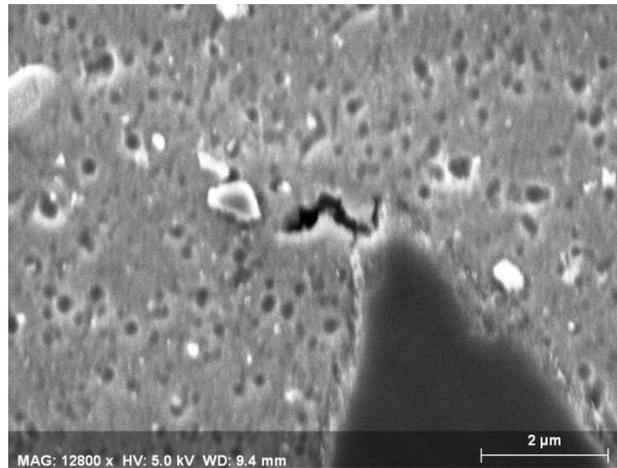
Figure 4-13 Crack on the tip of the carbon fiber.

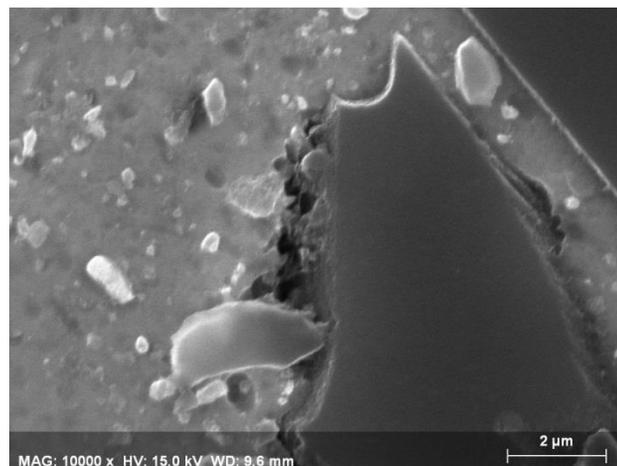
Figure 4-14 Void between the reinforce and the matrix.

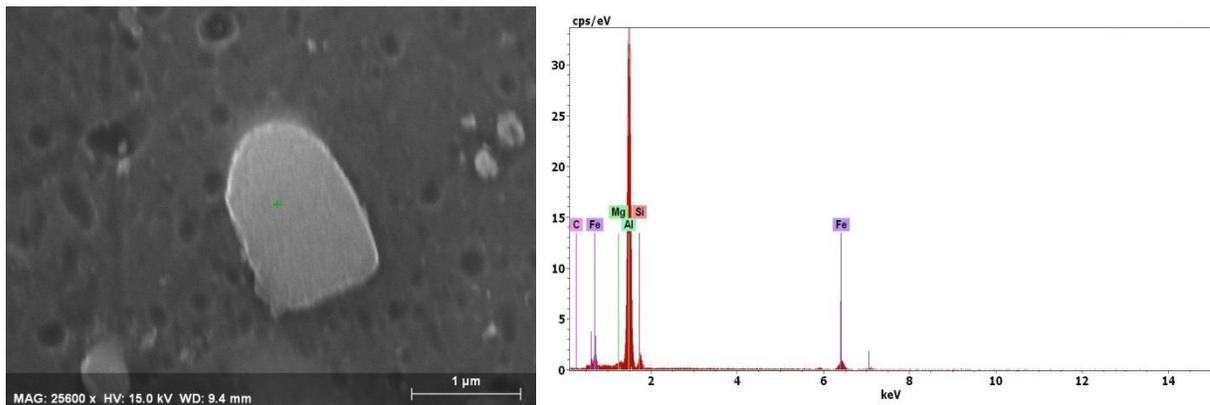
Figure 4-15 Intermetallic particle and corresponding EDS analysis.

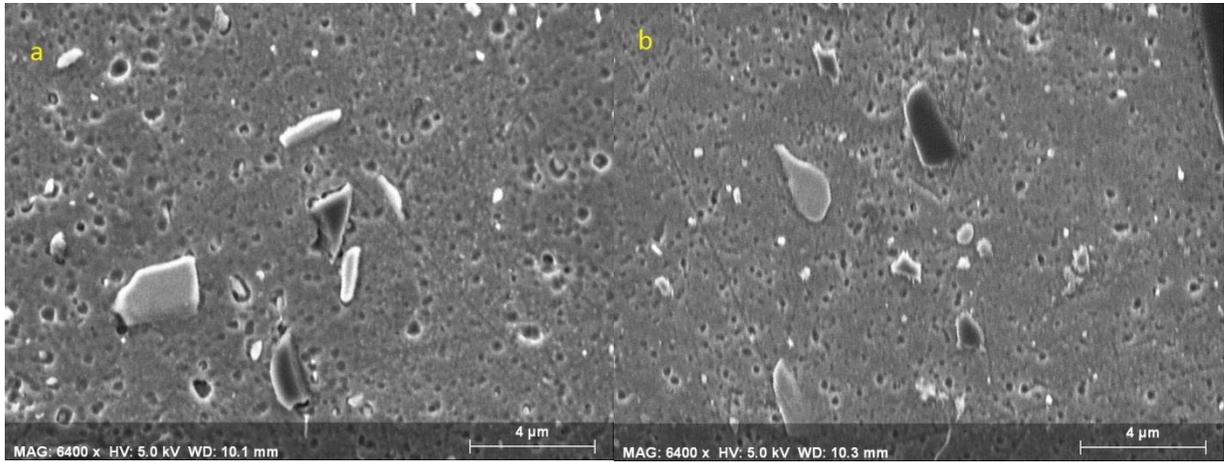
Figure 4-16 Evolution of the shape with the solubilization time: a) 0 hour and b) 4 hours for the same age hardening time.

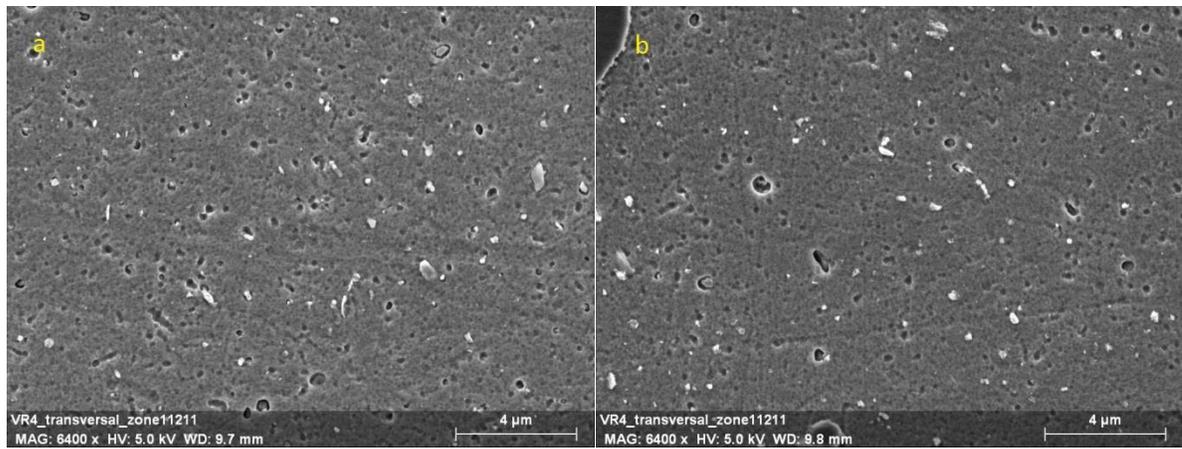
Figure 4-17 Intermetallic particles after 48 hours of age hardening. On the left the solubilization time was 0h and on the right 48 hours. It is possible to observe that the number of the precipitates increase in comparison to the same samples in Fig. 4-16.

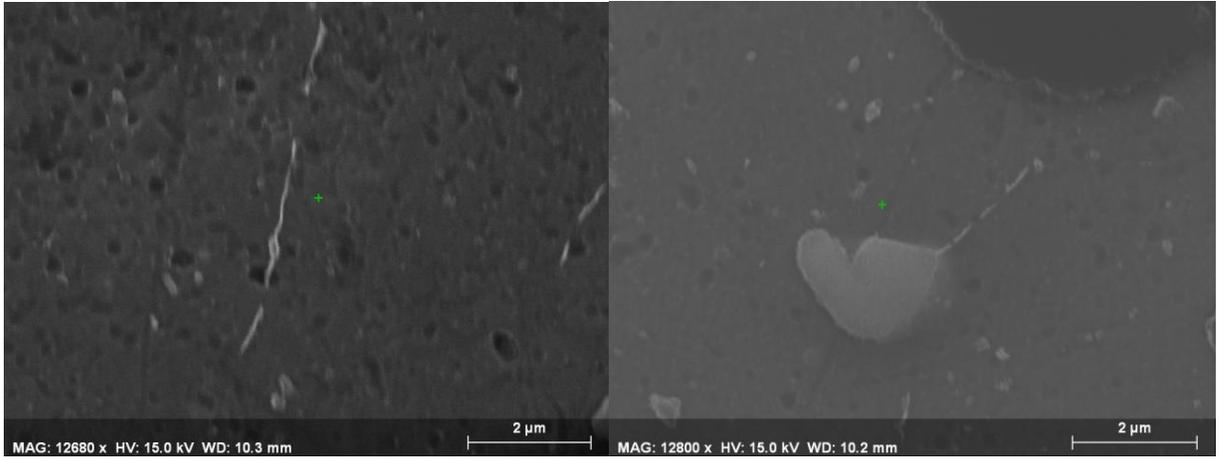
Figure 4-18 Thin precipitates observed for samples age hardened for 1 hour.

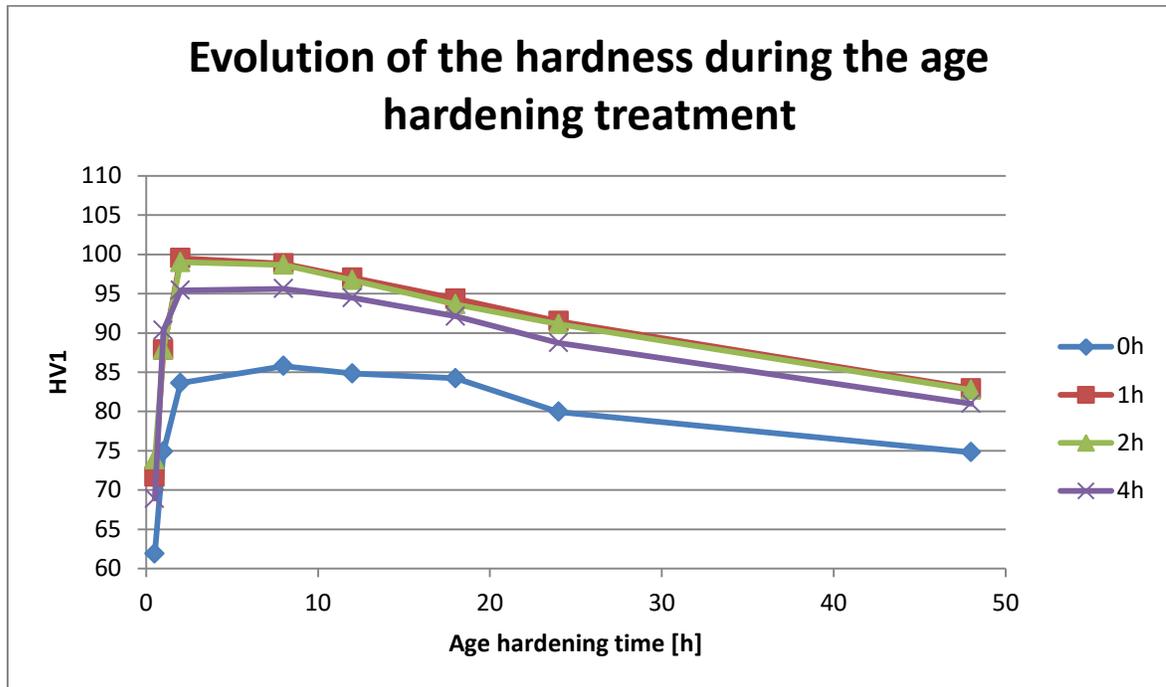
Figure 4-19 Evolution of the hardness with the ageing time. The four series correspond to the solubilization time.

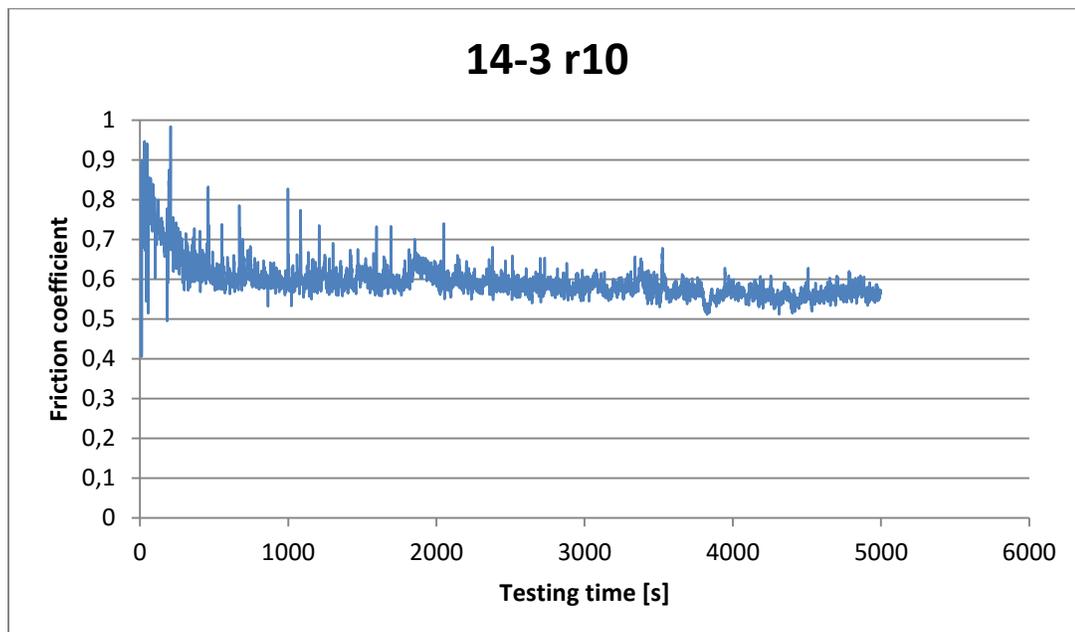
Figure 4-20 Plot of the friction coefficient for the reference material.

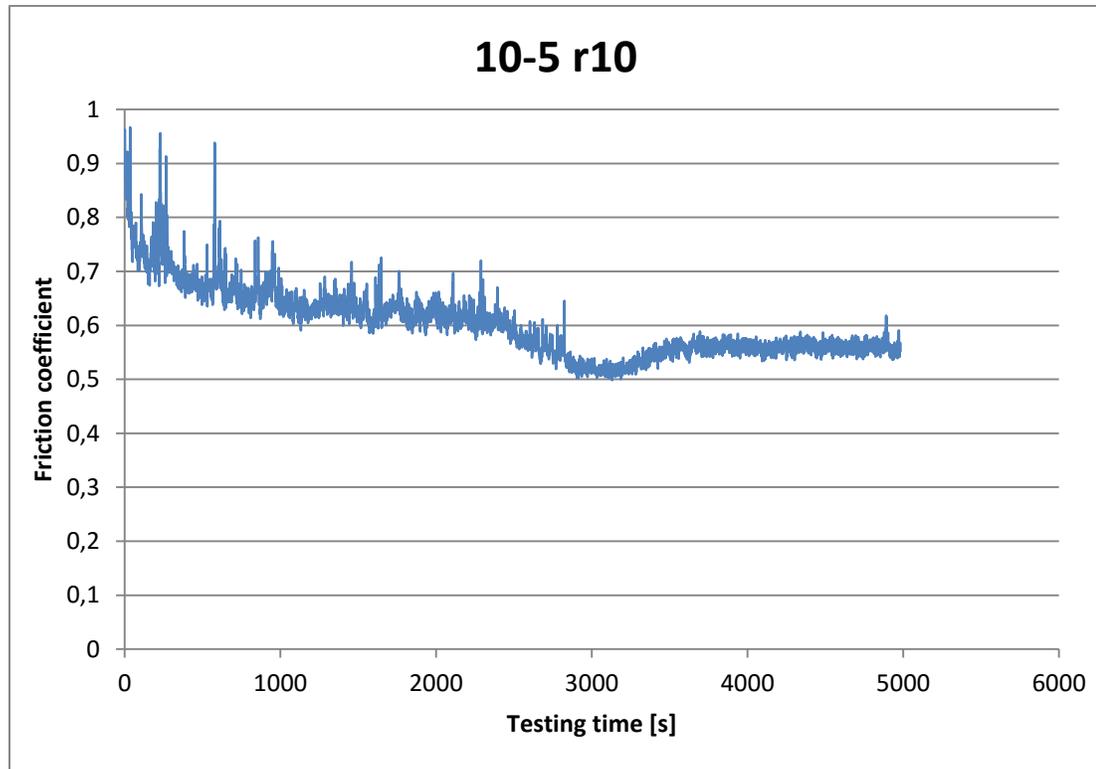
Figure 4-21 Plot of the friction coefficient for the MMC.
