Post-processing treatments for improving the wear resistance of FSPed Al-matrix composites

Post-processing treatments for improving the wear resistance of FSPed Al-matrix composite

MARCO STORTI
Final Year Project

Abstract

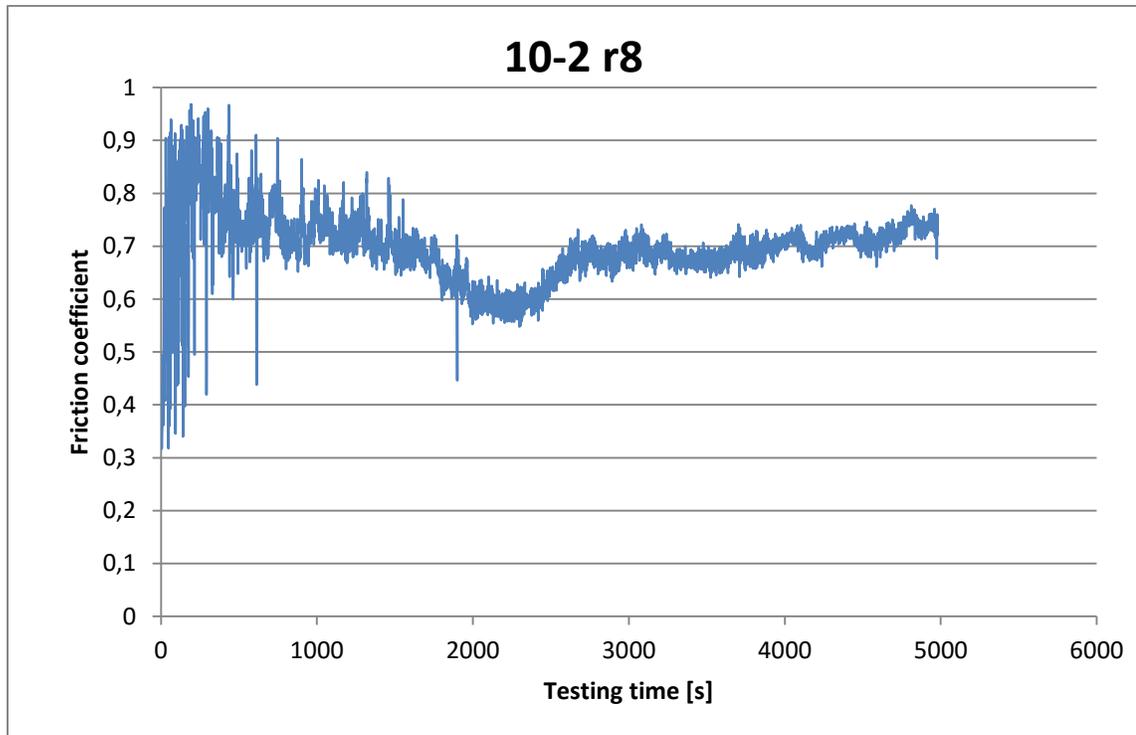
Figure 4-22 Plot of the friction coefficient for sample 10-2. Here, after the drop, the friction coefficient returns to the same value as before.

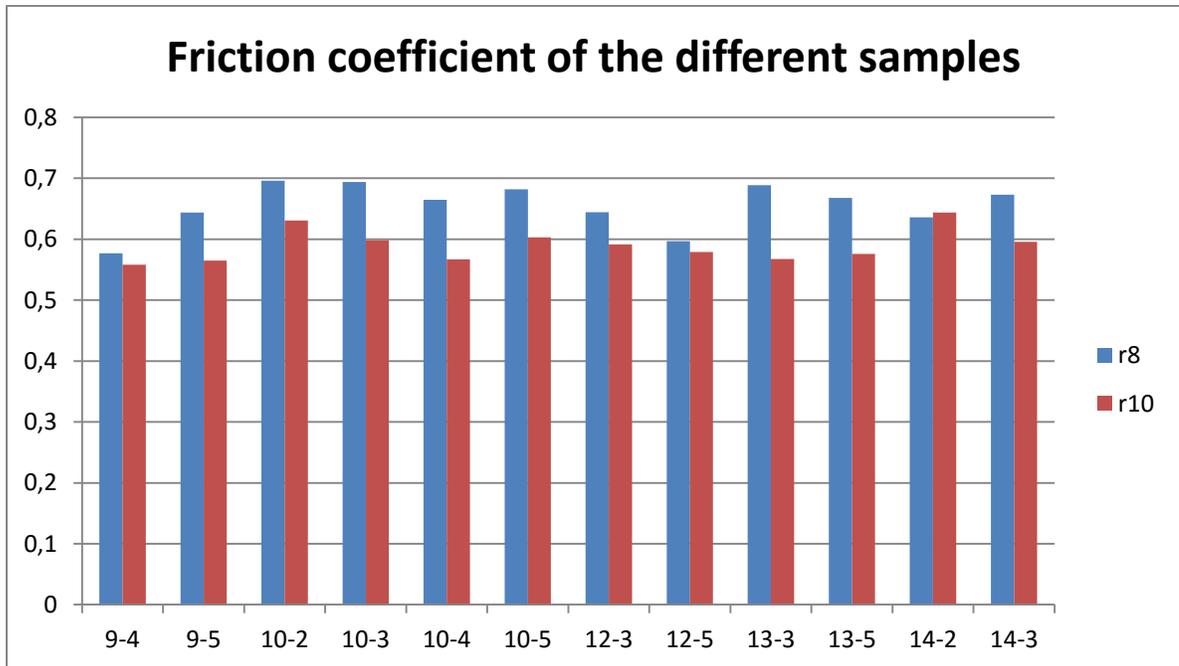
Figure 4-23 Plot of the average friction coefficient for each sample.

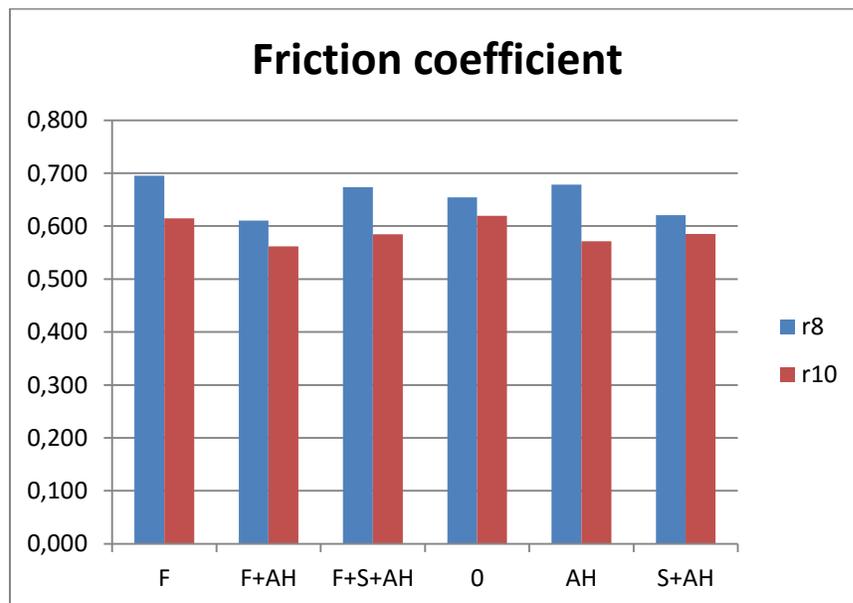
Figure 4-24 Plot of the average friction coefficient for the different condition of the samples.

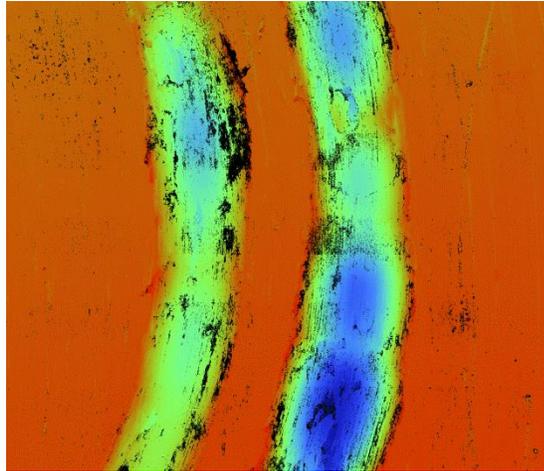
Figure 4-25 Sample 9-4. The colors vary from blue for the deepest zones to red. The 8mm track is the one on the left, while the other is the 10mm.

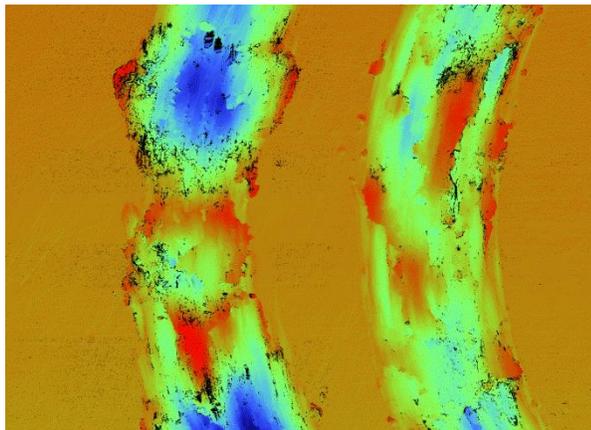
Figure 4-26 Sample 12-3. In this picture is possible to see more clearly the cluster in both tracks.

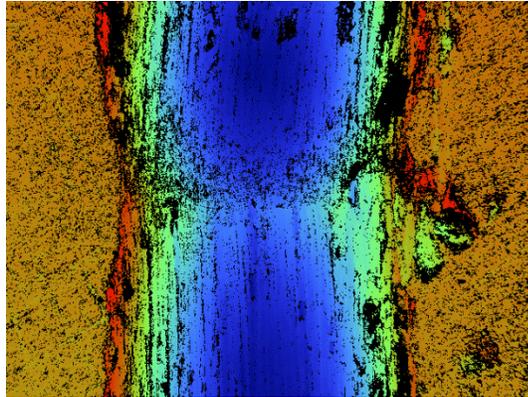
Figure 4-27 Sample 10-4, 10mm track. It is possible to notice the accumulation of material on the edge of the track.

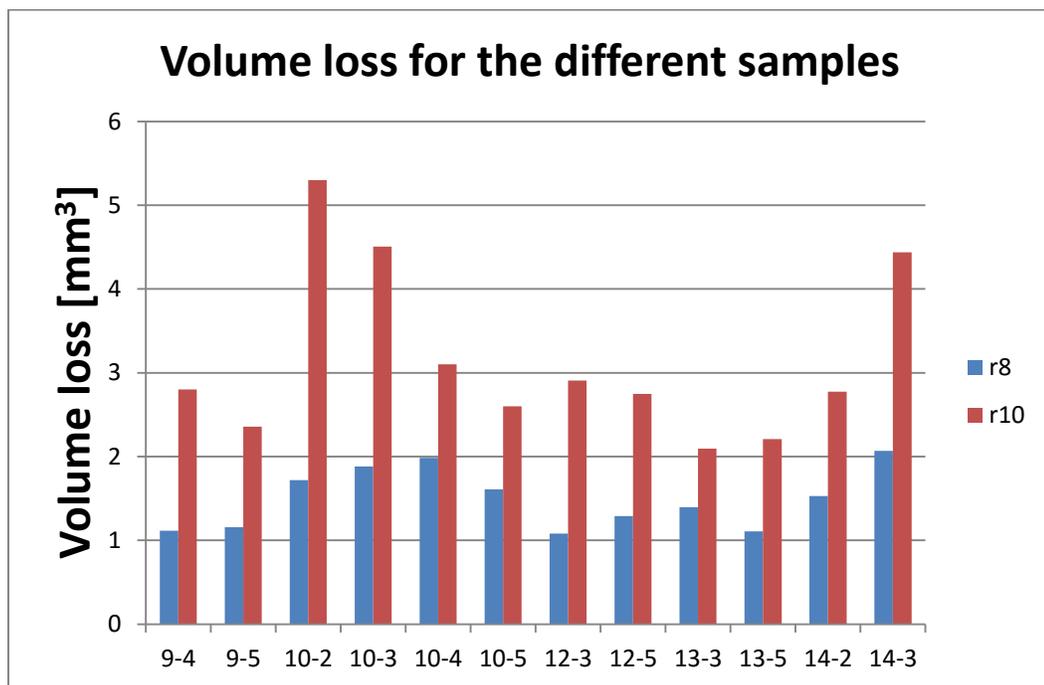
Figure 4-28 Volume loss for each sample.

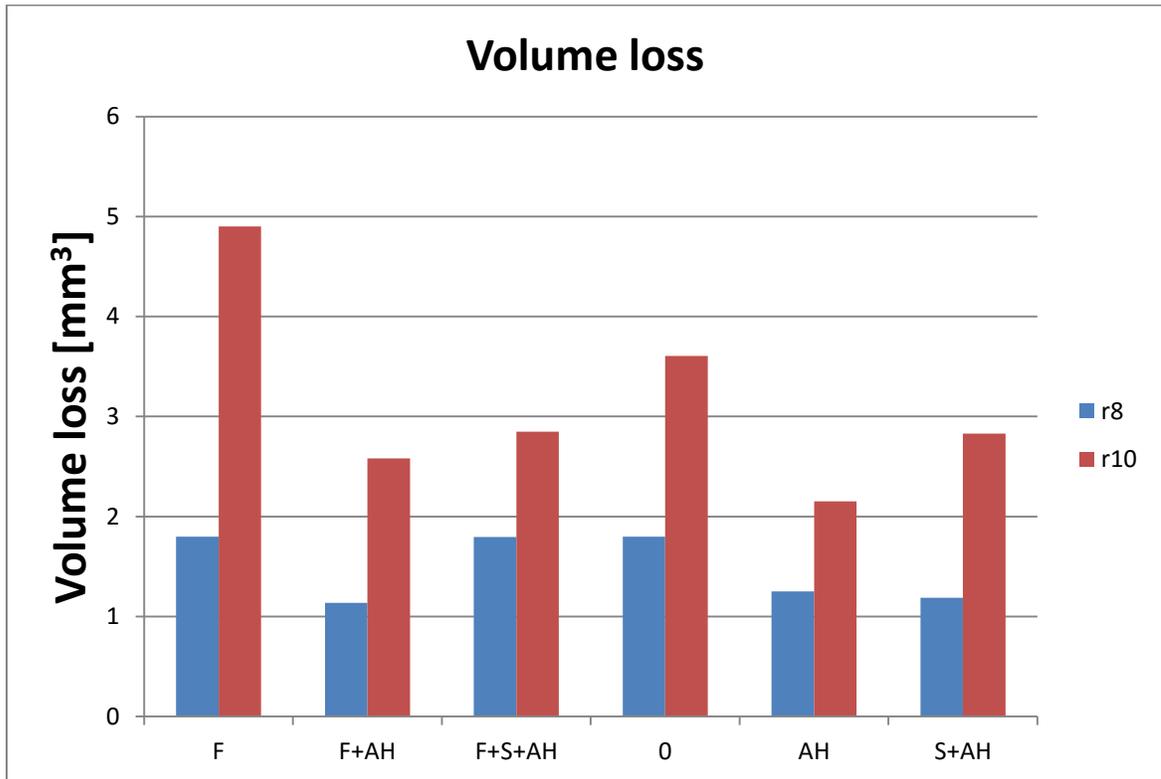
Figure 4-29 Volume loss for each sample's configuration.

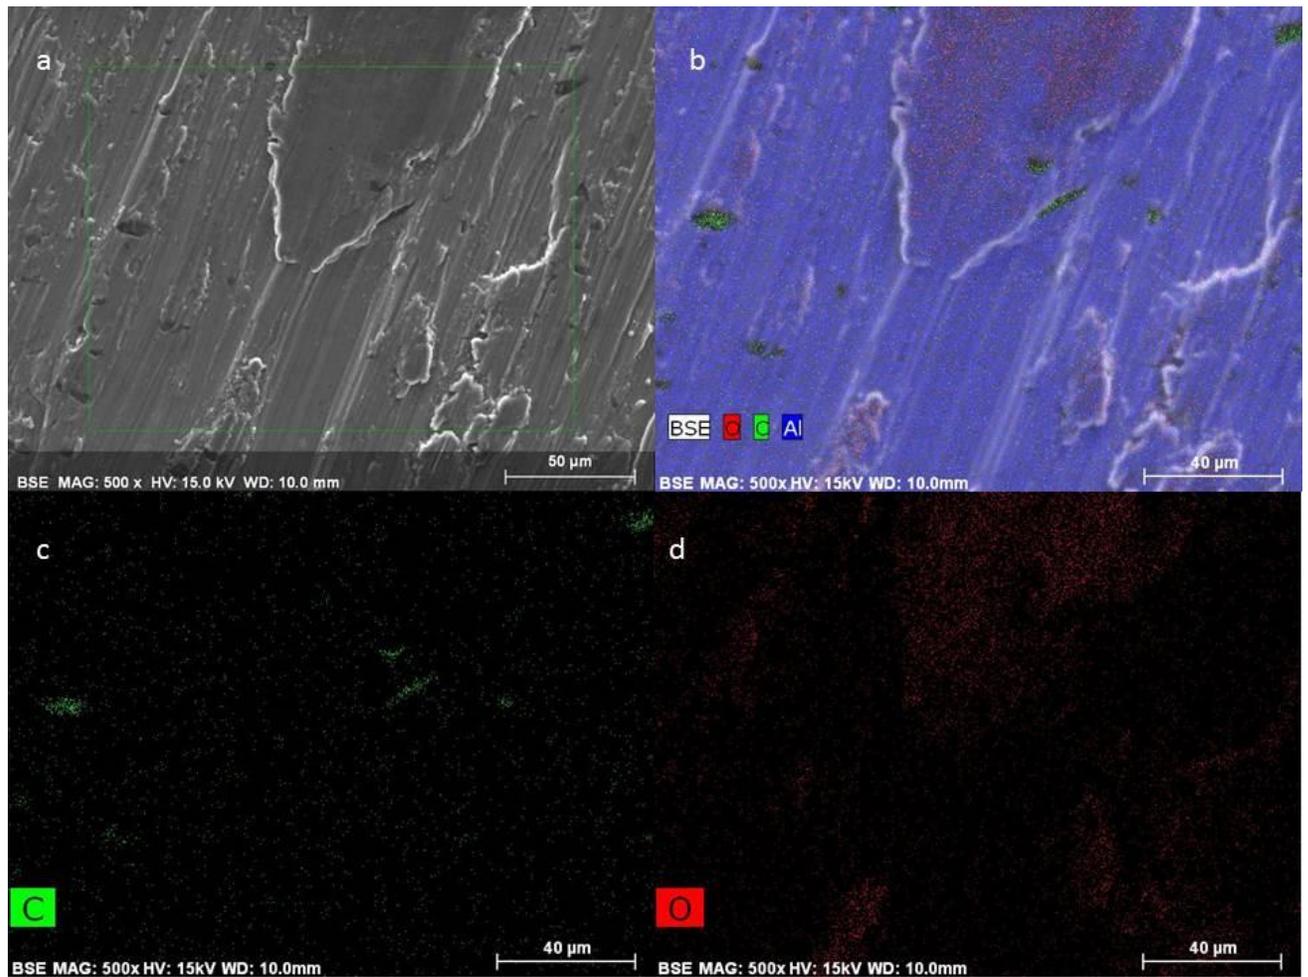
Figure 4-30 a) ESEM picture of sample 9-5, track 8mm. b) EDS mapping of the highlighted area for O, C and Al. c) Mapping only for C. d) Mapping only for O.

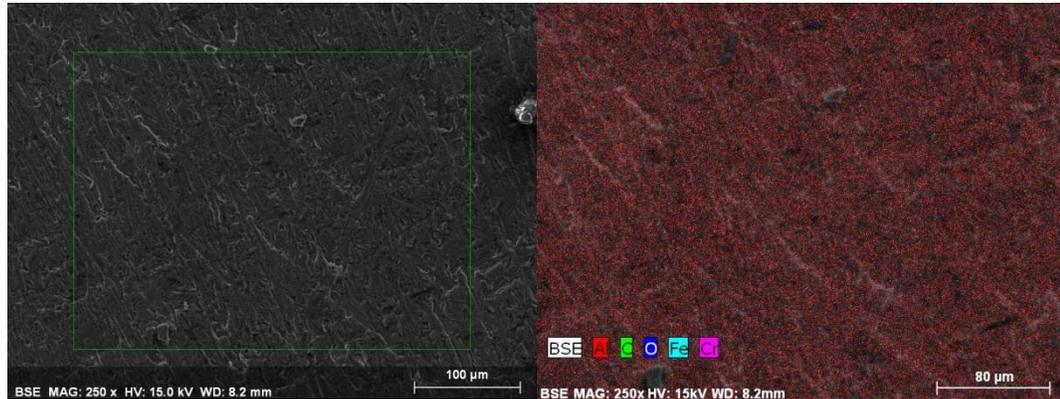
Figure 4-31 EDS mapping made on the center of sample 10-4. No oxides are revealed.

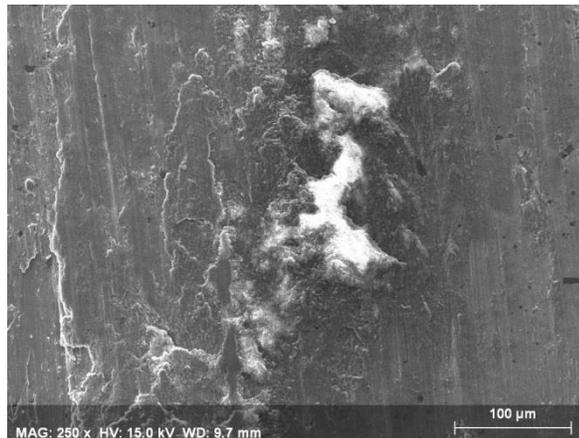
Figure 4-32 A cluster found in sample 9-4, 8mm track. The EDS analysis revealed that it is made of oxide.

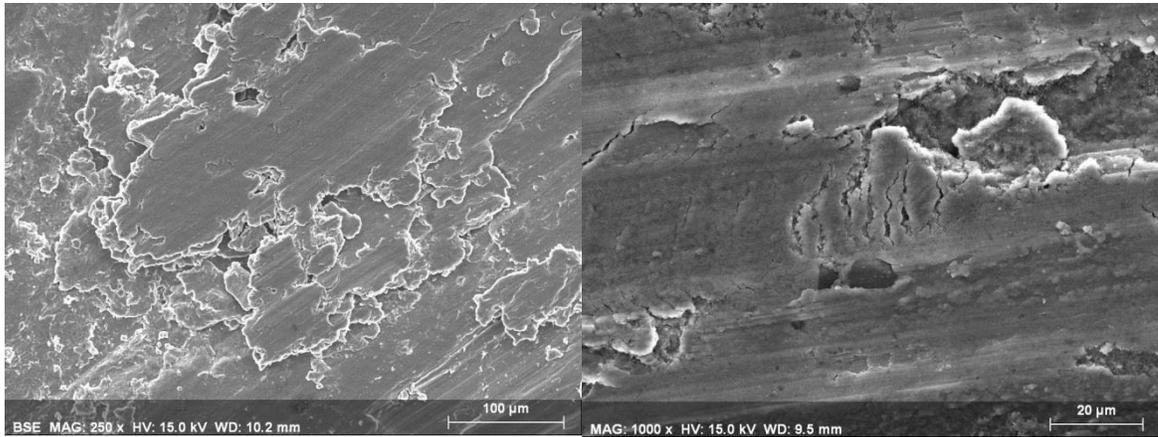
Figure 4-33 Broken oxide layer. On the left sample 12-3 10mm track. On the right sample 10-3 10mm track.

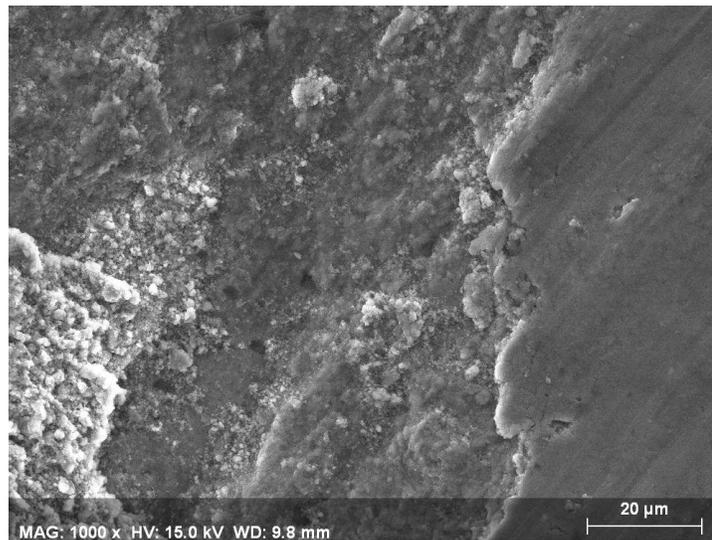
Figure 4-34 Debris material observed in sample 9-4, 8mm track.

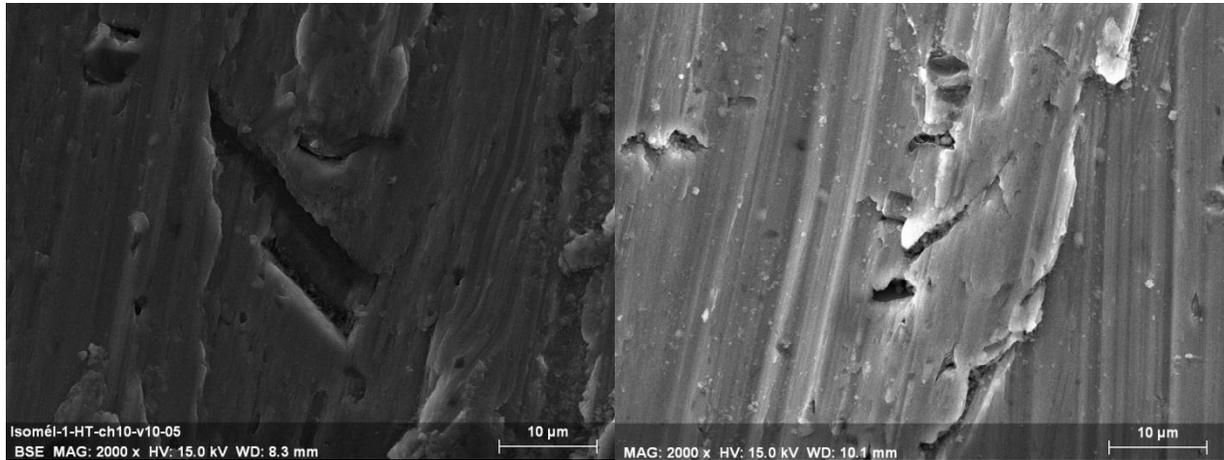
Figure 4-35 Holes left by the removed fibers. On the left sample 10-4 8mm and on the right sample 10-5 8mm.

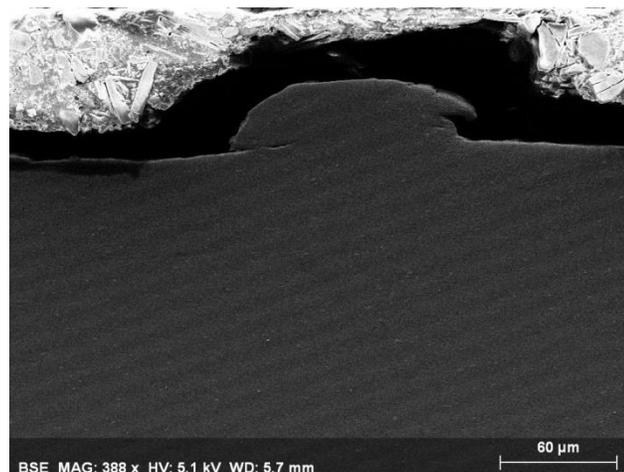
Figure 4-36 Sample 13-5, 8mm track. It is possible to notice the material on the edge of the track.

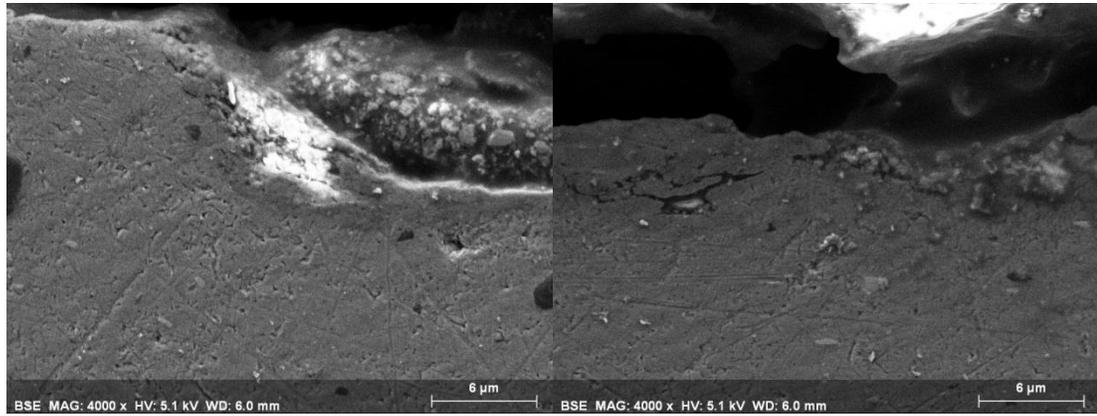
Figure 4-37 Sample 10-3, 10mm track. In the right picture we can see some cracks at the junction between the debris layer and the aluminum matrix.

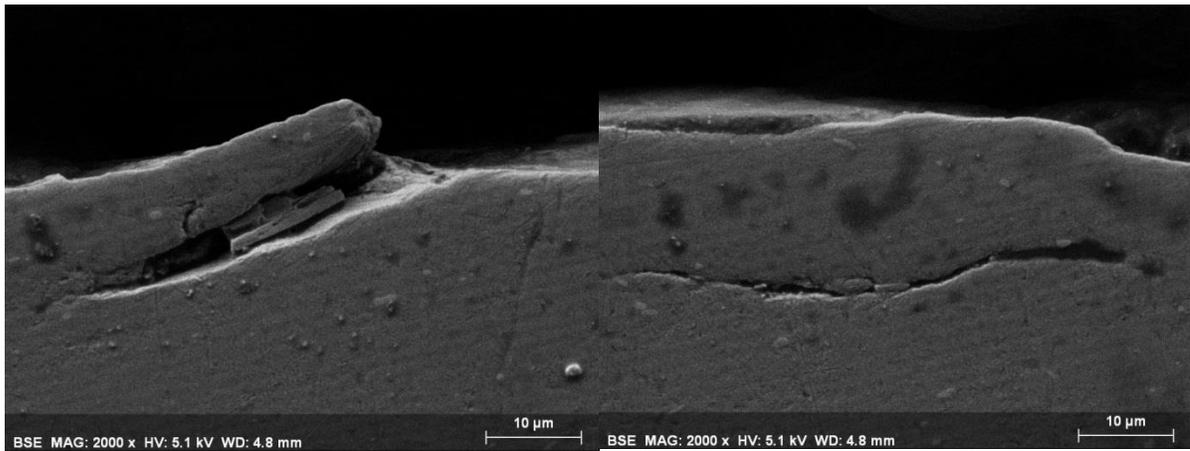
Figure 4-38 Sample 12-5, 10mm track. Other particulars of the debris layer.

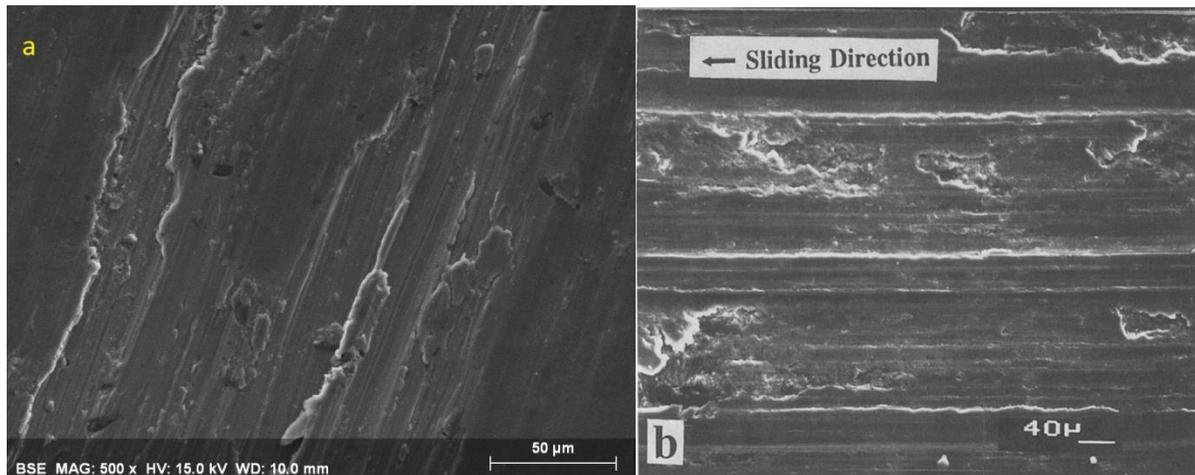
Figure 5-1 a) SEM image of the surface of the inner track (8mm) in sample 9-5. b) SEM image of a wear track made by Zhang and Alpas [63] in mid wear regime.

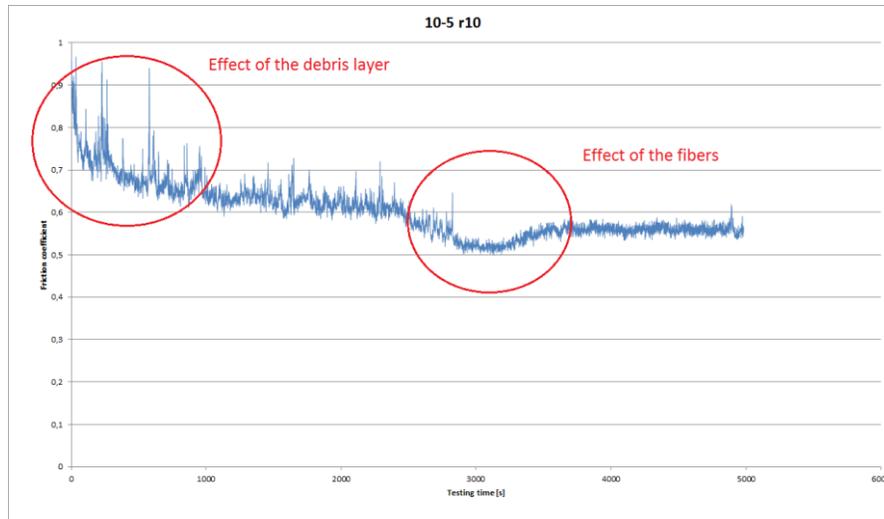
Figure 5-2 Evolution of the friction coefficient for the 10mm track of sample 10-5. The effects of the debris layer and of the fibers are highlighted.
