## Le recul stratégique comme méthode de lutte face à l'érosion du littoral

**Auteur :** Verspieren, Sophie

**Diplôme :** Master architecte paysagiste, à finalité spécialisée

# ANNEXES

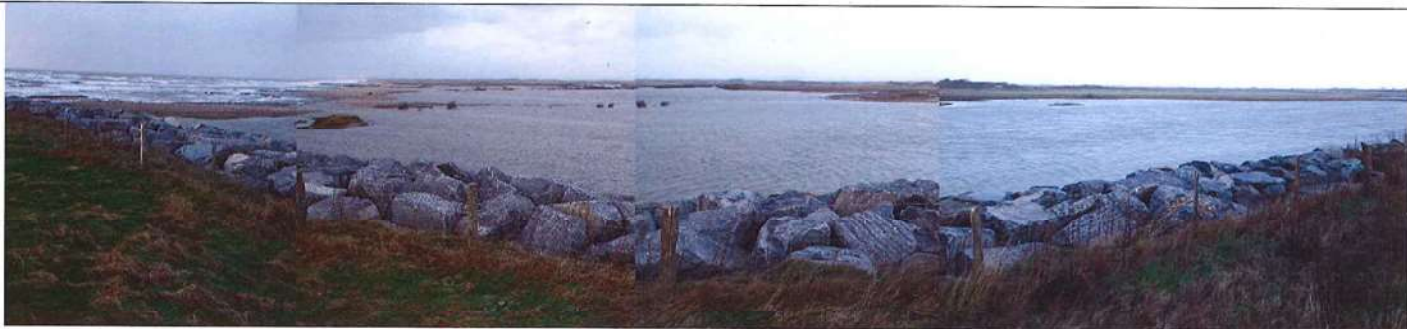
01/01/2018 – Storm at Medmerry. Taken from the Eastern arm near Bunn Leisure.

Shows the wave energy being dissipated as it flows into Medmerry over the top of the old beach.

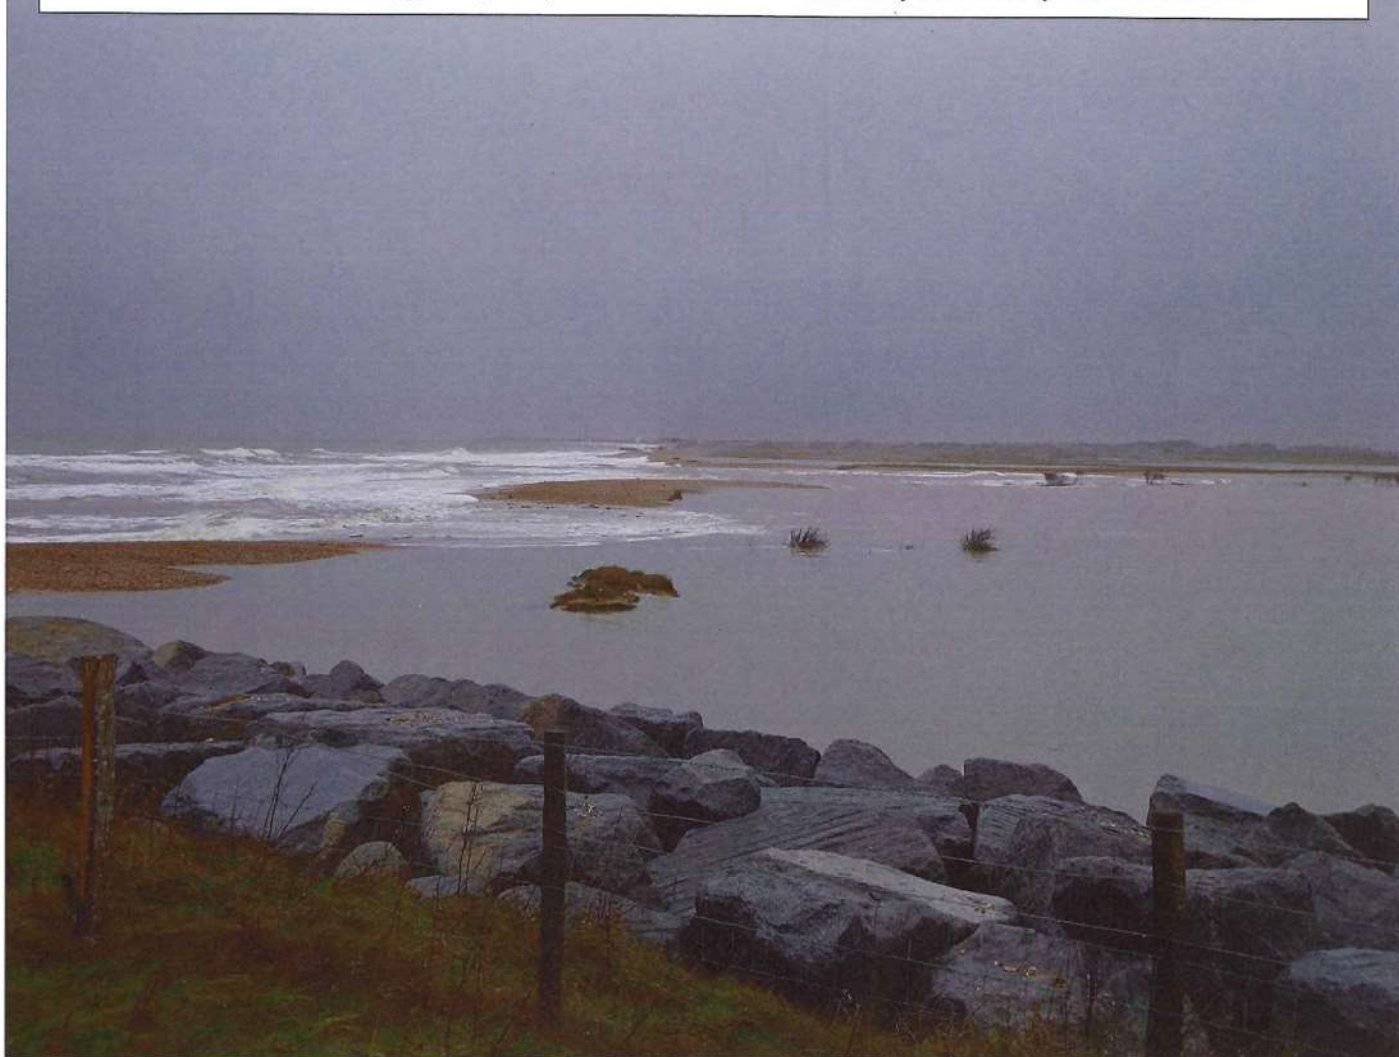
PHOTOGRAPH 1

01/01/2018 – Storm at Medmerry. Taken from the Eastern arm near Bunn Leisure.

Shows the wave energy being dissipated as it flows into Medmerry over the top of the old beach.

THE VOLUME OF WATER MEDINERRY CAN TAKE FROM THE SEA IS  
PREVENTING FLOODING. IT ALSO REMOVES WAVE ENERGY (PHOTOGRAPH 1)

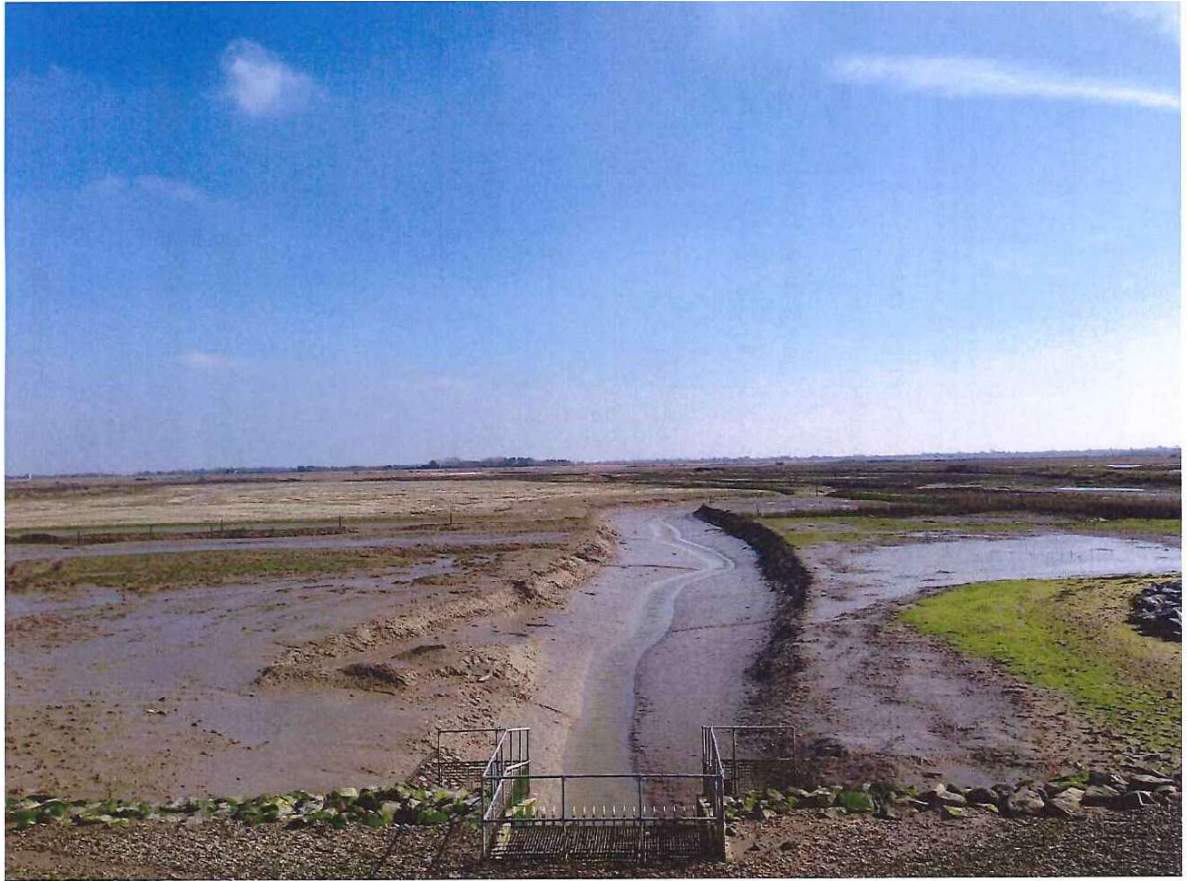
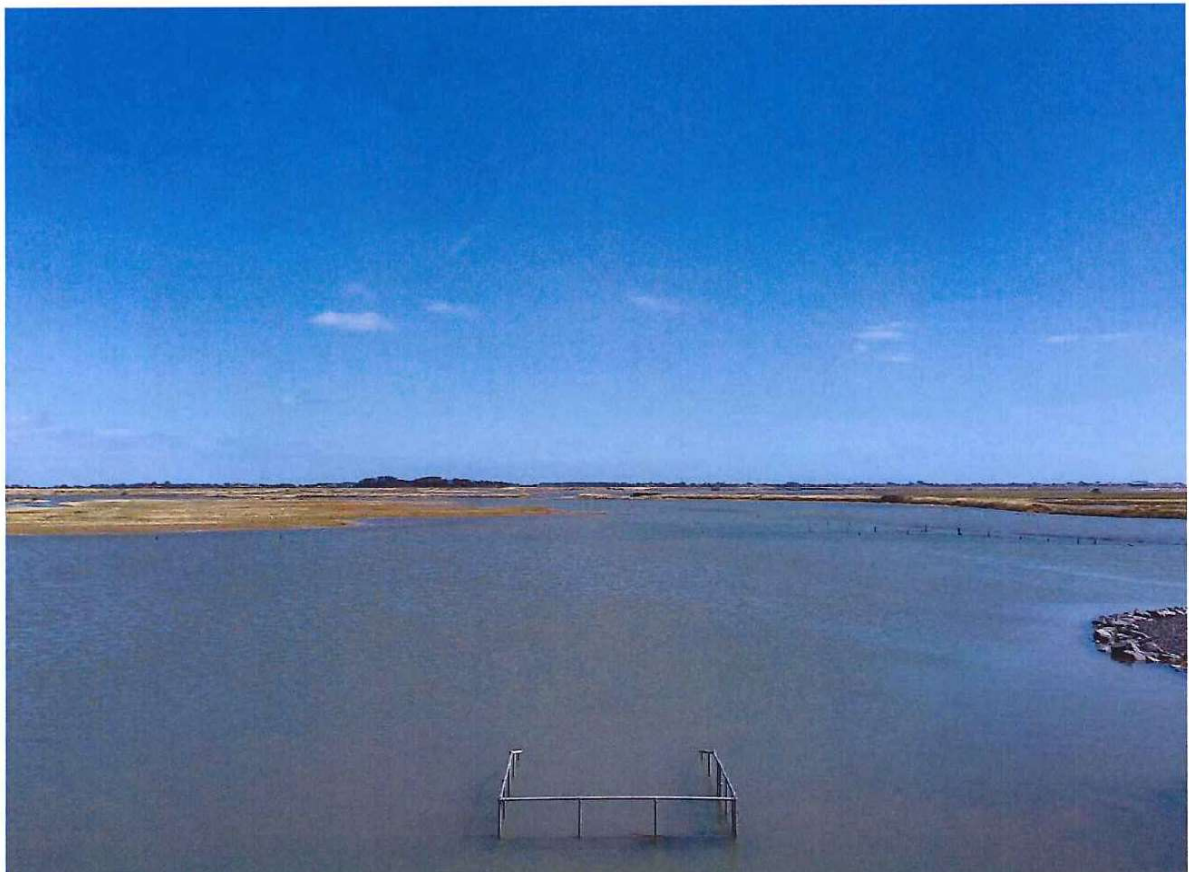
**ANNEXES 7: Photographies montrant le paysage à marée basse et marée haute.**

Difference in low tide (above) and a very high tide at one of the freshwater outfalls. Location shown on the map.

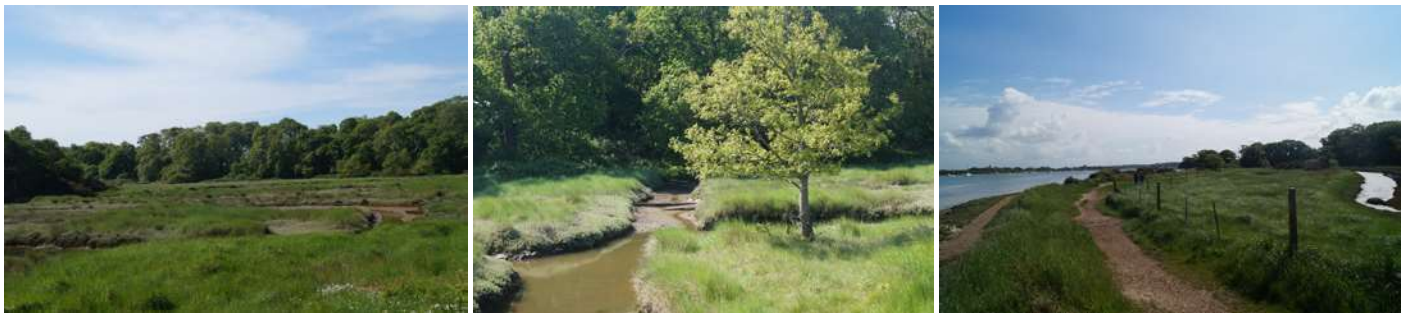
**Site 1:** Chalkdock Marsh. Controlled tidal restoration: 2000, Area: 3.2 ha, Zone : 31135 m<sup>2</sup>

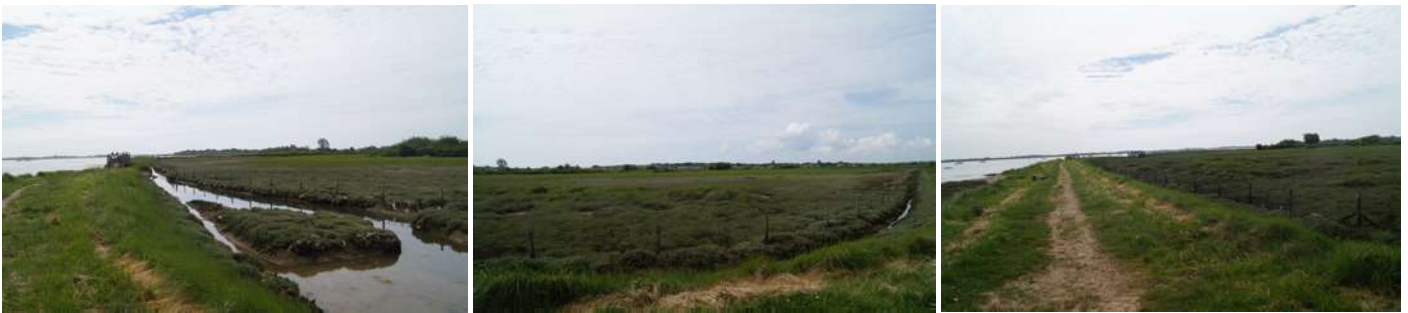
**Site 2:** Thornham Point. Breach of defence: 1997, Area: 7 ha, Zone : 61153 m<sup>2</sup>

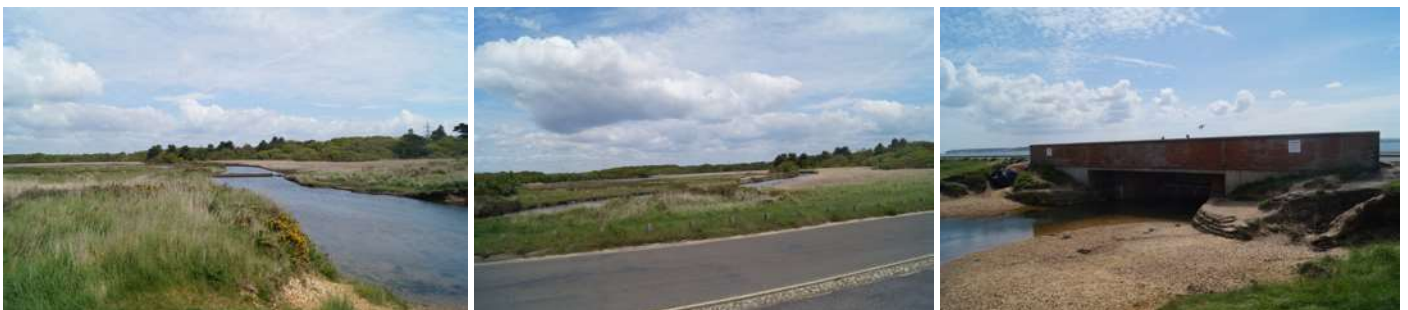
**Site 3:** Lepe-Darkwater, Controlled tidal restoration: 2007, Area: 5 ha, Zone : 31393 m<sup>2</sup>
